# Hot vulcanising vs cold bonding for pulley lagging application – what are the differences?

This technical bulletin provides details on the differences between hot vulcanized lagging and cold bonded lagging, and how these differences impact the end use performance.”

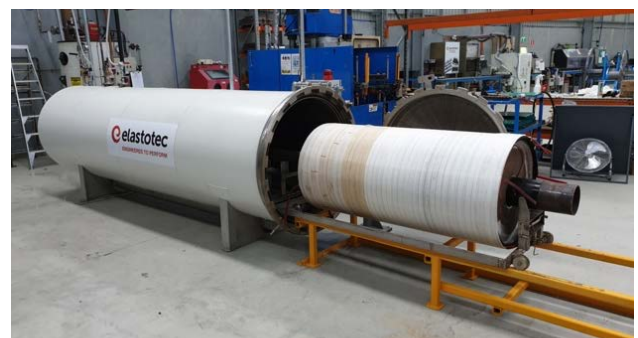
PHOTO #1

Hot vulcanized lagging application involves curing the lagging at elevated temperature, typically 140-160°C for 3-6 hours. This necessitate the use specialized equipment called an autoclave (PHOTO #1) and can only be done in factory setting. Hot vulcanized lagging cannot be done in the field or with the pulley installed on the conveyor.

Hot vulcanized lagging is also applied at room temperature with similar steps to those above, but with the final curing process done in a pressure vessel called an autoclave at an elevated temperature of 140-160°C. The differences between the cold bonded and hot vulcanized application process detailed above result in a number of performance outcomes, specifically:

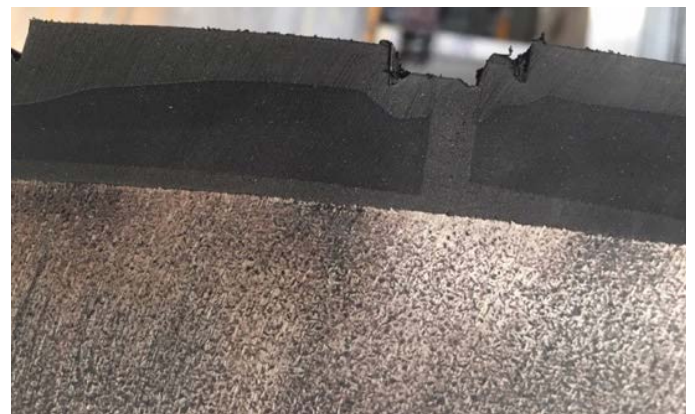
PHOTO #3

5. Rubber tear chemical bonds over the entire pulley surface and at the joints between strips – effectively the joints between strips disappear as shown in the photo below:

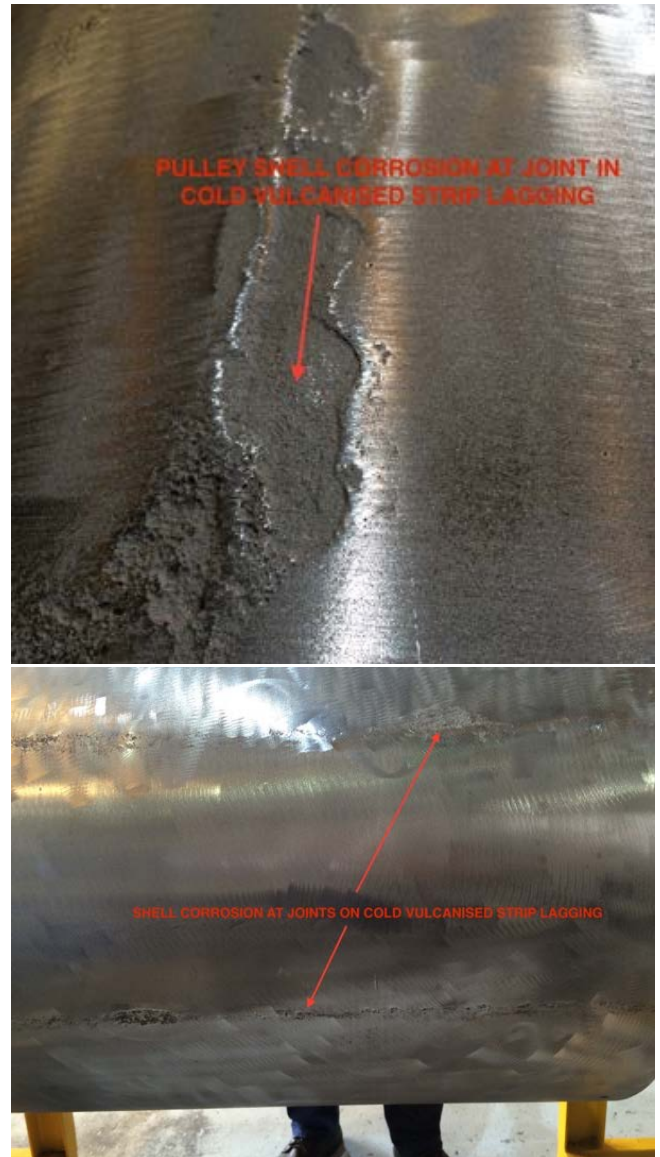
PHOTO #4

PULLEY SHELL PITTING FROM CORROSION DUE TO WATER INGRESS BETWEEN LAGGING STRIPS

For the corrosion failure at the joints between lagging strips this can also result in additional unnecessary expense when the depth of the corrosion reduces the shell thickness below what is required for the designed operating loads, and the pulley has to be scrapped.

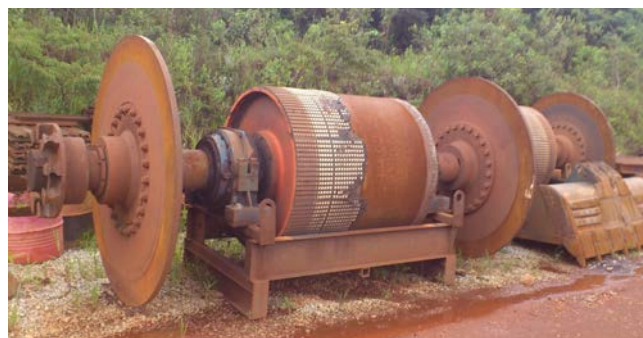
PHOTO #6

CATASTROPHIC CERAMIC LAGGING FAILURE DUE TO DEBONDING FROM THE PULLEY SHELL

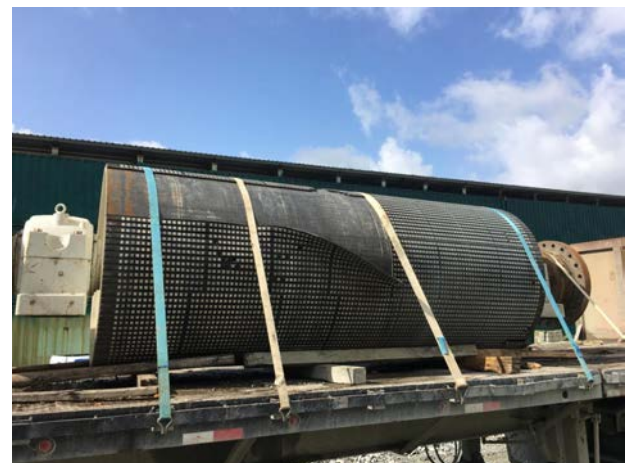
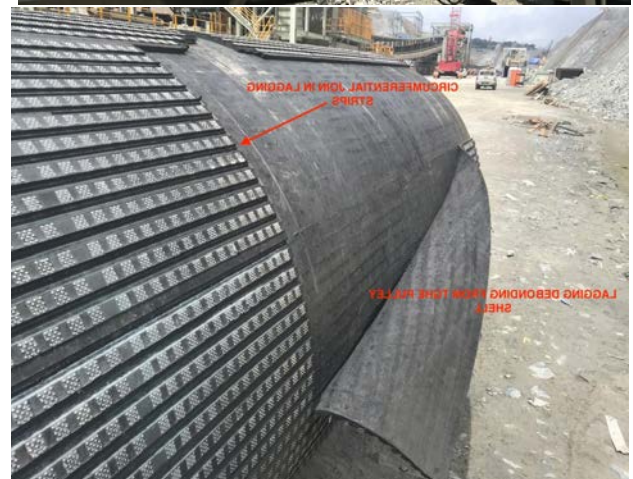
PHOTO #7

An additional factor that increases the likelihood of failure with cold bonded lagging is presence of localised shear forces. In drive pulleys as the T1/T2 ratio increases the cyclic shear forces that the lagging is exposed to increase. Cold bond lagging has a lower tolerance to these cyclic shear forces than hot vulcanised lagging and so conveyor working conditions such as stop/start operation or higher loadings when production tonnages are increased can result in de-bonding that would not occur with hot vulcanised lagging. The photos below show a pulley with cold bonded lagging that failed within two weeks of installation at a new site. The conveyor was being set up so there was a lot of stop/start operation with a high T1/T2 ratio (>4).

DRIVE PULLEY COLD BOND LAGGING FAILURE AFTER TWO WEEKS FROM INSTALLATION ON A NEW CONVEYOR WITH STOP/START APPLICATION

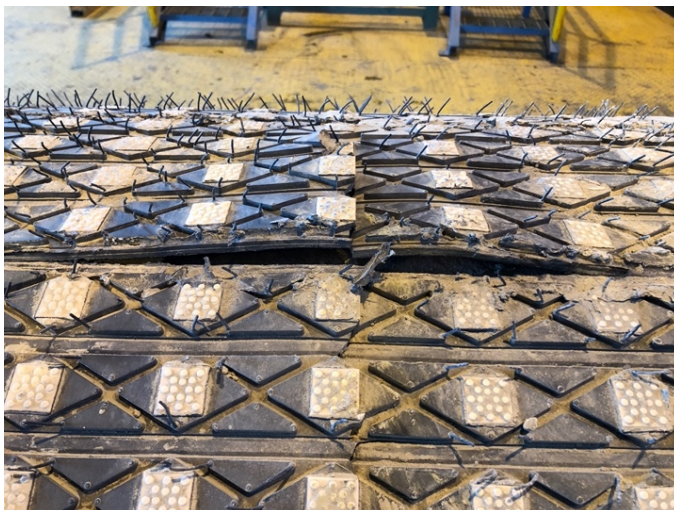
PHOTO #8

The photos below show a pulley with cold vulcanised lagging that failed shortly after installation in operating conditions at -35°C. Note the raised rubber lips on the surface of the pulley are still intact and have not had time to be worn away.

**COLD VULCANISED LAGGING FAILURE DUE TO DEBONDING UNDER LOAD AT LOW TEMPERATURE**

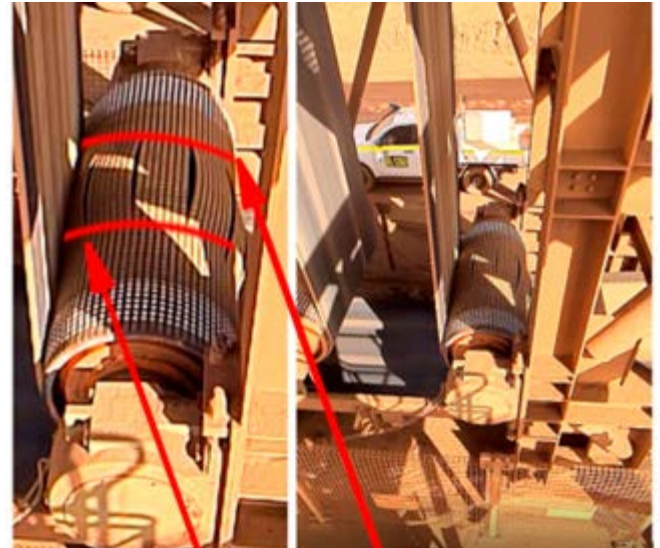
PHOTO #9

Similar de-bonding failure can occur on non-drive pulleys that are subject to high localised shear forces – this is most commonly seen in pulleys that contact the dirty side of the belt but can also be seen on snub pulleys and turnover pulleys (refer to the photo below).

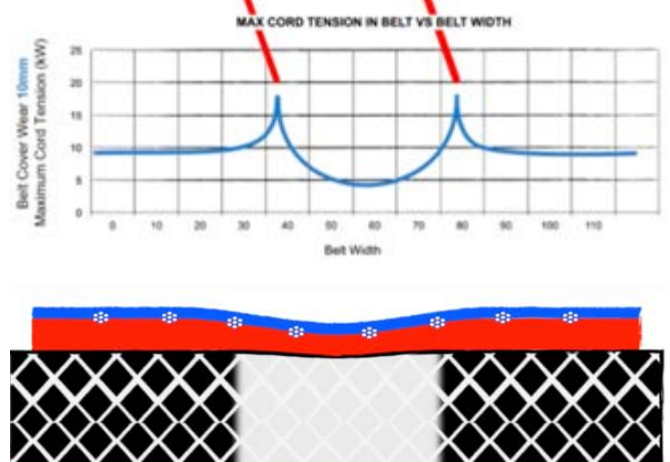
FIGURE #8

For pulleys that contact the dirty side of the belt the localised shear forces are generated by the uneven profile that results from the belt cover wear with increasing levels of wear leading to increasing localised shear forces. A detailed technical paper on this issue is available from Elastotec ELA1220-High Tension Bend Pulleys.

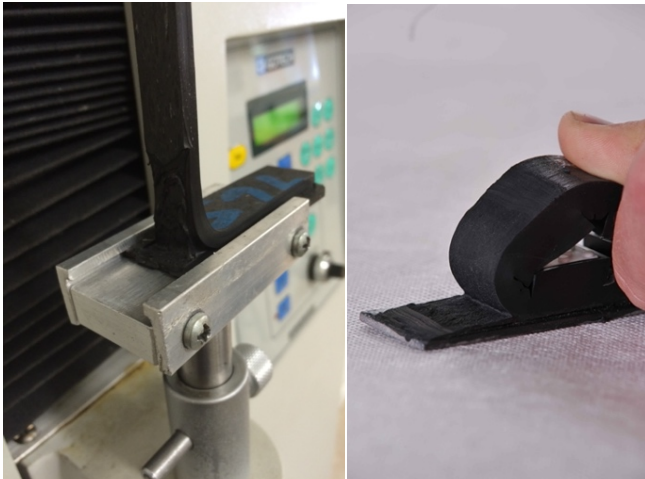
PHOTO #10

Elastotec Hot Vulcanised Ceramic Lagging (HVCL) provides a guaranteed 100% rubber tear bond between the lagging and the pulley shell that achieves 20-25 N/mm adhesion strengths – roughly double the adhesion that can be obtained through cold vulcanised lagging application under ideal conditions.

100% RUBBER TEAR BOND OBTAINED WITH HOT VULCANISED LAGGING APPLICATION AND TESTED ON EVERY ELASTOTEC LAGGED PULLEY

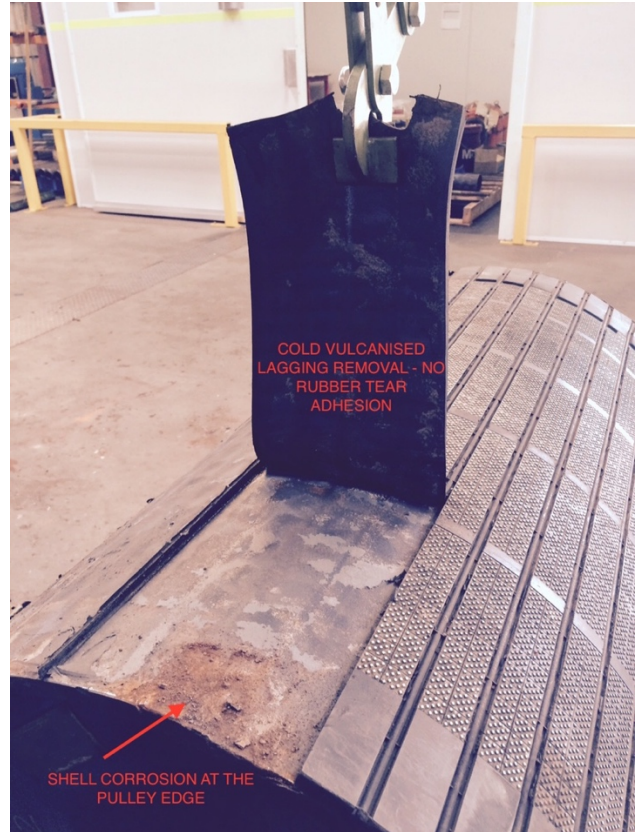
PHOTO #11

The following photo shows a common method of removing cold vulcanised lagging from the pulley shell by applying a load to the lagging at 90 degrees to the pulley.

For Elastotec HVCL the bond is so strong that if this technique is tried the pulley can be lifted by the lagging or the lagging will tear – there is no debonding from the pulley shell.

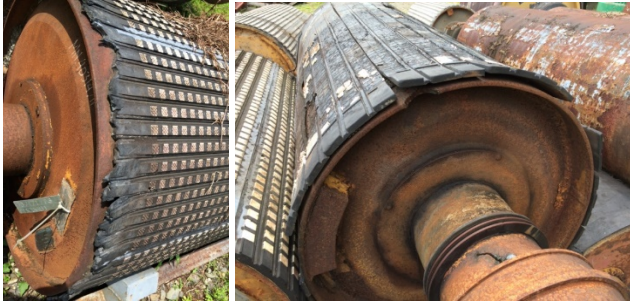
PHOTO #12

Edge lifting of pulley lagging is a common mode of failure for pulleys operating in wet or corrosive conditions that have cold vulcanised pulley lagging.

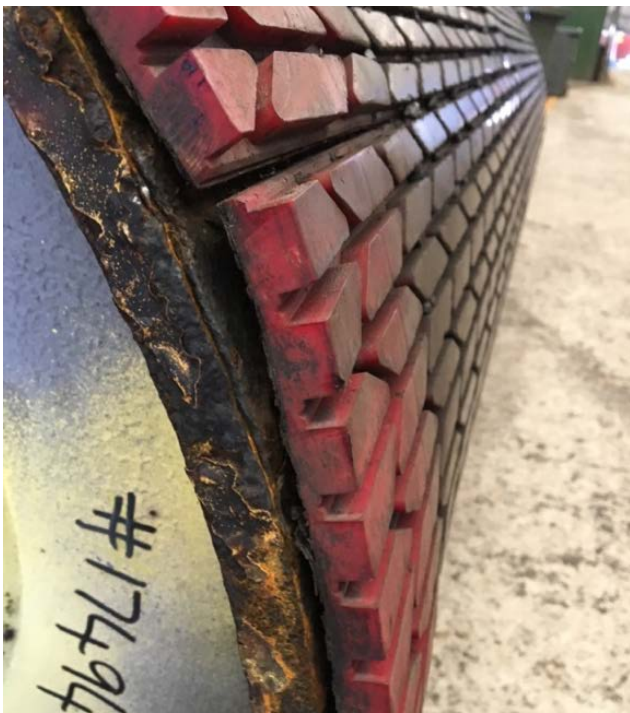
PHOTO #13

In many cases of edge lifting failure the pulley lagging itself is still fully serviceable – the photo below shows a pulley lagged with cold vulcanised polyurethane and put into service in a coal wash plant. Shell corrosion has started at the shell end and has resulted in the lagging separating from the pulley in this area. The photo also shows that the lagging is not worn and would be serviceable if the edge lifting had not occurred.

EDGE LIFTING OF COLD VULCANISED PU LAGGING OPERATING IN A COAL WASH PLANT

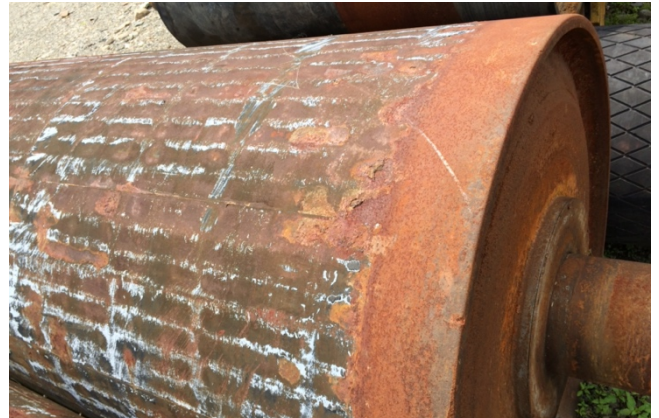
PHOTO #14

FAILED PULLEY WITH COLD VULCANISED LAGGING REMOVED TO SHOW EDGE CORROSION RESIDUAL ADHESIVE PATTERN

The light grey pattern is where a layer of adhesive remains on the pulley shell after the lagging has been removed. This corresponds to recesses in the lagging profile. The areas that have no adhesive are the raised sections of the lagging which have been hammered down during the cold vulcanising application process.

This has resulted in greater contact and adhesion between the lagging and the pulley shell directly below the raised lagging areas, and lower contact and adhesion in the recessed lagging areas. When the pulley shell ends are exposed to wet conditions the water is able to penetrate between the lagging and the pulley shell at the areas below the recessed lagging profile. Once shell corrosion begins it quickly spreads around the shell end and the lagging lifts from the pulley shell and is easily damaged (see photos below).

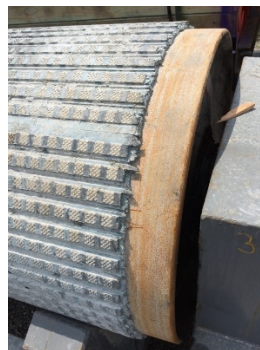
PHOTO #15

SEVERE LAGGING DAMAGE DUE TO EDGE LIFTING AND BELT TRACKING

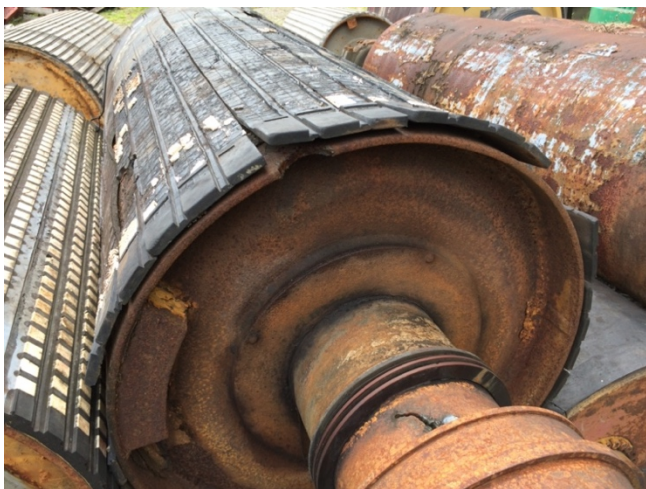
PHOTO #17

The two photos below show the results of operation at the same mine site of a pulley lagged with cold vulcanised ceramic lagging and one lagged with Elastotec Hot Vulcanised Ceramic Lagging. Both pulleys were installed at a large copper mine and operated in wet conditions where the water was acidic. There is corrosion evident on the end discs and locking elements of both pulleys. On the pulley with the cold vulcanised lagging there is severe edge lifting failure. The pulley with the HVCL shows no sign of edge lifting and the lagging remains fully serviceable.

COLD VULCANISED APPLICATION

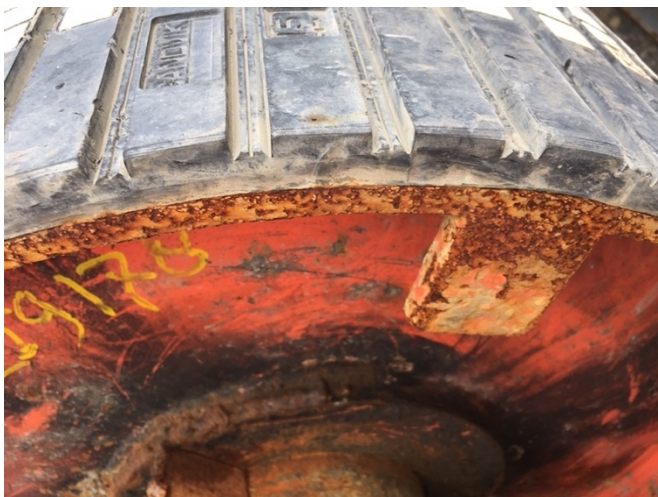
PHOTO #18

HOT VULCANISED APPLICATION

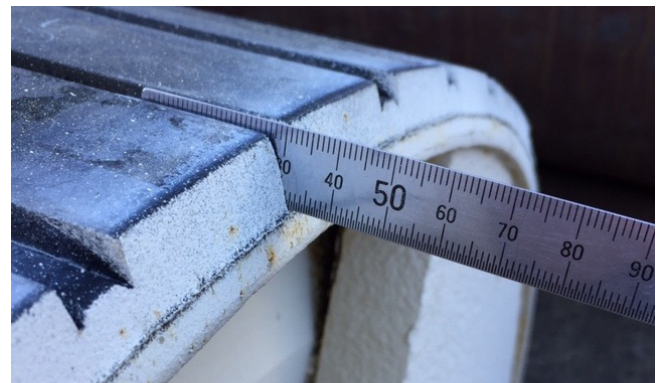
PHOTO #19

With regard to application techniques and workmanship many lagging applicators use a technique called “butt” lagging where each lagging strip is “butted” up against the previous strip. Depending on the skill and care of the operator the result can vary from having no gap between strips to having a gap several mm wide (see photo). It is common for lagging applicators to use liquid sealants such as “Sikaflex” to fill in gaps at the joins – the use of sealants to fill gaps will ensure lagging failure in wet conditions.

COLD VULCANISED LAGGING GAP BETWEEN LAGGING STRIPS

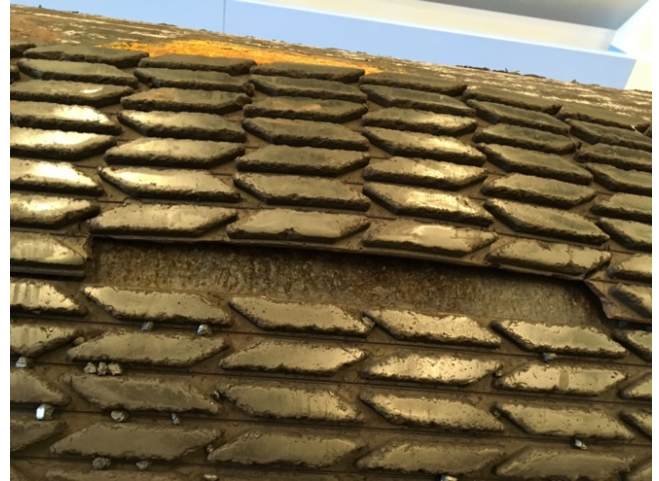
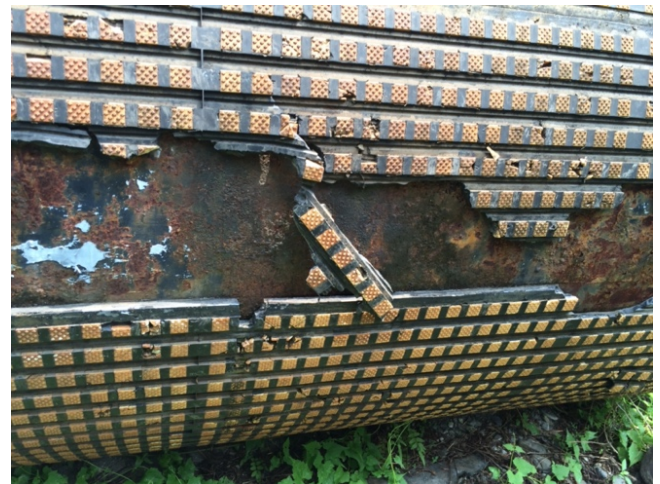
PHOTO #20

Eventually this corrosion leads to debonding of the lagging along the joints – see photos below.

CORROSION AND LAGGING DEBONDING AT JOINTS BETWEEN COLD VULCANISED LAGGING STRIPS DUE TO WATER PENETRATION

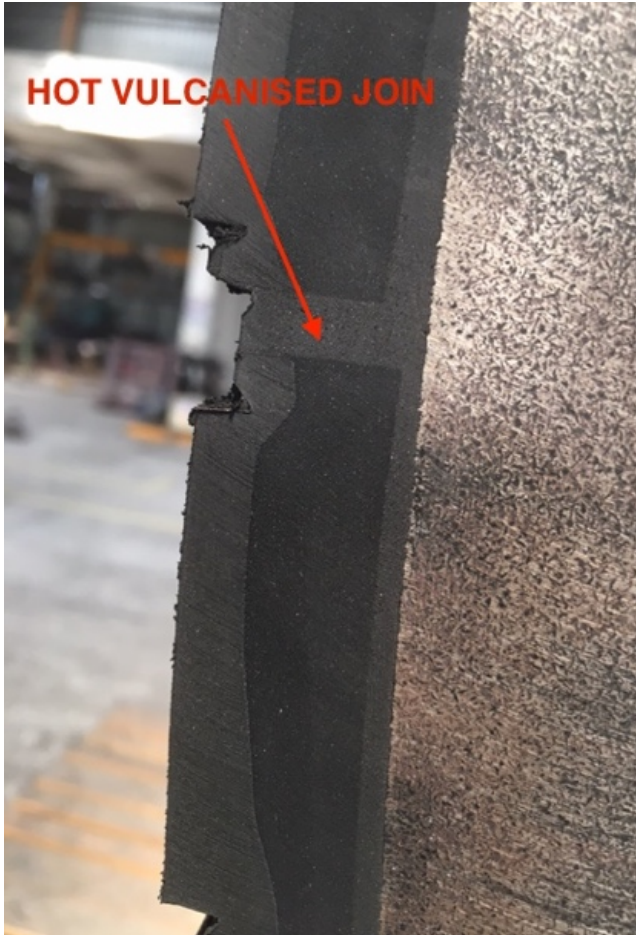
Hot vulcanised lagging eliminates joint failure and the resultant debonding of the lagging and corrosion damage to the pulley shell.

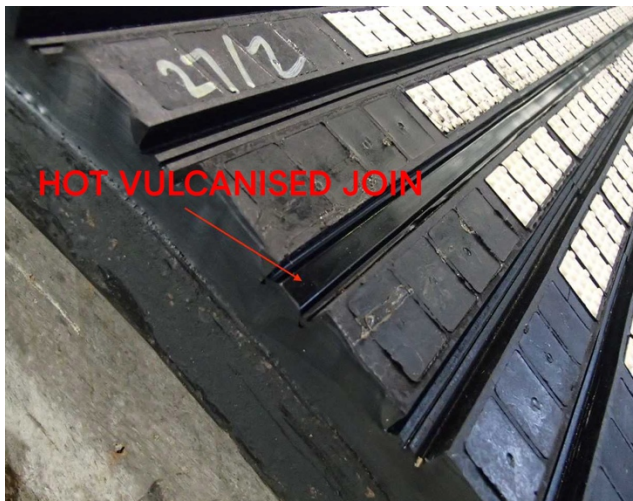
PHOTO #21

When hot vulcanised lagging is applied to the pulley shell there are no joints between the strips as the unvulcanised bonding layer along the edge of each strip fuses together to form a continuous lagging sheet with no joints or weak points between strips.

HOT VULCANISED JOIN COMPLETELY SEALED FROM THE LAGGING SURFACE TO THE PULLEY SHELL – NO CHANCE OF SEPARATION OR WATER PENETRATION
