CONSEQUENCES OF CATASTROPHIC FAILURE WITH COLD BONDED LAGGING FOR NEW MINING PROJECTS

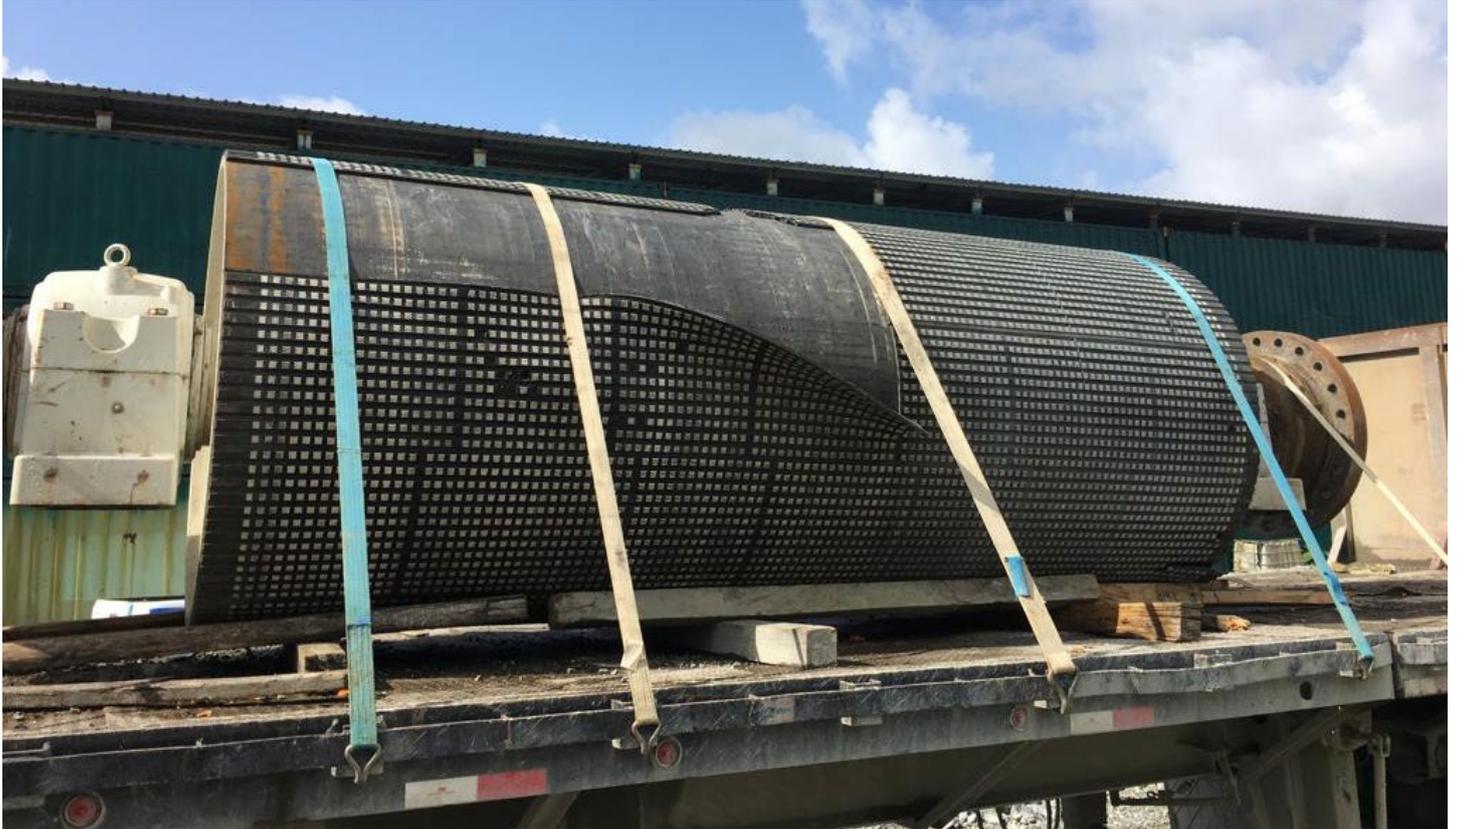
The photo above is one of four new pulleys supplied earlier this year to a new mine site undergoing commissioning and commencement of production – this was the first pulley placed into service.

Catastrophic lagging failure due to debonding occurred within two weeks of installation and operation of the pulley, resulting in a shutdown of production, and necessitated a replacement of the pulley. Within only two weeks of service, this ceramic lagging was already experiencing loss of the ceramic tiles.

The second pulley put into service as a replacement also suffered the same catastrophic lagging debonding, and resulted in a second plant shutdown. At this point, the conveyor component manufacturer PROK was contacted by the customer to evaluate and provide a solution to the failure. The pulleys in question were cold bond lagged and provided by another well-known pulley manufacturer.

PROK engaged partner supplier Elastotec to work on a solution. Our recommendation was for both new and refurbished pulleys to be applied with hot vulcanised lagging. The reason for this is that the 100% rubber tear bond achieved with a hot vulcanised lagging application, eliminates any chance of lagging failure due to debonding. In this instance, due to time pressure to restart the plant, and the lead time required to ship the pulleys for hot vulcanising, this was not an option, and the Elastotec cold bonded lagging and adhesive system was chosen.

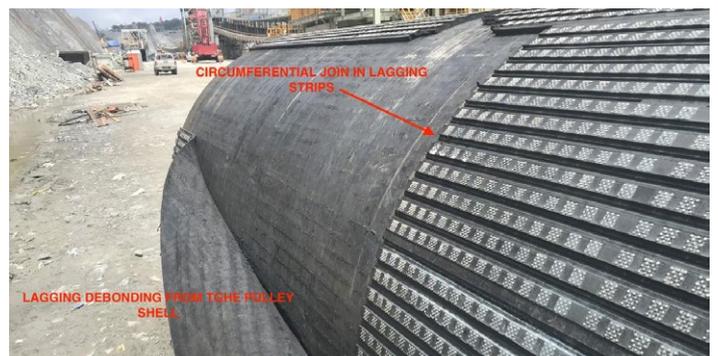
In addition to the catastrophic debonding and the tile loss after only two weeks service, a fundamental flaw in application technique was observed in a circumferential joint in the lagging (see photo below).

These pulleys have a 3600 mm face width and the original applicators have chosen to cut and join shorter strips to cover the 3600 mm pulley. This places a weak point midway across the pulley and greatly increases the risk of a lagging failure. Strip pulley lagging must always be applied as strips that cover the full pulley face width in a single piece.

Elastotec supported PROK to urgently manufacture the 3800 mm long ceramic lagging strips for the four pulleys and had this shipped, with the Elastotec cold bonding system, by airfreight to the mine site. An Elastotec applications engineer was sent to the site to assist with training, and supervision of the lagging application – duplicate adhesion tests were carried out on each pulley lagged, and the results were above the Elastotec requirement of a minimum of 12N/mm. The pulleys are back online and are operating satisfactorily.

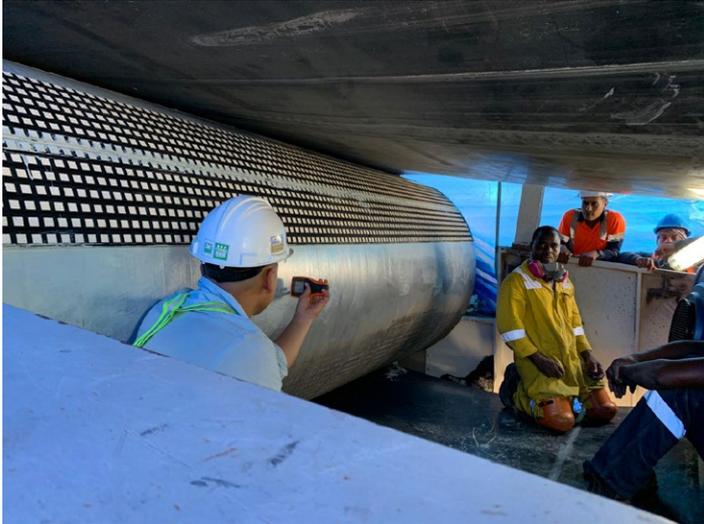
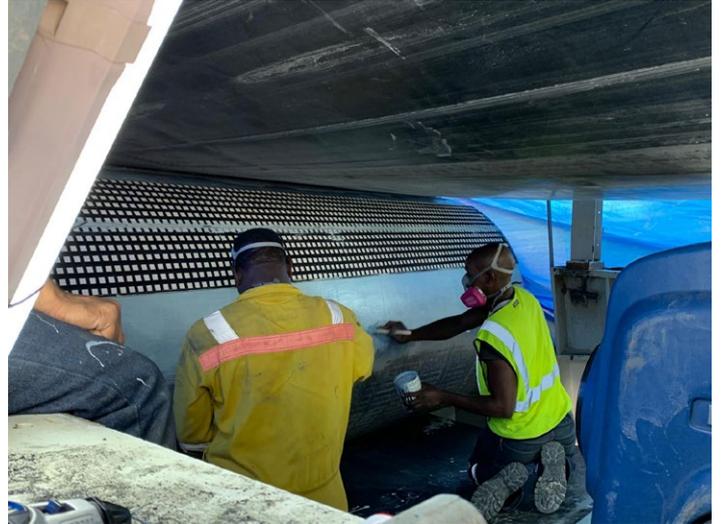
Elastotec ceramic lagging being applied on conveyor with Elastotec supervision and training
