BLUESCOPE STEEL PORT KEMBLA

BlueScope Steel Port Kembla

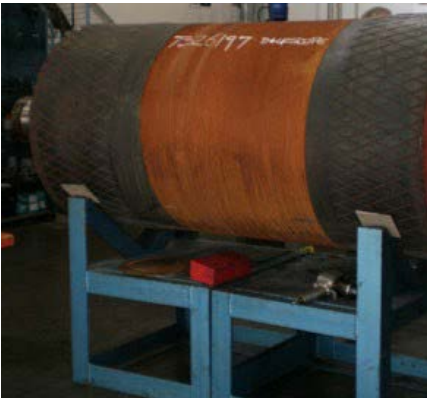
PHOTO #1

Feed stock for the blast furnace is an iron sand material transported by the 501 belt conveyor. The iron sand is highly abrasive and carry back on the belt is causing severe lagging wear on a number of critical pulleys – see photo#1 & 2

Lagging wear down to the pulley shell as shown in Photo#1 was occurring in as little as 2 years and once the steel shell was exposed this also began to wear.

The recommendation to meet these requirements was the PROK/Elastotec Hot Vulcanised Ceramic Lagging (HVCL). This lagging is a composite of highly abrasion resistant 96% aluminium oxide tiles bonded into a rubber backing strip. These strips are then applied to the pulley in a hot vulcanising process where the pulley is placed into an autoclave and the lagging is cooked onto the pulley at 140C under a pressure of 400KPa. This process guarantees a 100% rubber tear bond to the pulley which ensures there is no chance of the lagging debonding.

An additional feature of the recommendation was that the ceramic lagging coverage be extended to the full pulley face width with no rubber end pieces as are used by many lagging suppliers. This was important to eliminate the chance of the rubber end pieces being worn out as a result of the belt tracking from side to side.

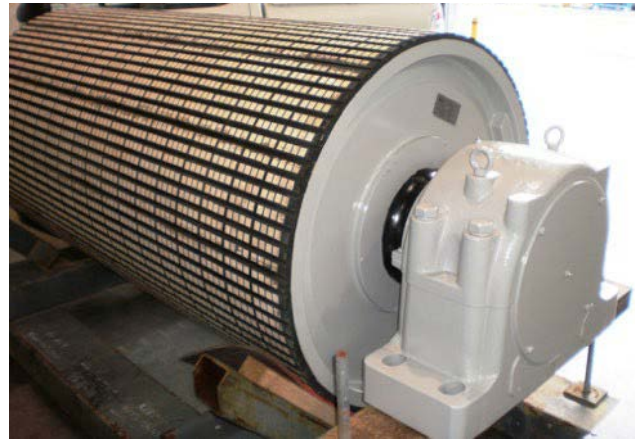
PHOTO #3

BlueScope accepted the PROK recommendation in early 2014 and the first pulley with the HVCL was installed in August 2014 – see Photo #3

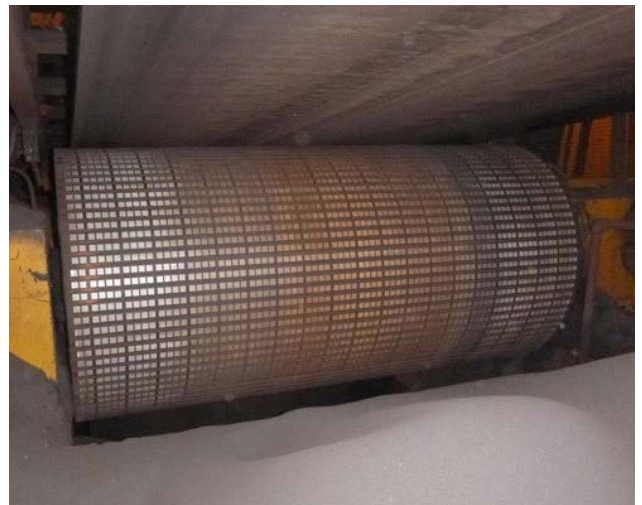
PHOTO #4

This pulley has been inspected at regular intervals since installation with ultrasonic measurements taken on the lagging thickness by BlueScope maintenance staff. At August 2016 there was no significant wear of the HVCL and there is a high degree of confidence that the 5 year service life target will be achieved. See Photos #4 & 5.
