## HOW TO MAXIMISE YOUR PULLEY LAGGING SERVICE LIFE: HOT VULCANISED VS COLD VULCANISED APPLICATION

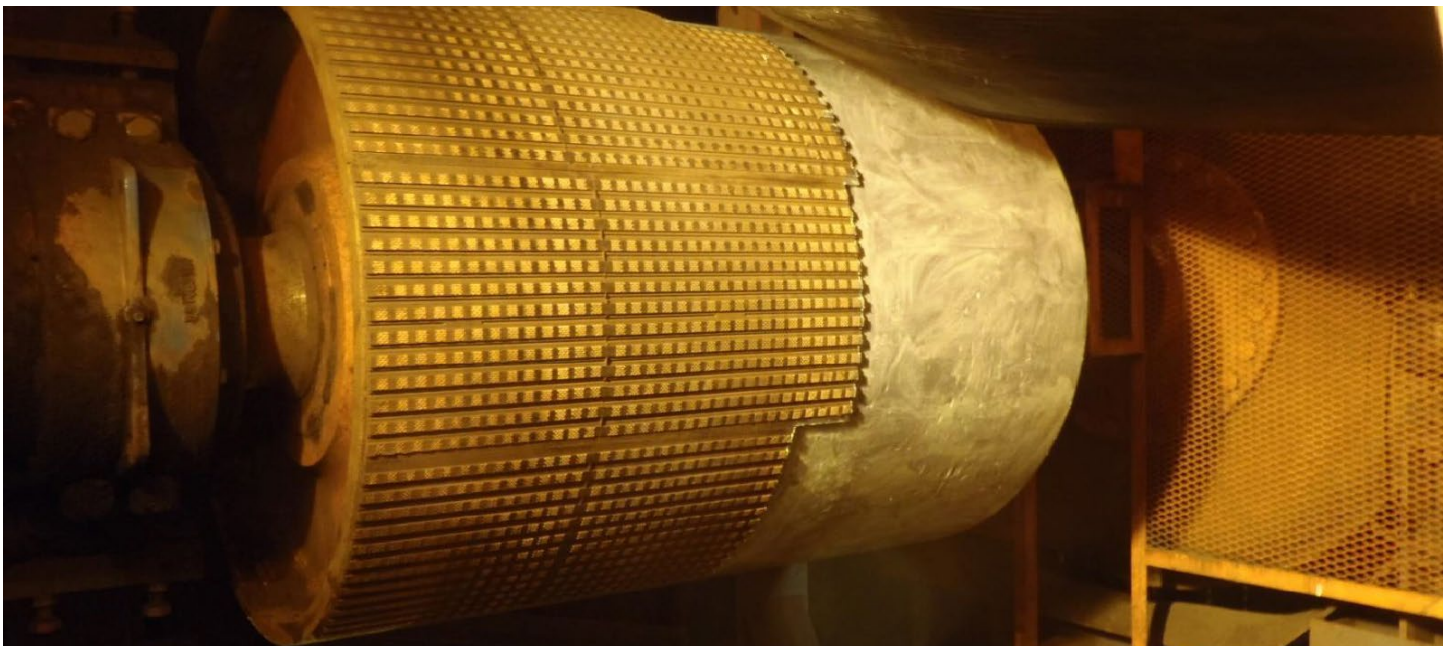
**Photo #1.** Large Drive pulley with cold vulcanised ceramic lagging that has debonded from the pulley shell under load.

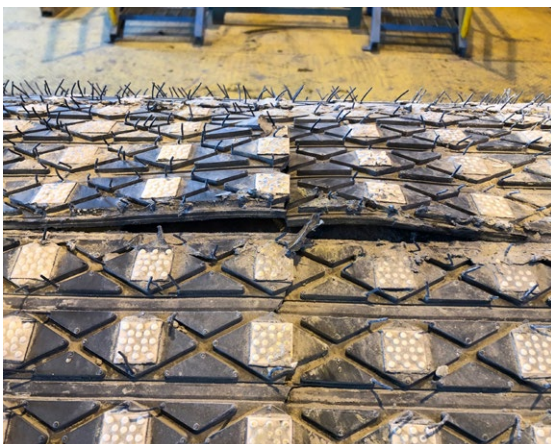
**Photo #2.** Cold vulcanised lagging failure due to debonding under load at low temperature.

Photos #2 and #3 show a pulley with cold vulcanised lagging that failed shortly after installation in operating conditions at -35°C. Note the raised rubber pips on the surface of the pulley are still intact and have not had time to be worn away.

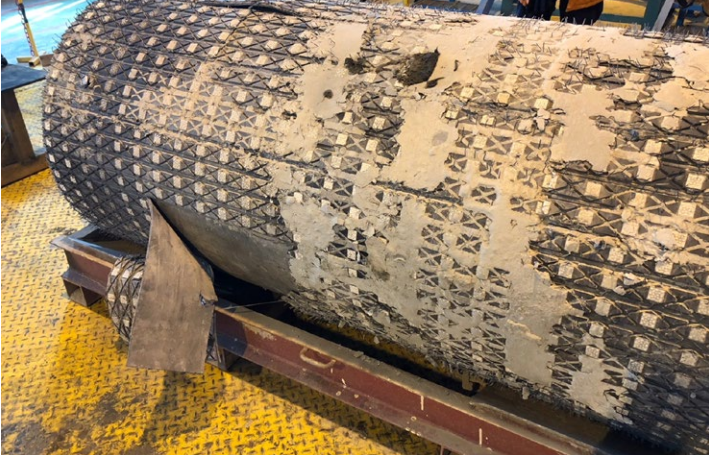
**Photo #3.** Cold vulcanised lagging failure due to debonding under load at low temperature.

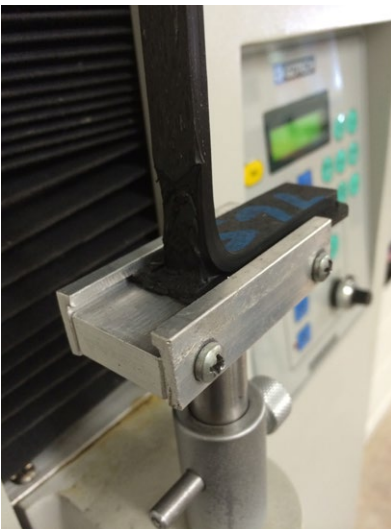
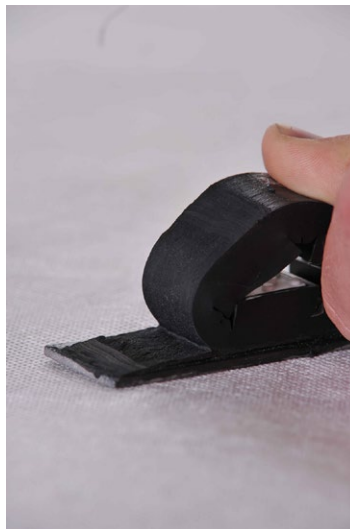
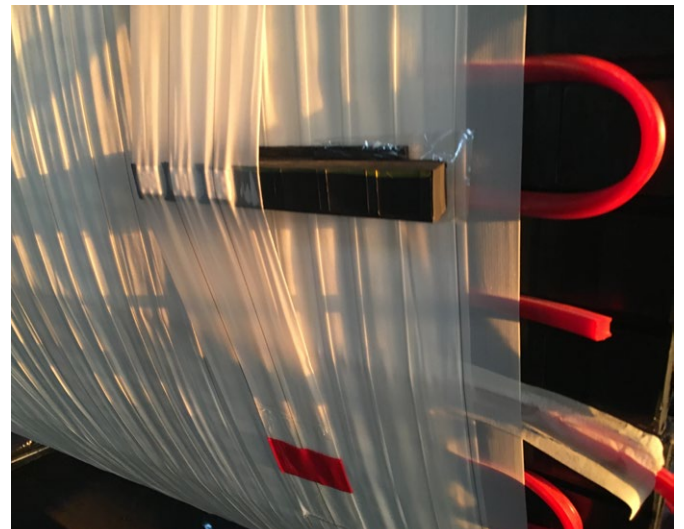
**Photos #4, #5 and #6.** 100% Rubber Tear bond obtained with hot vulcanised lagging application and tested on EVERY Elastotec lagged pulley.

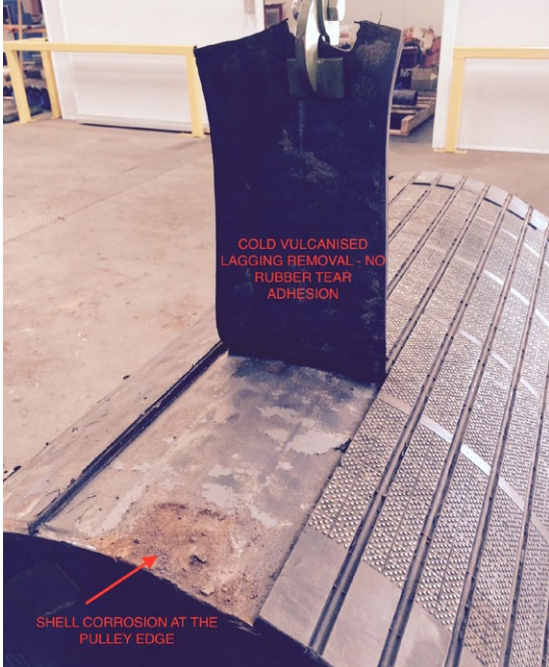
Photo #7.

Photo #7 shows a common method of removing cold vulcanised lagging from the pulley shell by applying a load to the lagging at 90 degrees to the pulley.

For Elastotec Hot Vulcanised Ceramic Lagging, the bond is so strong that if this technique is tried the pulley can be lifted by the lagging or the lagging will tear – there is no debonding from the pulley shell.

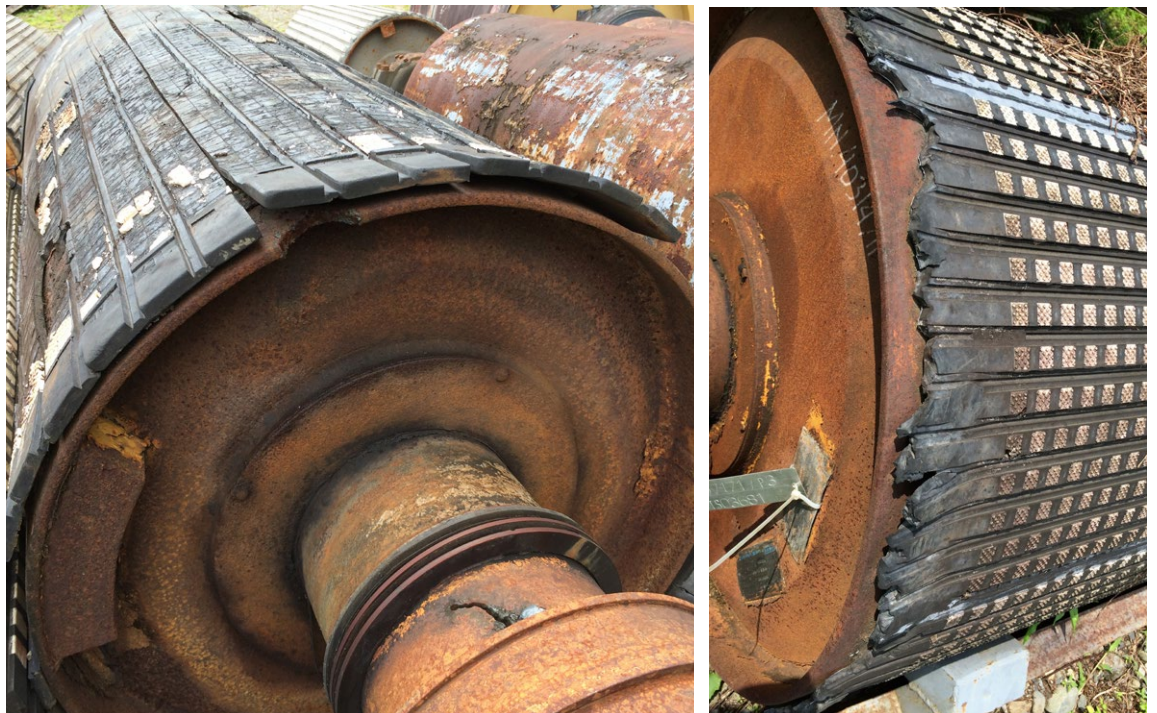
Photo #8 and #9.

Edge lifting of pulley lagging is a common mode of failure for pulleys operating in wet or corrosive conditions that have cold vulcanised pulley lagging.

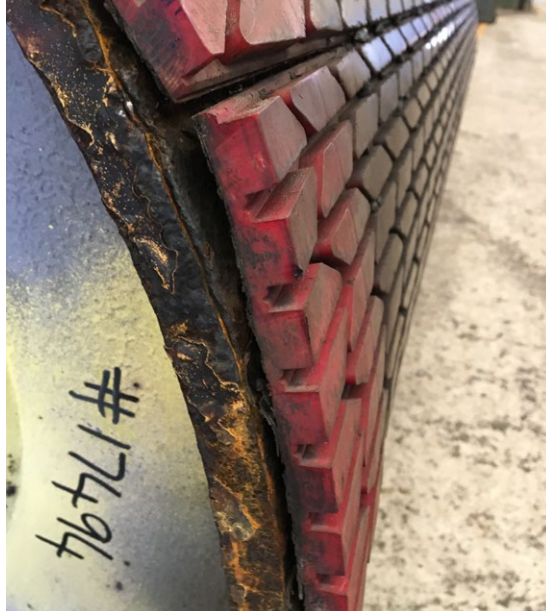
**Photo #10.** Edge lifting of cold vulcanised PU lagging operating in a coal wash plant.

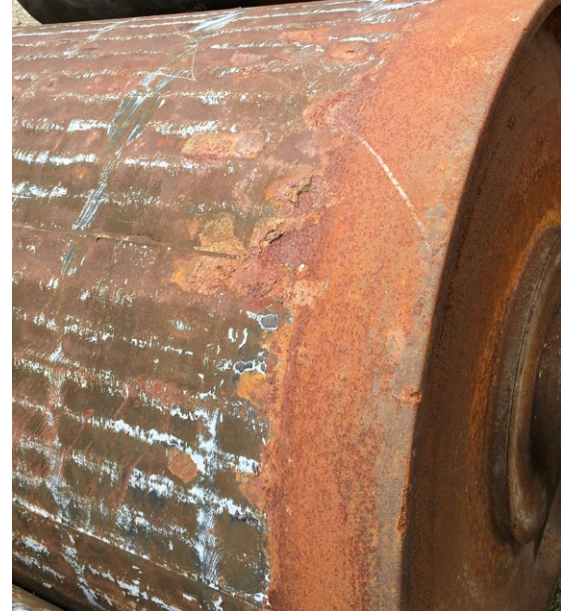
**Photo #11.** Failed pulley with cold vulcanised lagging removed to show edge corrosion residual adhesive pattern.

Photo #11 gives an indication of one of the mechanisms for this failure. The light grey pattern is where a layer of adhesive remains on the pulley shell after the lagging has been removed. This corresponds to recesses in the lagging profile. The areas that have no adhesive are the raised sections of the lagging which have been hammered down during the cold vulcanising application process.

This has resulted in greater contact and adhesion between the lagging and the pulley shell directly below the raised lagging areas, and lower contact and adhesion in the recessed lagging areas. When the pulley shell ends are exposed to wet conditions, the water is able to penetrate between the lagging and the pulley shell at the areas below the recessed lagging profile. Once shell corrosion begins, it quickly spreads around the shell end, the lagging lifts from the pulley shell, and is easily damaged (see photos below).

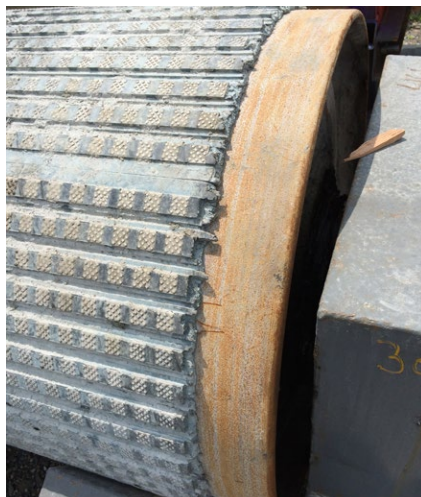
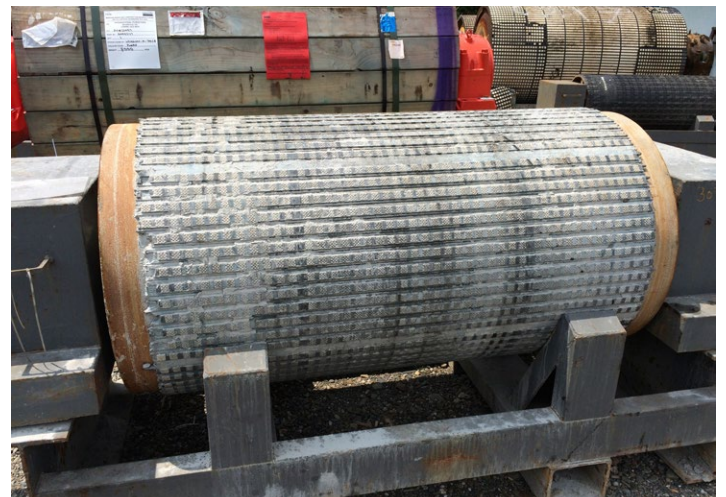
**Photo #12 and #13.** Severe lagging damage due to edge lifting and belt tracking.

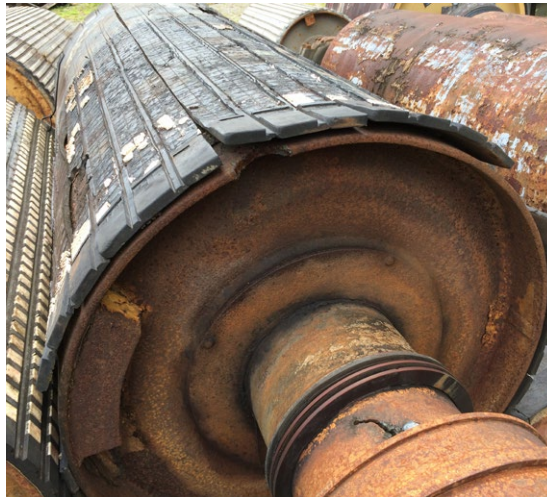
Photo #14.

Photos #14 and #15 below show the results of operation at the same mine site of a pulley lagged with cold vulcanised ceramic lagging and one lagged with Elastotec Hot Vulcanised Ceramic Lagging. Both pulleys were installed at a large copper mine and operated in wet conditions where the water was acidic. There is corrosion evident on the end discs and locking elements of both pulleys. On the pulley with the cold vulcanised lagging there is severe edge lifting failure. The pulley with the Elastotec Hot Vulcanised Ceramic Lagging shows no sign of edge lifting and the lagging remains fully serviceable.

**COLD VULCANISED APPLICATION**

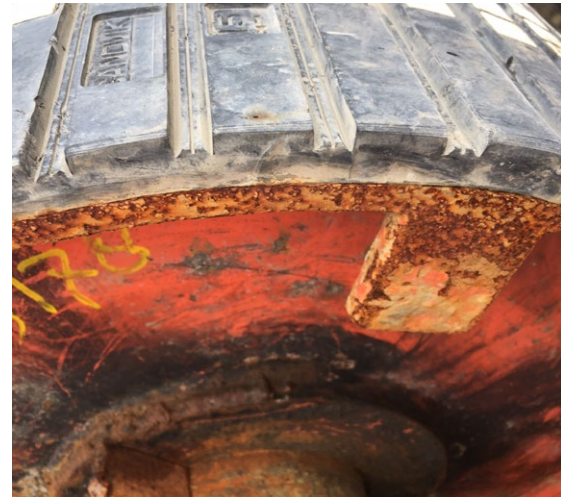
Photo #15.

**HOT VULCANISED APPLICATION**

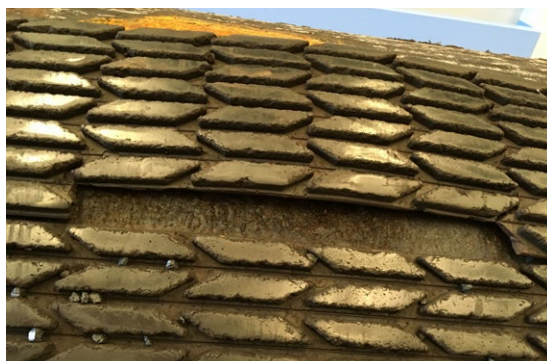
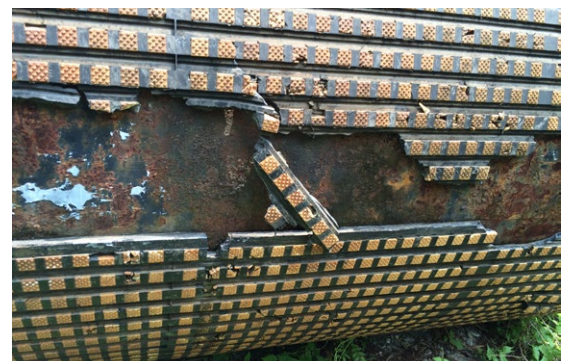
**Photo #16 and Photo #17.** Corrosion and lagging debonding at joints between cold vulcanised lagging strips due to water penetration.

As the belt comes onto the pulley, these loads act in a way that wants to open up the joints between lagging strips. When the pulley is operating in a wet environment, this opening of the joint, coupled with the hydraulic force generated by water caught between the belt and the pulley lagging, results in water reaching the pulley shell and causing corrosion. Eventually this corrosion leads to the debonding of the lagging along the joints – see photos #16 and #17.

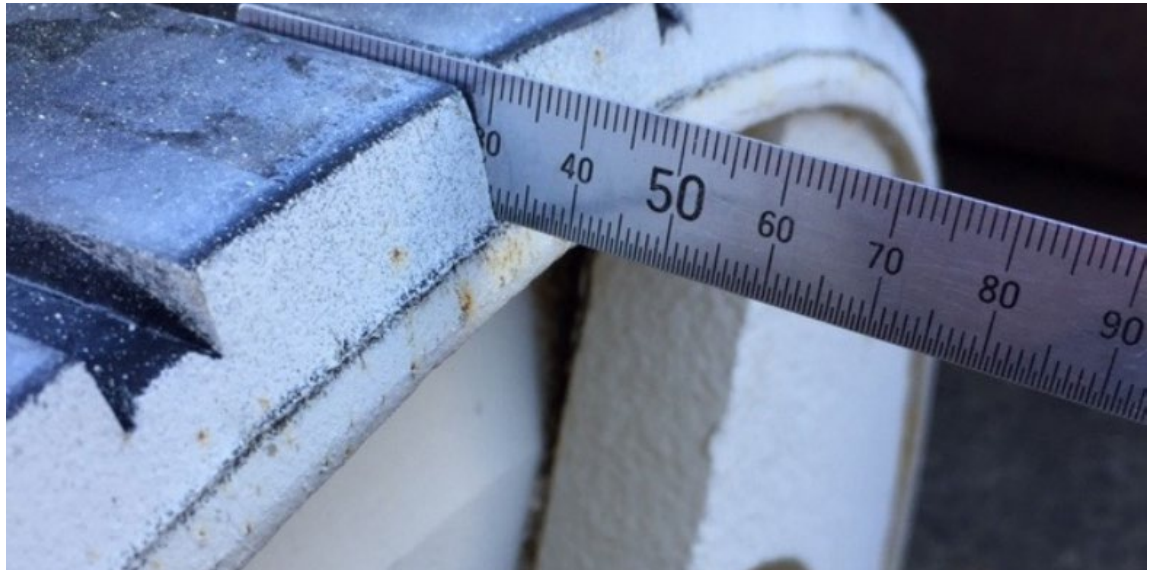
**Photo #18.** Cold vulcanised lagging gap between lagging strips.

With regard to application techniques and workmanship, many lagging applicators use a technique called “butt” lagging where each lagging strip is ‘butted’ up against the previous strip. Depending on the skill and care of the operator, the result can vary from having no gap between strips to having a gap several millimetres wide (see photo #18). It is common for lagging applicators to use liquid sealants such as ‘Sikaflex’ to fill in gaps at the joints – **the use of sealants to fill gaps will ensure lagging failure in wet conditions.**

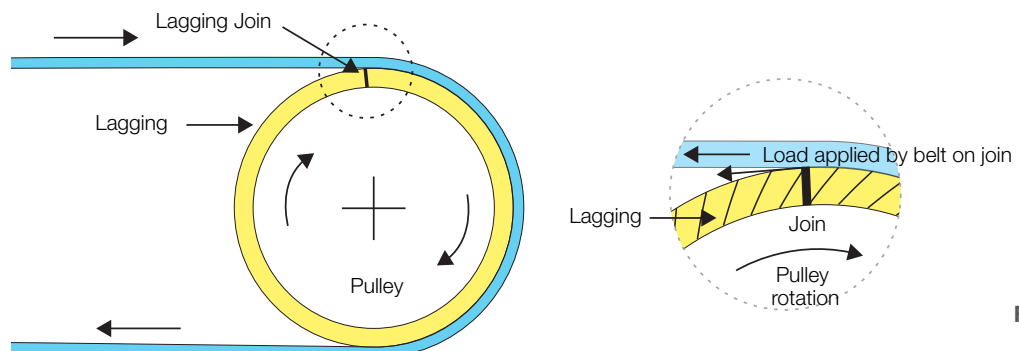
**Fig #1.**

When we look at forces applied to the lagging joints by the belt during operation, we see that the belt applies a load to the lagging – the highest loads occur on drive pulleys and on high-tension bend pulleys. (See Fig#1.)

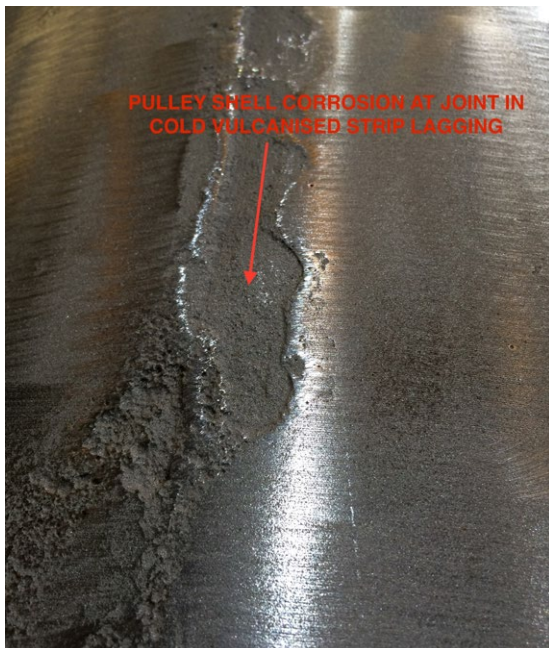
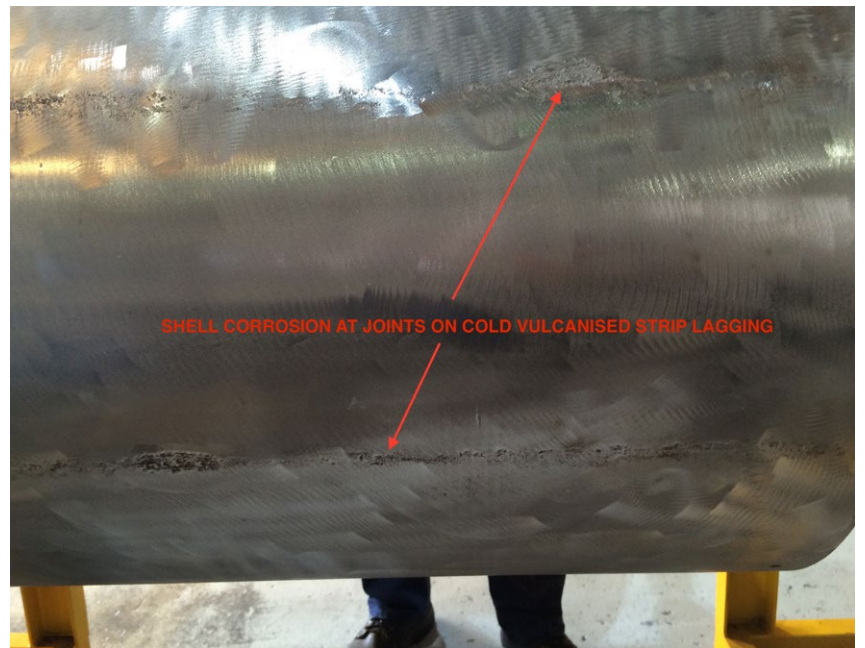
Photo #19.

Photo #20. Pulley shell pitting from corrosion due to water ingress between lagging strips.

For the corrosion failure at the joints between lagging strips, this can also result in additional, unnecessary expense when the depth of the corrosion reduces the shell thickness below what is required for the designed operating loads, and the pulley has to be scrapped. See photo #19 and 20.

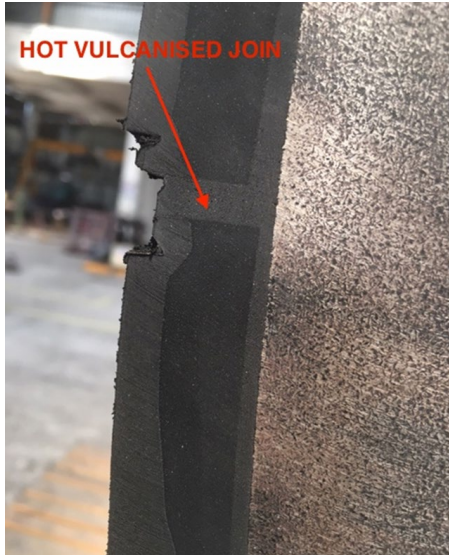
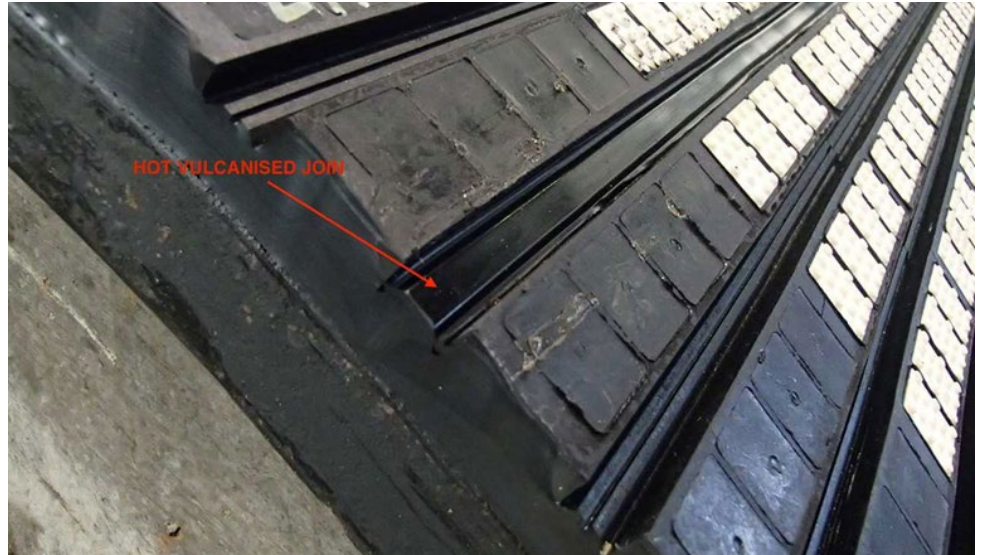
Photo #21 and Photo #22.

When Elastotec Hot Vulcanised Ceramic Lagging is applied to the pulley shell, there are no joints between the strips as the unvulcanised bonding layer along the edge of each strip fuses together to form a continuous lagging sheet, with no weak points between strips. See Photos #21 and #22.

**Hot vulcanised joint completely sealed from the lagging surface to the pulley shell – no chance of separation or water penetration.**
