# CERAMIC LAGGING TILE LOSS – CAUSES AND PREVENTION

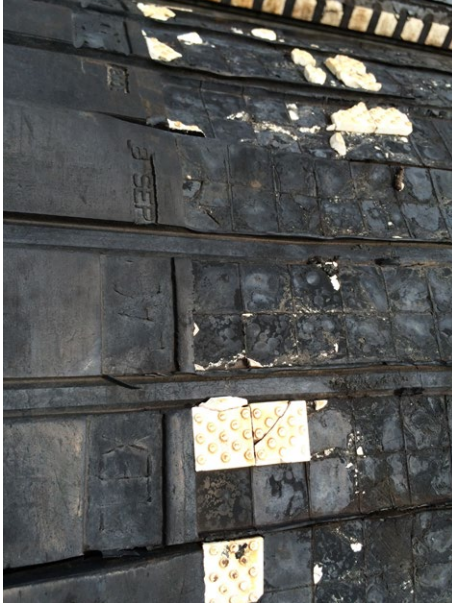
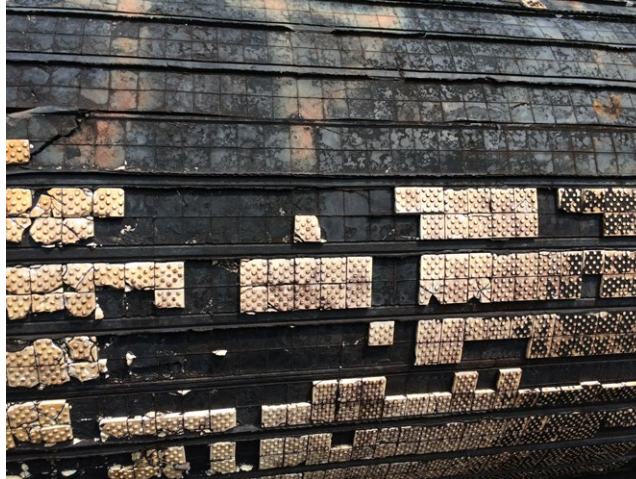
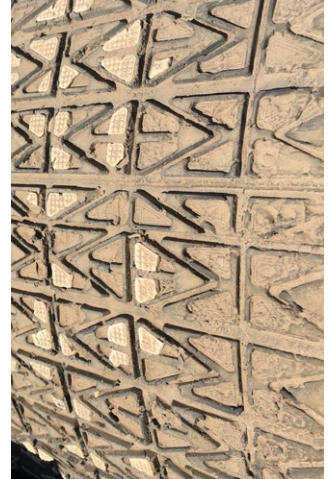
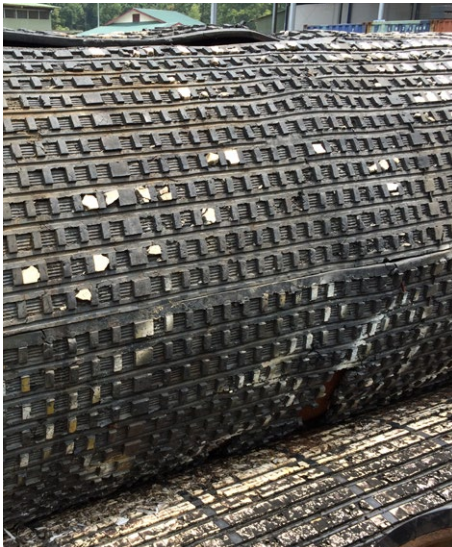
Tile debonding is very easy to identify as the recesses in the rubber backing where the tiles are missing, are smooth, and have a detailed imprint of the back of the tile – often this can be seen as ribs or marks in the rubber surface (see photos #2 #3 and #4).

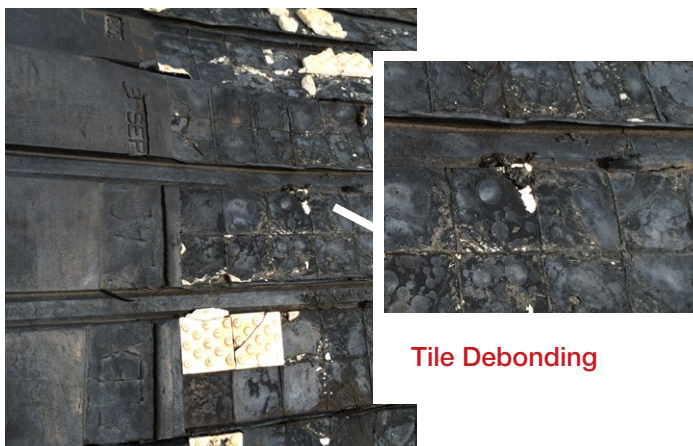
Photo#2

Tile Debonding

Causes of tile loss due to debonding include:

**Manufacturing:** Poor process control (there are many areas where the ceramic lagging production process can result in defective tile bonding if not controlled properly)

**Operation:** Adhesive not suitable for outdoor service - **the wrong adhesive has been used by the lagging manufacturer.**

- Adhesive not suitable for use at maximum and minimum service temperatures
- Adhesive not suitable for contact with liquids (water, acid, bases, oil)
- Adhesive not suitable for exposure to sunlight.

**Ceramic tile loss due to debonding is always a production fault and is the lagging manufacturers responsibility.**

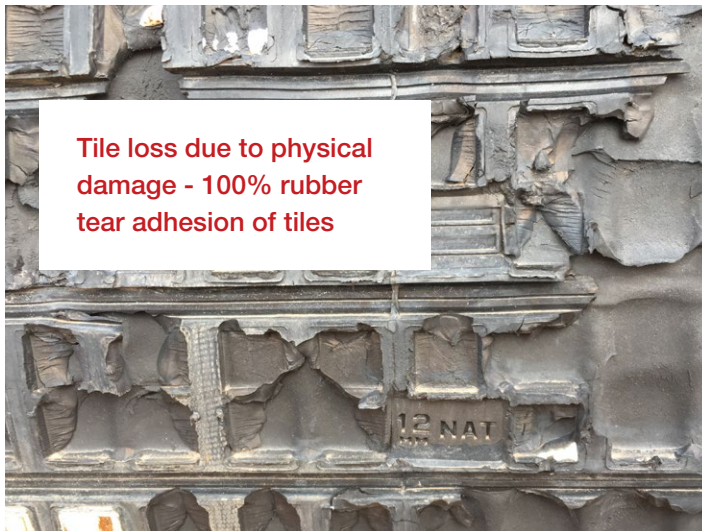
This form of tile loss occurs when the load applied to the tiles in service exceeds the strength of the rubber backing layer and results in the tiles being torn out of the rubber backing – the tiles are removed with a layer of rubber bonded to the tile on all surfaces that were in contact with the rubber (Photo# 5).

Photo#5 Tile loss due to physical damage.

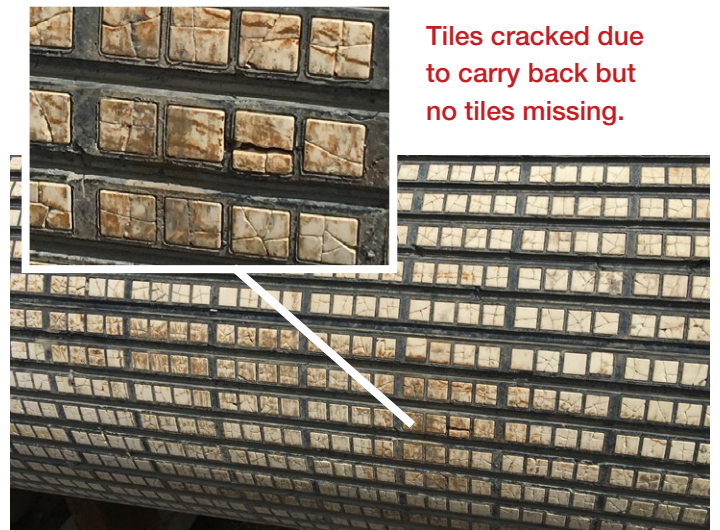
- Bend pulleys in contact with the dirty side of the belt and subject to carry back. On these pulleys when the system is new lagging performance can be okay but as the centre of the belt wears the localised shear stress in the centre of belt increases dramatically and eventually will result in the tiles being torn from the lagging ( see Photos 6).
- The presence of carry back on the uneven belt surface can accelerate this failure.
- Bend pulleys receiving carry back can suffer from severe tile breakage and tile loss. In these circumstances many of the remaining tiles will be broken and the recesses where tiles are missing will have rough surface.

Photo#7 shows a non drive pulley with Elastotec Hot Vulcanised Ceramic Lagging that has been in contact with the dirty side of the belt and with continuous exposure to carry back. Although all the tiles have been cracked, none have debonded and none are missing. This pulley remained in service until a bearing failure necessitated a pulley change out.

Consultation with conveyor maintenance personnel and careful evaluation of all operating requirements is required before selecting the best lagging for each application – Ceramic lagging is not the cure all solution for all forms of lagging failure. Ceramic lagging failures that occur due high localised shear forces, and/or the presence of carry back causing tiles loss due to physical damage, require a different type of lagging. Elastotec has a number of high performance laggings designed specifically for these difficult applications.
