OUTDOOR AGEING PERFORMANCE OF ELASTOTEC CERAMIC LAGGING

ELIMINATION OF CERAMIC TILE LOSS DUE TO DEBONDING

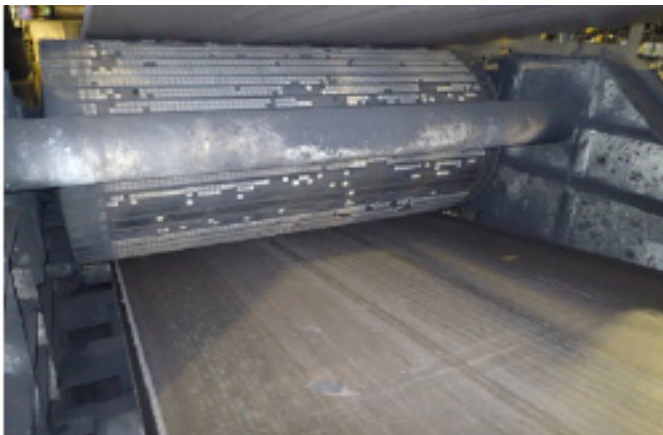
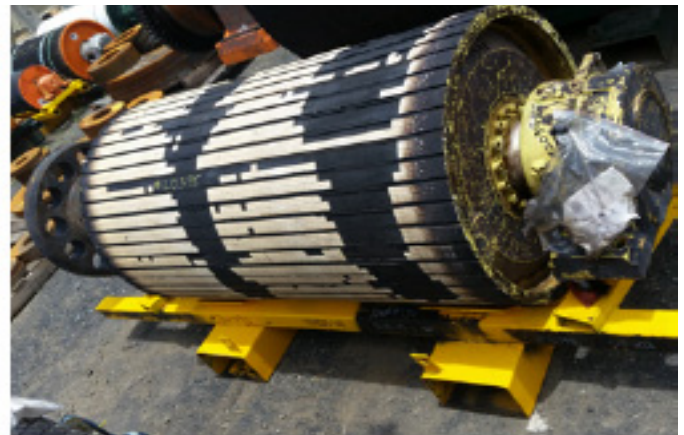
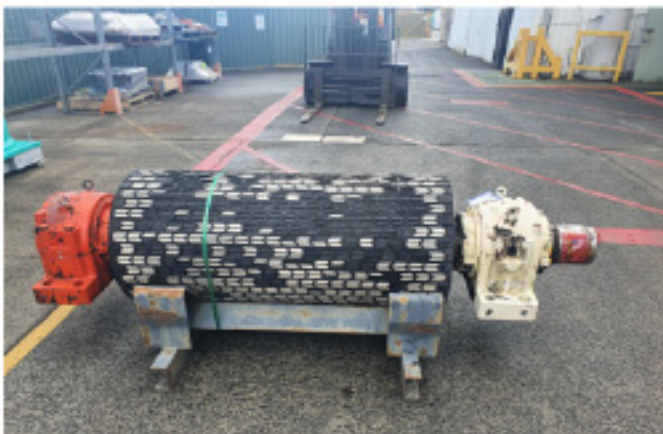
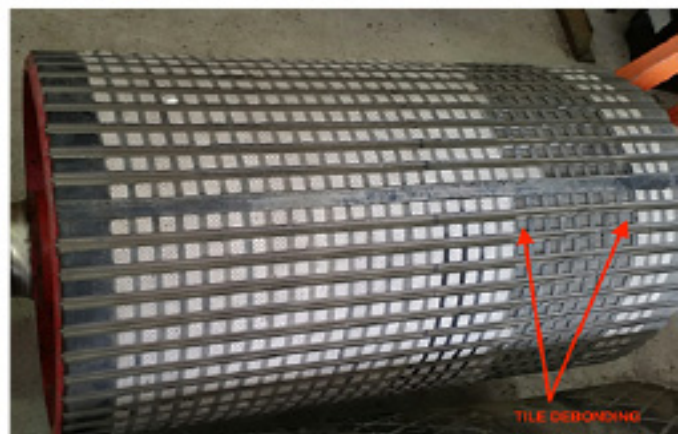
CERAMIC LAGGING FAILURE DUE TO TILE LOSS BY DEBONDING

Unfortunately, many manufacturers of ceramic lagging have problems with loss of the ceramic tiles due to debonding. This tile loss is due to many factors including:

Tile loss has a profound effect on the performance of the ceramic lagging and in severe cases can result in an unplanned shutdown.

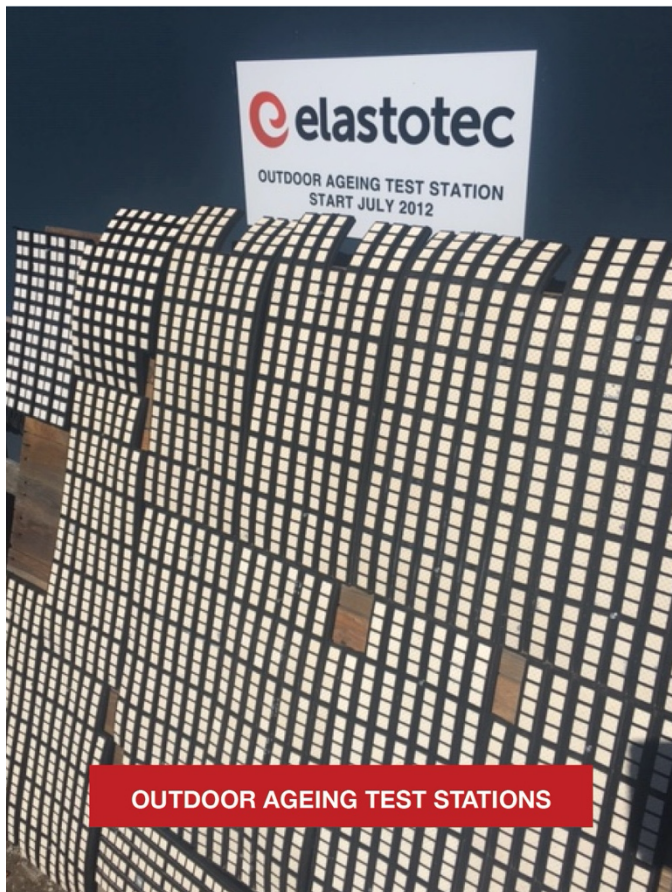
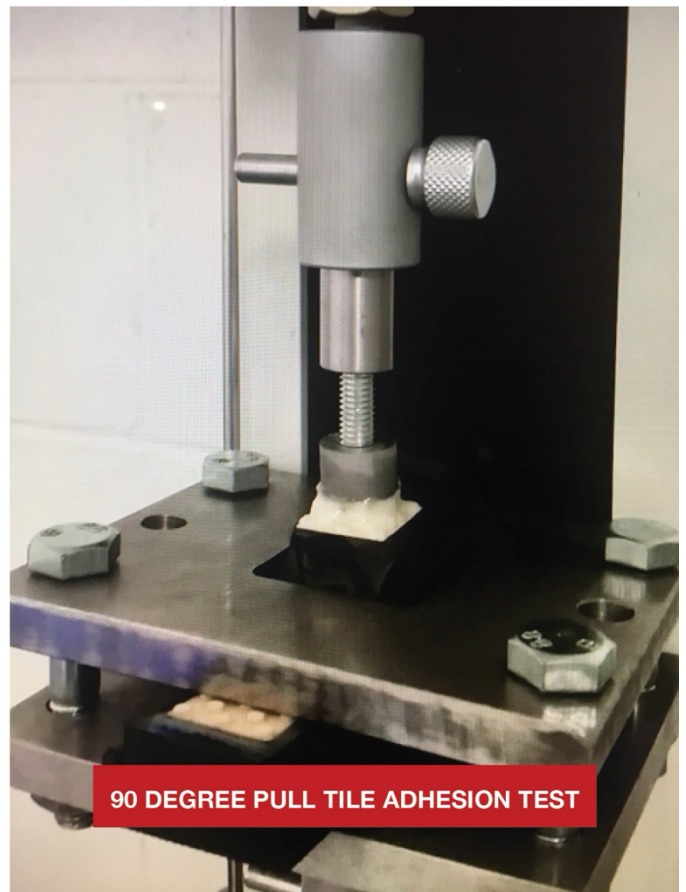
- Initial adhesion test with flexing at 90 degrees of the tile rubber joint and visually checking for separation at the bond line
- Measure tile pull out force for a 90 degree tension pull (see photo below)
- Check mode of failure for the 90 degree tension pull (this must be 100% RT – Rubber Tear)
- Outdoor ageing with annual checks of the tile adhesion and failure mode.

Elastotec has had this outdoor ageing testing programme in place since 2013 and the test results are shown below. Ceramic lagging samples that have been continuously exposed outdoors since 2013 are tested annually for the adhesion of the ceramic tiles to the rubber backing. The testing method is a 90 degree pull test as shown in the photo below.
