ELASTOTEC CERAMIC WEAR PANELS – CASE STUDY LARGE GOLD MINE

BACKGROUND:

As part of a major production upgrade at a large gold mine Carters Engineering was asked to produce a new slurry box for the ore treatment plant. The slurry box was to be located in a position with difficult access making removal/replacement difficult. Any replacement of the wear lining needed to be done easily and quickly to minimise process plant downtime.

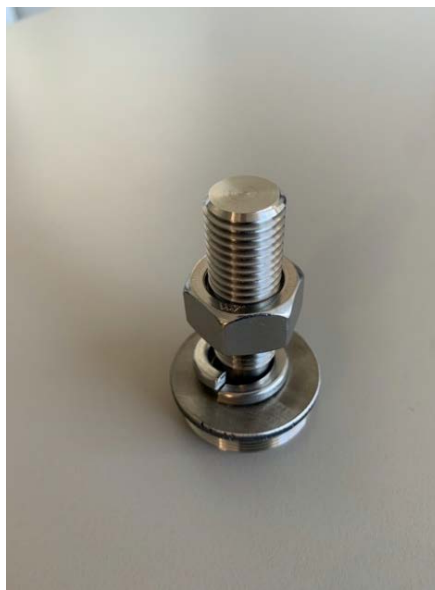
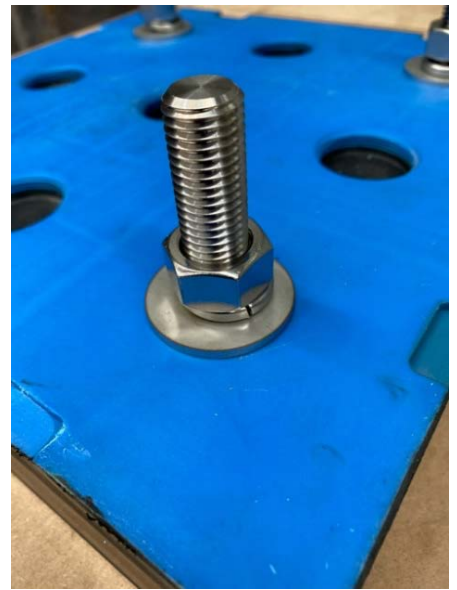
The Elastotec recommendation was for 38mm thick ceramic wear liners as this was best suited to achieving the required service life. Additionally, as the operating conditions required full immersion in a water-based slurry, the Magnefast wear panels with an engineering plastic backing plate were selected as these eliminated

the possibility of corrosion, and the resulting possible debonding of the ceramic liners. The Magnefast system allows for attachment to the steel walls via two methods – high strength magnets and S/S studs. In this case the mine site engineers selected attachment using the S/S studs.

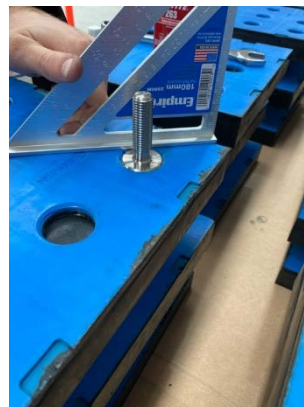
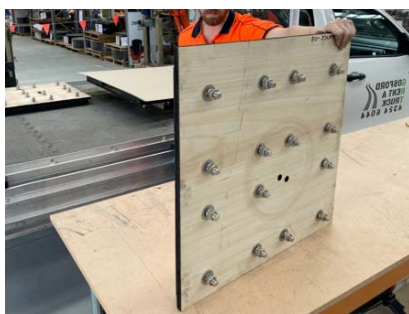
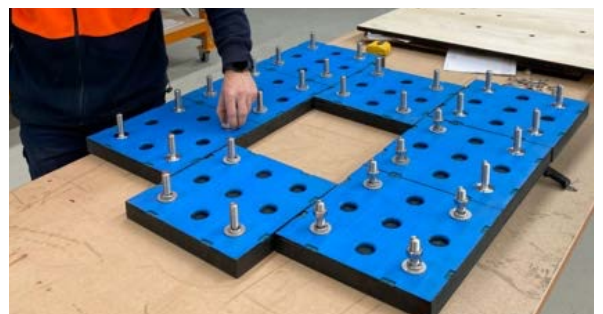
Carters Engineering provided individual drawings for all the cut liners, plus templates for mounting liners that required hole cuts. Elastotec has a state-of-the-art CNC cutting station set up at their Somersby factory which enabled the cut panels to be completed quickly and to the required tolerances for ease of fitment.

For the ceramic wear panels that required holes to be cut the panels were bolted into place on a plywood template that was marked with a centre hole. Holes were then cut with 600mm, 350mm, 338mm and 75mm diameters to suit the attached pipe work.

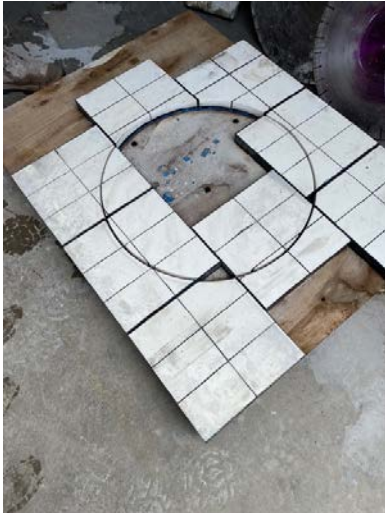
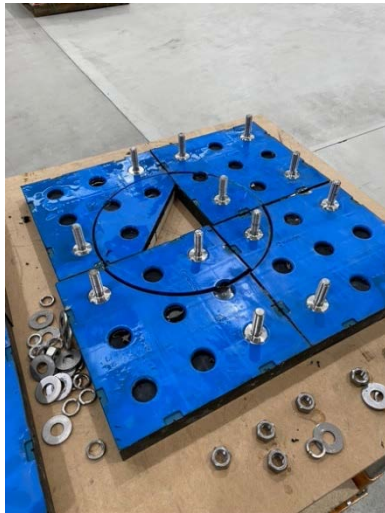
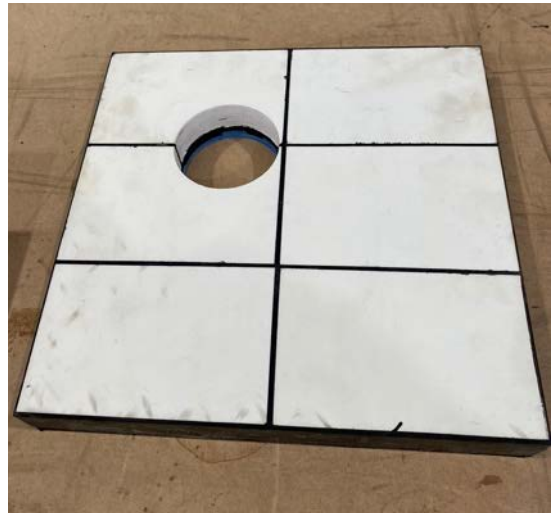
Prior to rubber lining and painting of the slurry box the ceramic liners were fitted to ensure dimensions were correct and identify any problems. Each of the cut liners had been fabricated to a dimensional tolerance of +/-2mm

with all cut sizes checked prior to shipment. All panels were fitted to the slurry box with no problems – cut holes aligned with the incoming pipework and stud positions were trouble free.
