ELASTOTEC CERAMIC WEAR PANELS – CASE STUDY QUARRY – SCREEN UNDERPAN CHUTE

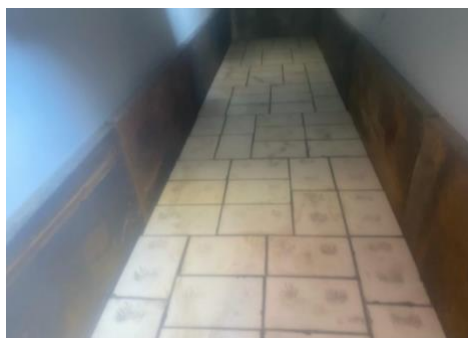
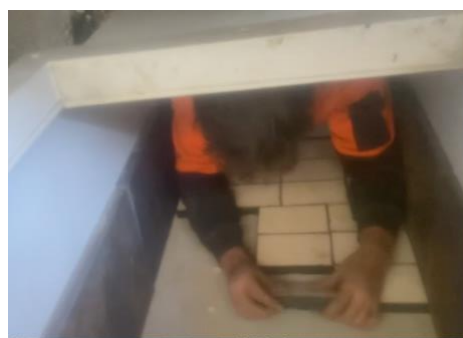
Installation of the 120 Magnefast liners in the chute took 15 minutes. Removal time is estimated at less than 30 minutes.

Estimates of the time required to install ceramic tiles in this chute using direct bond ceramic tiles range from eight hours for the install and grouting with an additional eight hours for removal of this type of ceramic lining.
