NEW TECHNOLOGY IMPROVES SERVICE LIFE OF CERAMIC PULLEY LAGGING

By David Molesworth, Elastotec P/L and Michael Finlen, PROK

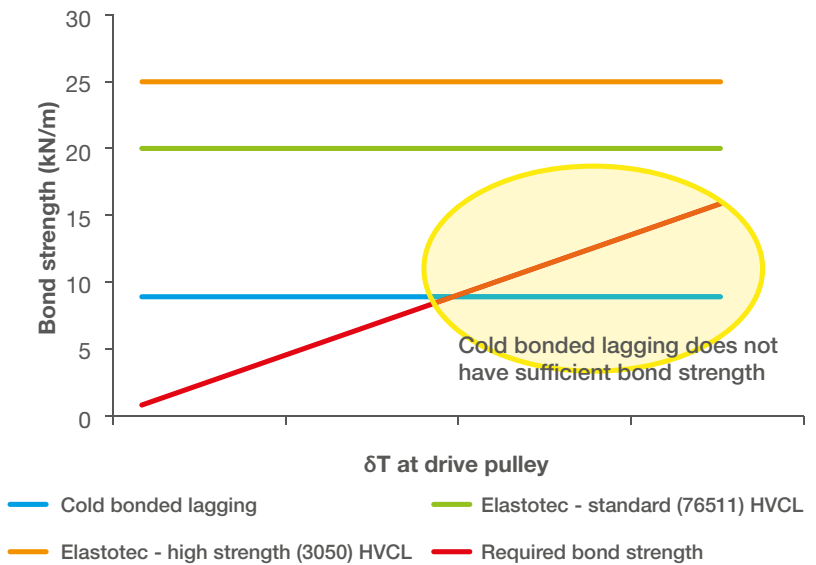
GRAPH#1- Required bond strength estimate

Graph#1 illustrates how increased belt tension at the drive pulley increases the required lagging bond strengths, which can be well above the adhesion value of 9 kN/m, currently used as a requirement for cold bonded ceramic lagging.

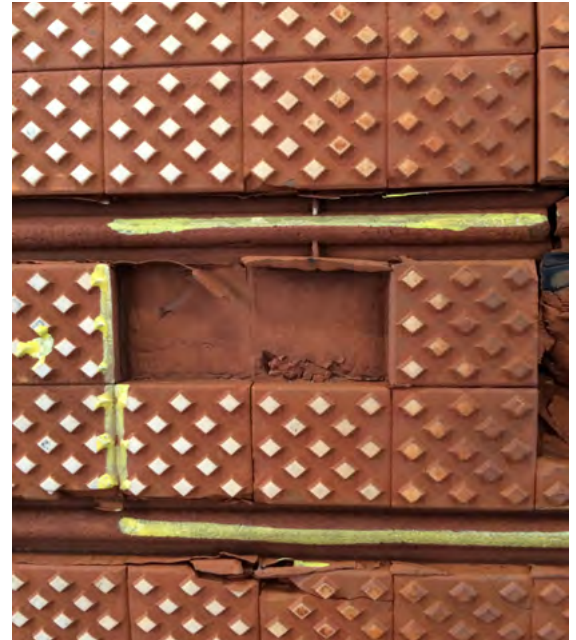
Image#2 - Tile pull out

- Lagging design that only bond the ceramic tile on the back of the tile results in less of the tile surface area bonded, leaving the edge of the tile exposed as a potential weak point for bond failure (see Image#2).

- Bond strengths between the ceramic tile and the rubber backing have been lower than the applied shear forces from high tension conveyor belts, resulting in tile pull out.

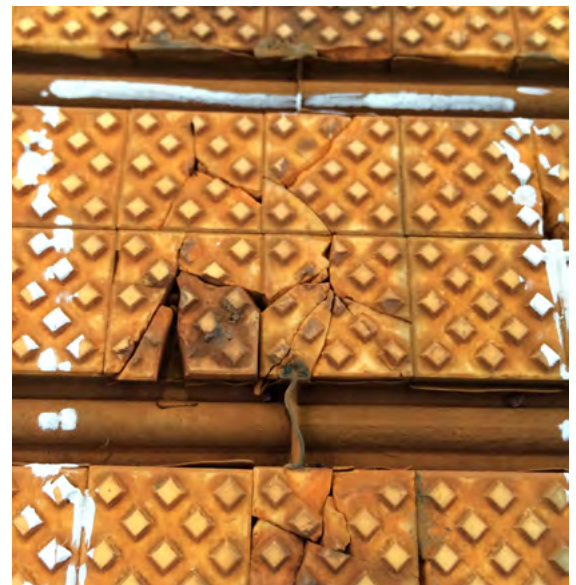
Image#3 - Tile cracking

- Lagging design that has the ceramic tiles butted up against one another can result in cracking from impact between the tiles when subjected to shock loads, which can occur when material becomes caught between the conveyor belt and the ceramic lagging (see Image#3).
- Poor quality aluminium oxide tiles are prone to cracking and breakage/wear of the raised dimples. Eighty percent of the raw material cost of ceramic lagging is the aluminium oxide tiles and this offers the largest potential cost saving for manufacturers of lower cost ceramic lagging. Unfortunately, reducing the quality of the aluminium oxide tiles has a direct impact on the ceramic lagging performance.
- With the increase in aluminium oxide content, the vickers hardness, wear resistance and flex cracking resistance also increase. The tile cost also increases with aluminium oxide content (refer Table#2 below).

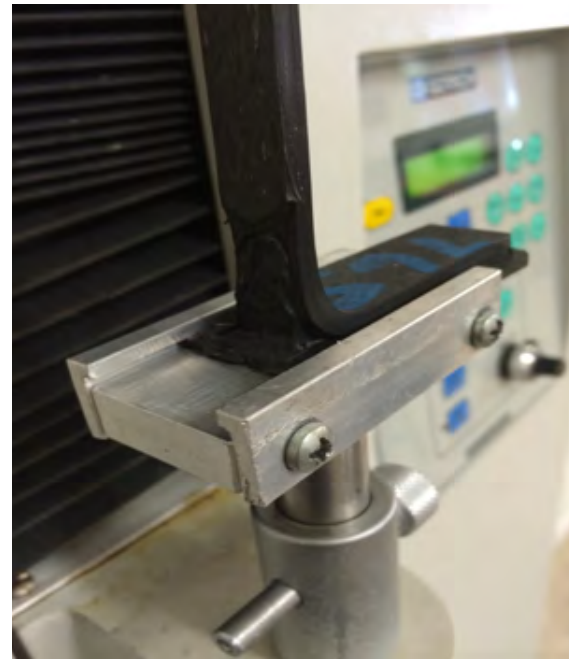
Image#4 - 90 degree peel test

A process for installing ceramic lagging using hot vulcanising has been developed and is available as PROK Hot Vulcanised Ceramic Lagging (HVCL). This solves any issues with lagging to shell bonding, providing a stronger and more reliable connection between not only the lagging and the pulley, but also, importantly, between the individual lagging strips. HVCL ensures a 100% rubber tear bond between the lagging and the pulley shell, resulting in considerably higher adhesion strength (refer to Table#3).

RUBBER COMPOUND	RUBBER TENSILE STRENGTH (MPa)	BONDING SYSTEM	ADHESION 90 DEGREE PEEL (kN/m)
Conventional Rubber Backed Ceramic Lagging	76511	15.0 min	COLD	5.0 - 15.0
Elastotec HVCL (Standard)	76511	15.0 min	HOT	20.0 min
Elastotec HVCL (High Strength Rubber)	3050	30.0 min	HOT	25.0 min

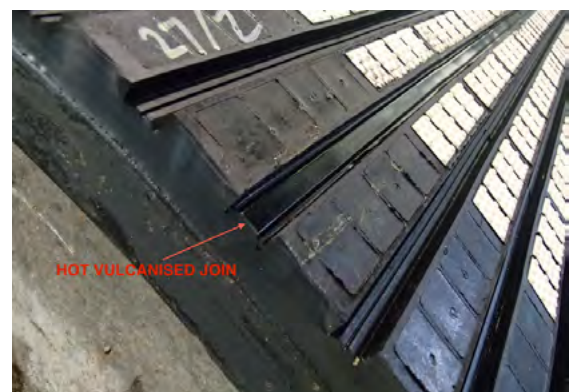
Image#5 - Hot vulcanised join

An additional significant advantage of HVCL is that there are no joins between the ceramic lagging strips (see image#5). When HVCL is vulcanised the uncured rubber at the edges of the lagging flows together and vulcanises to form a continuous layer that is strong and also impervious to water, preventing shell corrosion. This removes the potential weak points where the joins meet, which can lead to failure of the ceramic lagging.

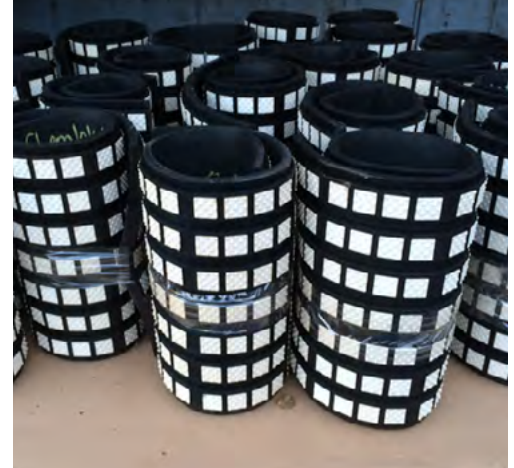
Image#6 - Outdoor adhesion testing

Elastotec checks the integrity of the bonds throughout the outdoor testing process, where the tile/rubber bond is under constant stress. The testing is done by bending a strip of ceramic lagging into a tight circle, with the ceramic tiles on the outside of the circle. The sample is then held in this position during the outdoor exposure period. The results are recorded at regular intervals and have been used to identify the optimum primer/adhesive system for long-term adhesion performance (see Table#4).

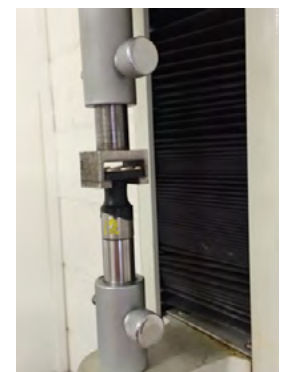
Image#7 - Tension pull adhesion testing

Additional testing has been carried out to increase the adhesion strength between the rubber backing and the aluminium oxide tiles, as well as the steel for the pulley shell. This testing was undertaken using the tension pull method – (see Image#7 and Table#5)

Primer	Adhesive	Tension Pull (MPa)	Failure Mode
A3	B1	4.31	90% R
A3	B2	6.87	100% R
A4	B1	6.42	100% R
A4	B2	3.26	50% R

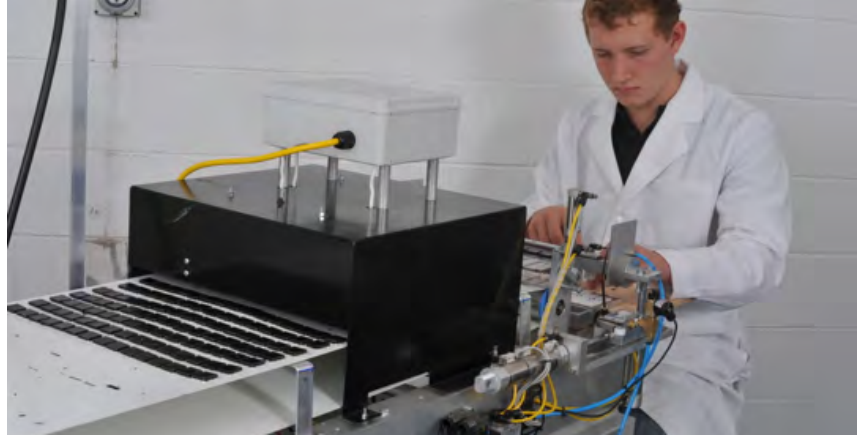
Image#8 - Tile coating

Elastotec uses a proprietary dipping process for the coating of the ceramic tiles with primer and adhesive, which ensures that all tile surfaces receive the necessary minimum coating weight of primer and adhesive. To date, more than 5,000,000 tiles have been coated using this method and there have been no reported bond failures.

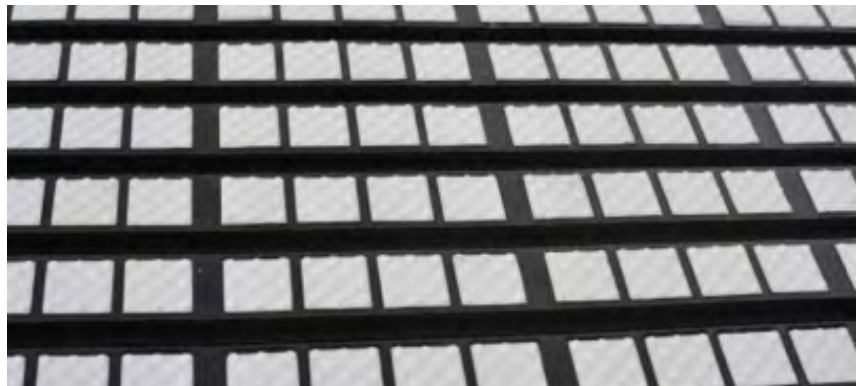
Image#9 - PROK HVCL design

The unique design of HVCL ensures that tiles are bonded with rubber on both sides and back, providing a more reliable layer of protection from impact and significantly reducing the risk of tile cracking.

An additional benefit of the lagging design is the increased area for bonding between the tile and the rubber. For typical 20 x 20mm-sized ceramic tiles used by many ceramic lagging manufacturers the bonding areas are:

Tile bonding back only	400 mm ² /tile
Tile bonding back and sides	720 mm ² /tile

This is an 80% increase in bonding area, resulting in increased force required to pull the tiles from the rubber.
