# Improvements in Cold Vulcanised Adhesion of Pulley Lagging

## IMPROVEMENTS IN COLD VULCANISED ADHESION OF PULLEY LAGGING

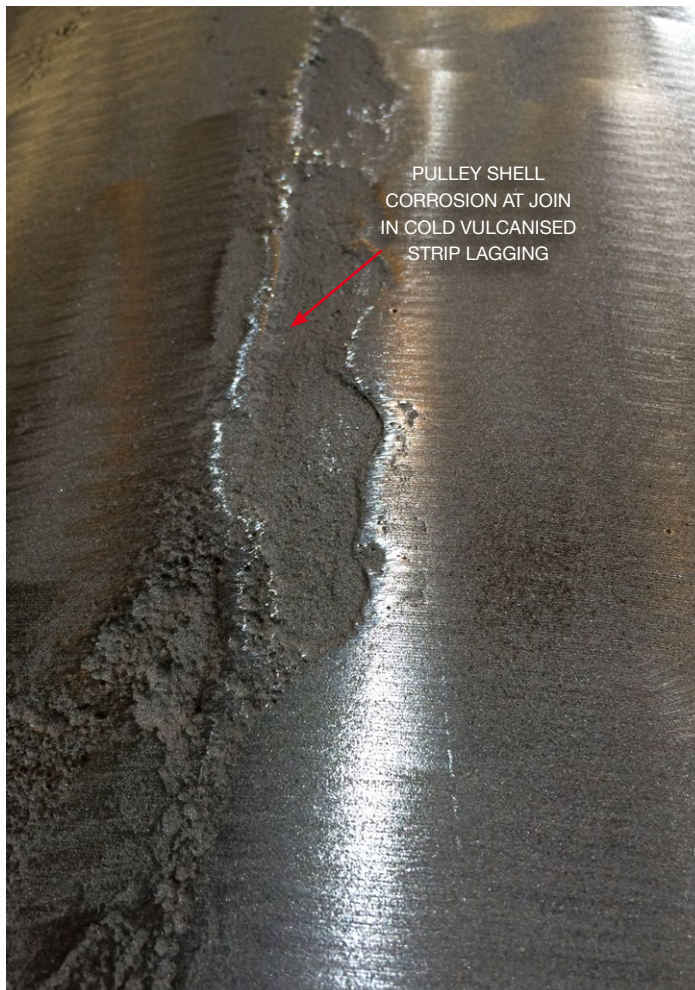
Failure of CV bonding to provide rubber tear adhesion can result in lagging coming away from the pulley and also to corrosion of the pulley shell at the lagging joints with the resultant pitting leading to a de-rating of the pulley service capability due to the reduction in shell thickness. Photo#1 & 2. The cost for these problems in plant down time and pulley refurbishment is always substantial, and in the case of the de-bonding is many times the cost of the original lagging application.

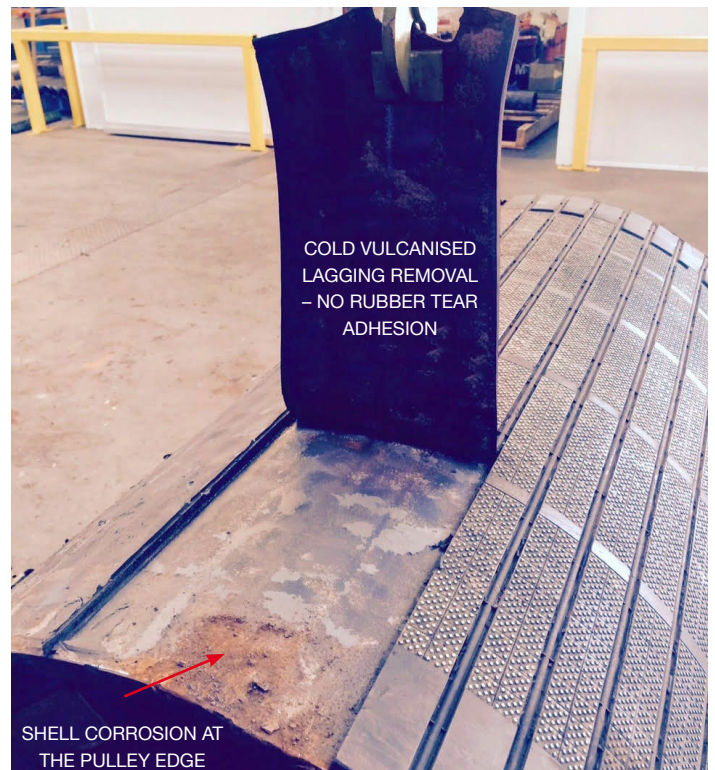
Photo #3

Most people involved in pulley refurbishment and/or lagging replacement know that removal of CV lagging is pretty simple and can be done by applying tension to the end of a lagging strip with a forklift or overhead crane. This usually peels the lagging away from the pulley shell with little or no rubber tear.

Refer to Photo#3. This photo also shows significant pulley shell corrosion adjacent to the pulley edge - this is usually the result of poor adhesion between the lagging and pulley shell and can lead to complete debonding of the lagging and unplanned conveyor down time.

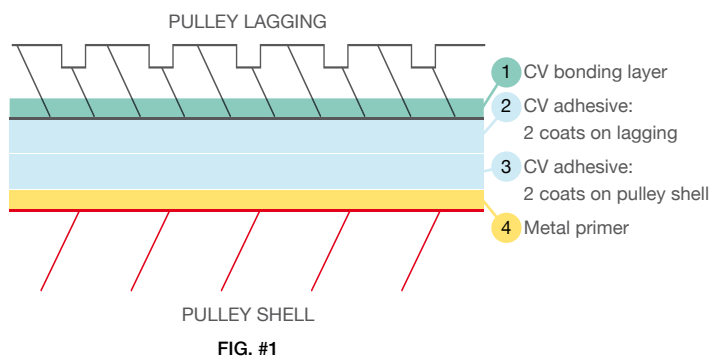
### Cold Vulcanised Bonding System

Fig#1 shows the construction of a typical CV bonding system made up of four layers

- Metal Primer
- Layer of CV adhesive applied over the metal primer
- Layer of CV adhesive applied to the lagging
- CN bonding layer as part of the lagging (not all lagging manufacturers have this)

Bond failure can occur between any of these layers and our testing shows that failure at the interface between layers tends to require a much lower force than failure that occurs wholly within the lagging CN bonding layer. From observing many adhesion peel tests the failure at the interface between layers occurs in small localised areas that focus the stress from the applied tension (Refer Photo#4).

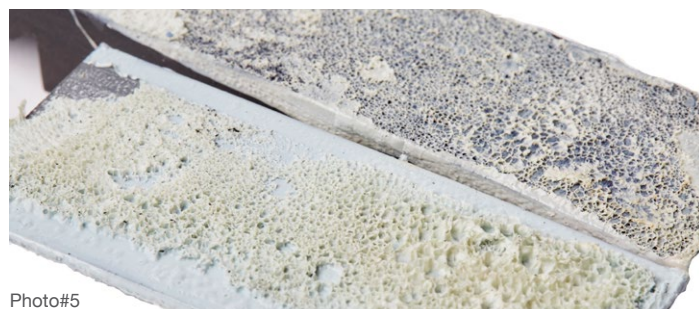
Photo#5

- It is important to ensure that the first coat of adhesive dries completely to ensure there is no chance of solvent entrapment – we recommend a drying time of 60 minutes for the first adhesive coat.
- The function of the second adhesive coat is to make the first coat "tacky" or "sticky" and must be a "light" coat only – a heavy second coat will result in solvent entrapment with poor adhesion results (see Table#1 and Photo#5).

#### FAILURE IN THE ADHESIVE LAYER DUE TO SOLVENT ENTRAPMENT

SUBSTRATE	LAGGING ON BONDING LAYER	PRIMER	ADHESIVE	1ST COAT THICKNESS	1ST COAT DRYING TIME (min)	2ND COAT THICKNESS	2ND COAT DRYING TIME @25°C (min)	ADHESION (N/mm)	FAILURE MODE
MILD STEEL	66511	2205	ELASTOTEC CVLA	THICK	60	THICK	6	4.6	100% ADHESIVE LAYER - SOLVENT ENTRAPMENT
MILD STEEL	66511	2205	ELASTOTEC CVLA	THICK	60	LIGHT	6	18.8	100% RUBBER TEAR

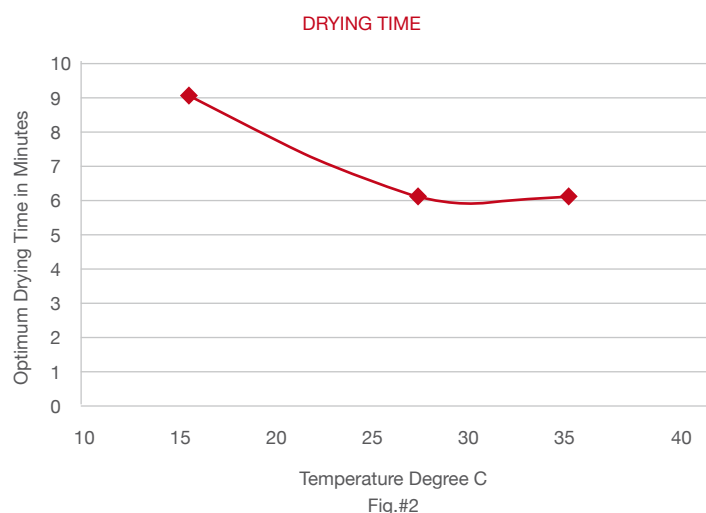
The drying time of the second adhesive coat is critical to the final adhesion strength. Elastotec provides detailed recommendations on the required drying times at temperatures from 15 to 35 C for the second coat of our CVA, before the two surfaces are pressed together (see Fig#2 below) – our application method requires that this be timed and recorded for all installations to ensure the best result.

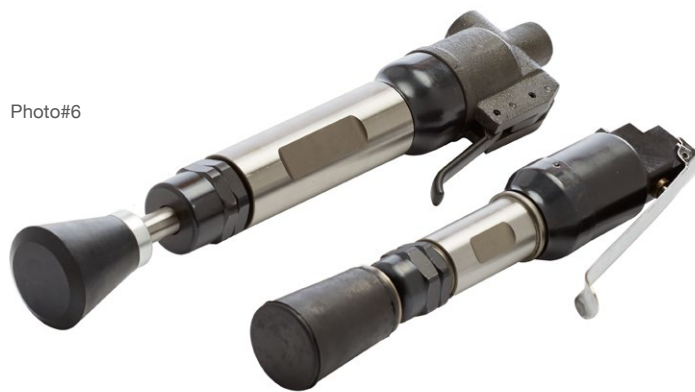
Photo#6

Adhesion is increased when surface contact and pressure between the two layers being bonded is high. Traditional methods of applying CV lagging use a rubber hammer and rely on the operator to apply the force across consistently over the entire lagging surface. Elastotec recommend the use of pneumatic hammers (Photo#6) for ensuring high levels of surface contact between the lagging and the pulley shell. The pneumatic hammer hits the surface 30 times/second with consistent force. An operator with a manual hammer cannot produce the same level of surface impact or contact coverage.

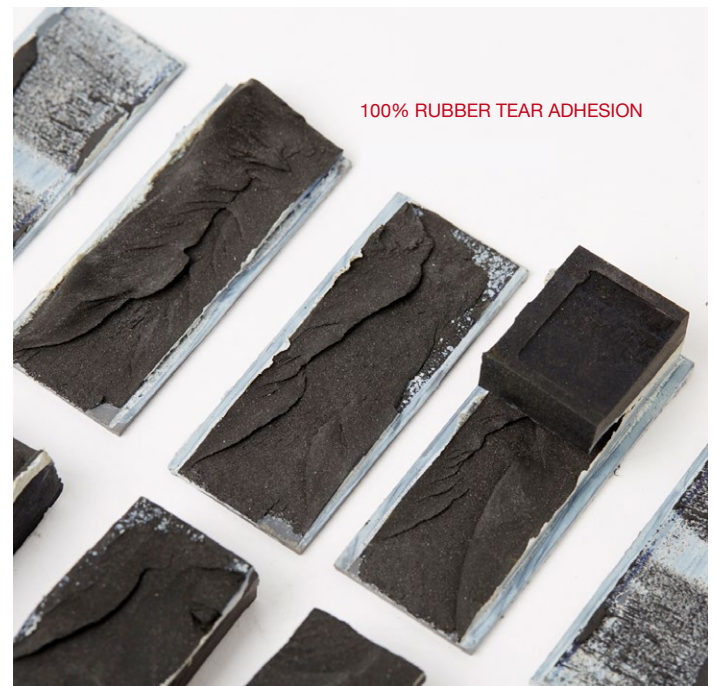
Photo#7

The combination of three bonding system components developed by Elastotec - Elastotec Metal Primer 2205 - Elastotec CV Adhesive - Elastotec CN Bonding Layer - together with the detailed applications instructions and working with approved and supervised applicators, ensures that Elastotec's Cold Vulcanising adhesion system provides reliable 100% rubber tear bonds that exceed 18 N/mm. (Refer photo #7)
