MAGNEFAST — POLYMETALLIC METAL MINE

Magnefast – Polymetallic metal mine

In September 2023 a trial installation of the Elastotec Magnefast ceramic wear panels was put in place on a dual deck transfer chute. The existing studded white iron wear liners were replaced with Magnefast ceramic wear liners on the top floor and side wall.

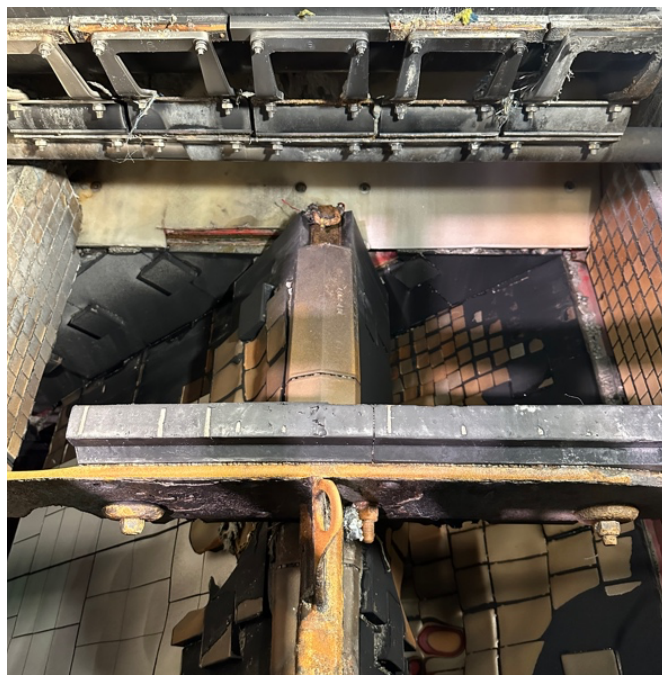
Below photo shows the lower floor white iron worn through into the rubber lining and into the chute substrate.

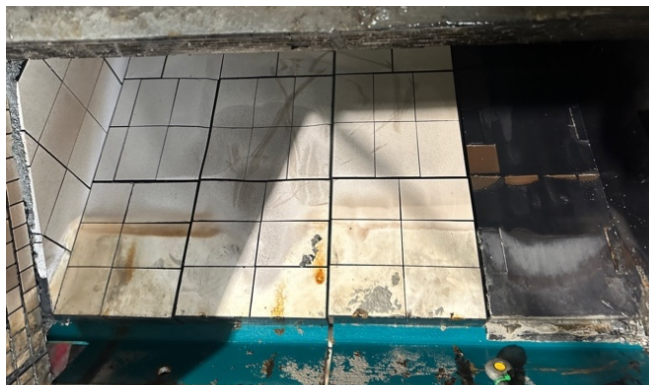
INSPECTION MARCH 2024

Magnefast trial achieved **6 MONTHS** service life meeting the current liner objective. The Magnefast liners showed 7 mm of wear in a 50 mm thick ceramic, panels have not been replaced and are expected to eliminate several liner changes.

Magnefast liners were not replaced at 6 month planned shut. Some panels rotated saving cost on product and reduced labor.

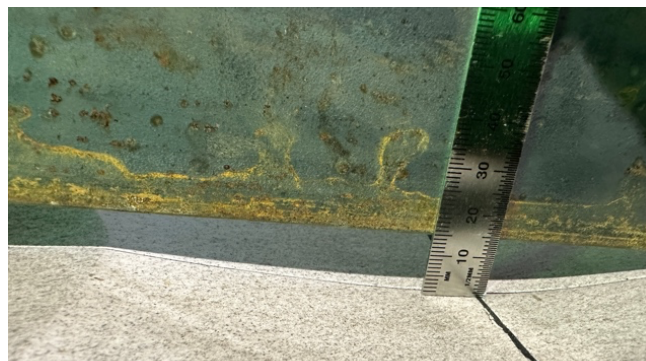
15MM WORN FROM 50MM CERAMIC MARCH 2024

Projected Magnefast service life of **18 MONTHS** based on a 15mm wear loss where impact occurs at 26-week inspection.

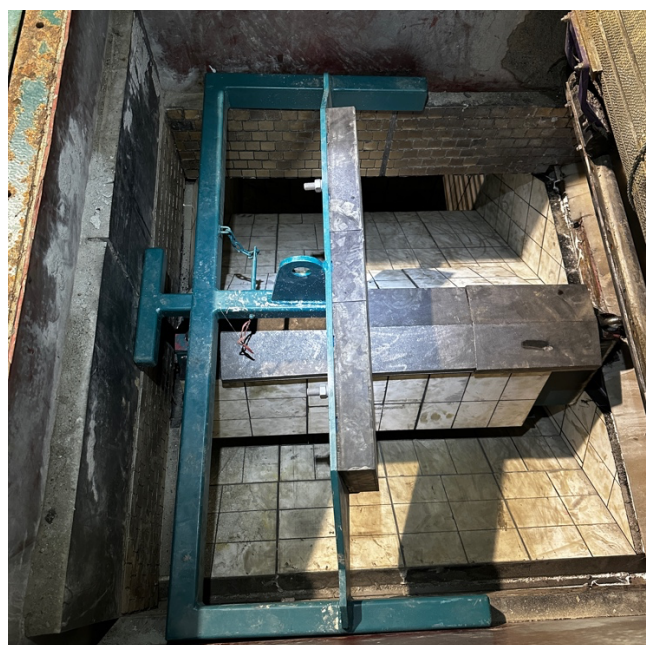
MAIN IMPACT ZONE WILL HAVE A HIGH INTEGRITY ZTA CERAMIC CALLED ZTA WHICH WILL FURTHER DECREASE WEAR IN THESE AREAS.
