TECHNICAL BULLETIN

PULLEYS IN CONTACT WITH CARRY SIDE OF BELT

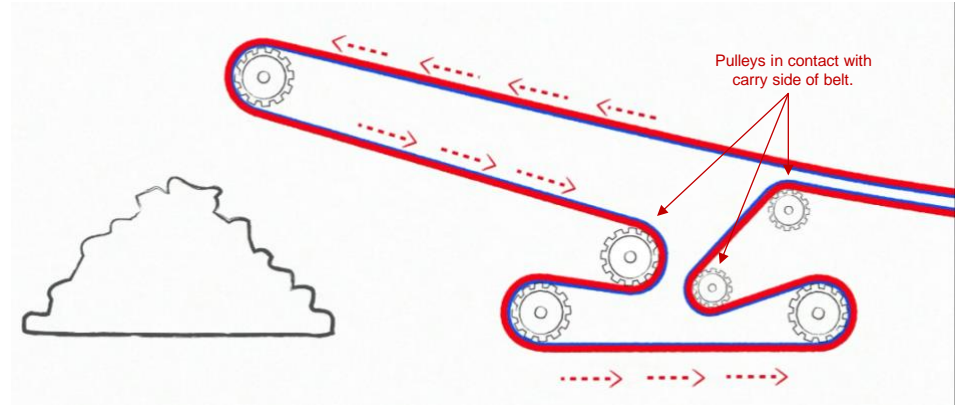
Pulleys in contact with the carry side (dirty) of the belt have a different challenge to all other pulleys on the conveyors. Lagging on these pulleys is in contact with the thick belt cover and have:

1. The wear profile continuously changing.
2. Risk of material build up due to being in contact with the carry side.

These two aspects of the operating conditions have an impact on pulley lagging and belt splices and cords service life.

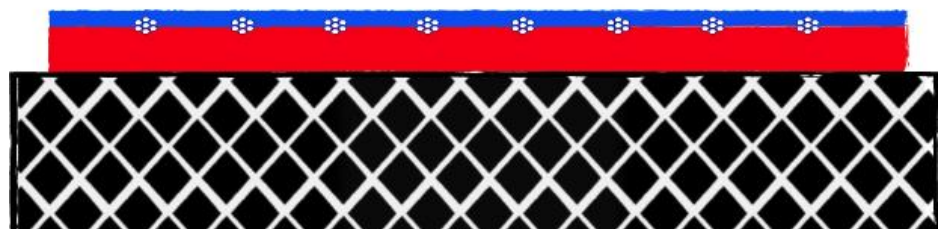
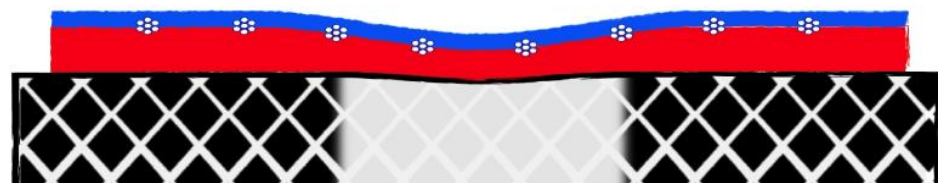
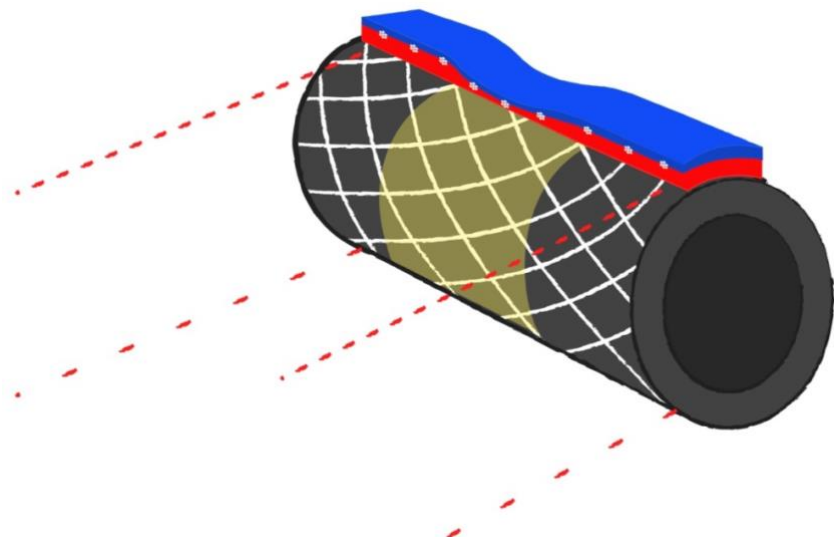
When a conveyor belt is new the belt cover profile is uniform as there is no wear of the belt cover. When both lagging profile and belt carry cover profile are even, all the cords are aligned across the pulley face width. All the cords have the same path length (same diameter to go around).

When the conveyor belt is further into its life and the belt cover profile starts to show signs of wear in the central section due to the carrying of material, when the belt reaches the pulley, the cords are not aligned. The cords in the center are closer to the pulley shell than the cords on the outside section. This cord displacement makes the cords in the center have a shorter path than the cords on the outside. Cords on the outside will try to go quicker than the ones in the center applying a torsion effect on the lagging and shearing it.

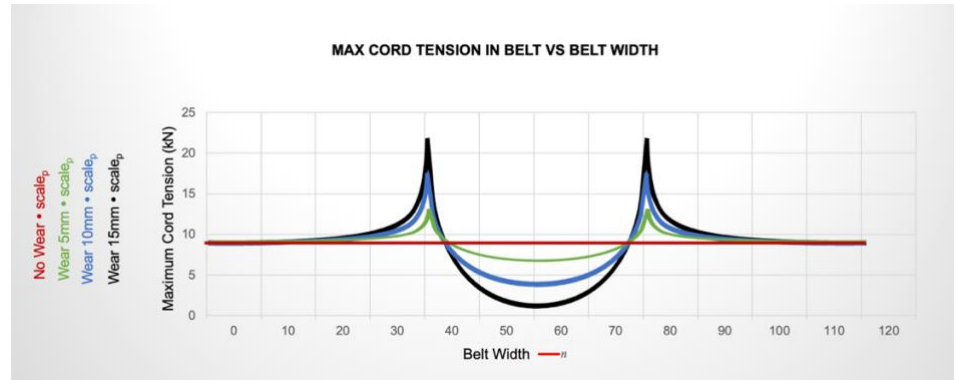
This uneven cord alignment introduces difference in tension which induces shear stresses at the interface. These induced stresses increase exponentially with belt cover wear. The more cord displacement, the more torsion and shear stress. These forces, when combined with cyclic loading and unloading with each pulley rotation, can cause substantial damage to the pulley lagging.

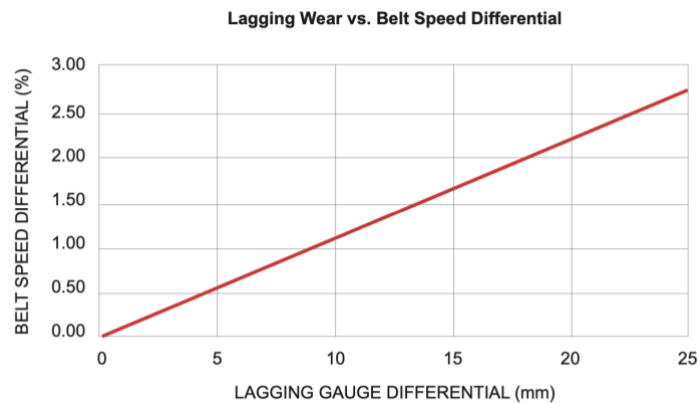
The damage that the lagging experiences is worse when dealing with high tension applications and large arc of contacts. In these cases, the forces are significant, and the damage happens quickly. This makes High tension bend pulleys the most demanding application for pulley lagging.

Increased wear rate is due to belt slip on the lagging due to the speed differential from the edge to the center of the belt.

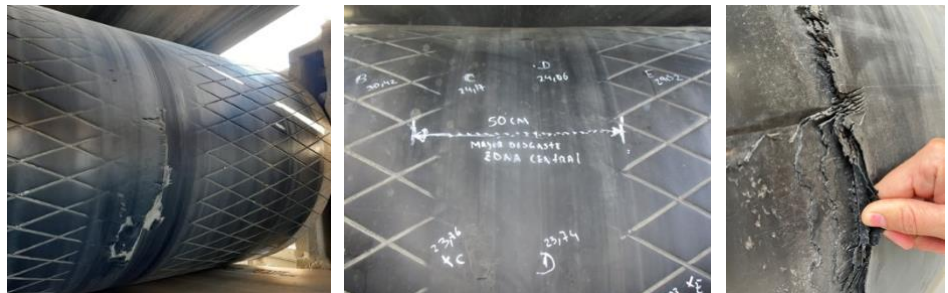
For rubber lagging, the damage is seen as excessive wear in a band around the center of the pulley, and for hot vulcanized rubber lagging made from plied sheets of uncured rubber, delamination between the plies can also occur. Cold bonded lagging should not be used on High Tension Bend Pulleys because of the high risk of the lagging debonding from the pulley shell.

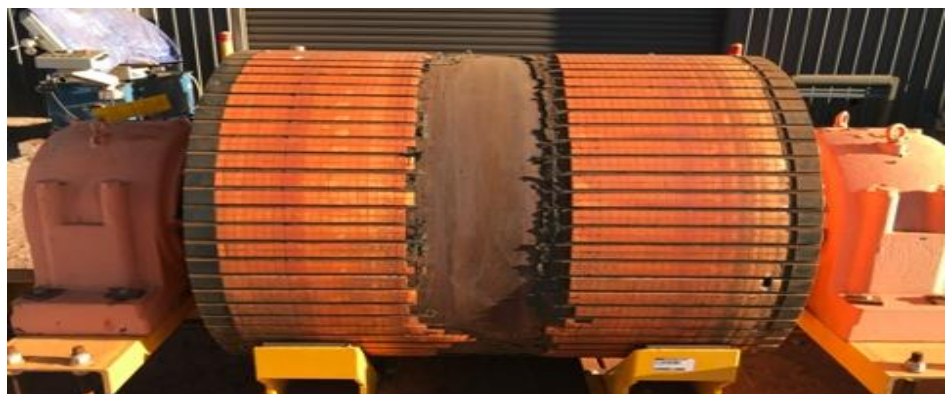
For rubber backed ceramic lagging the damage is seen as tiles torn out of the rubber backing in a central band around the pulley. The damage aligns with the contact area where there is maximum belt cover wear.

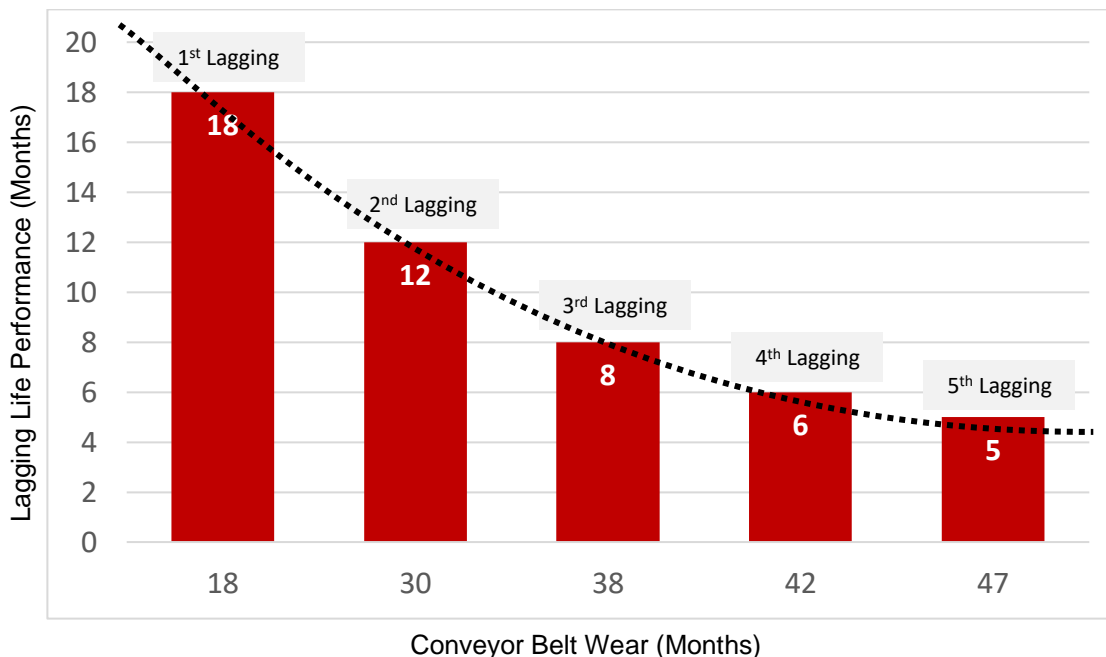
CONVEYOR BELT WEAR VS LAGGING LIFE PERFORMANCE

Lagging damage and service life is directly related to belt cover wear profile. When operating in contact with worn belt cover, lagging exponentially reduces the service life compared to the same lagging type operating with a new belt.

Lagging service life reduction with belt cover wear

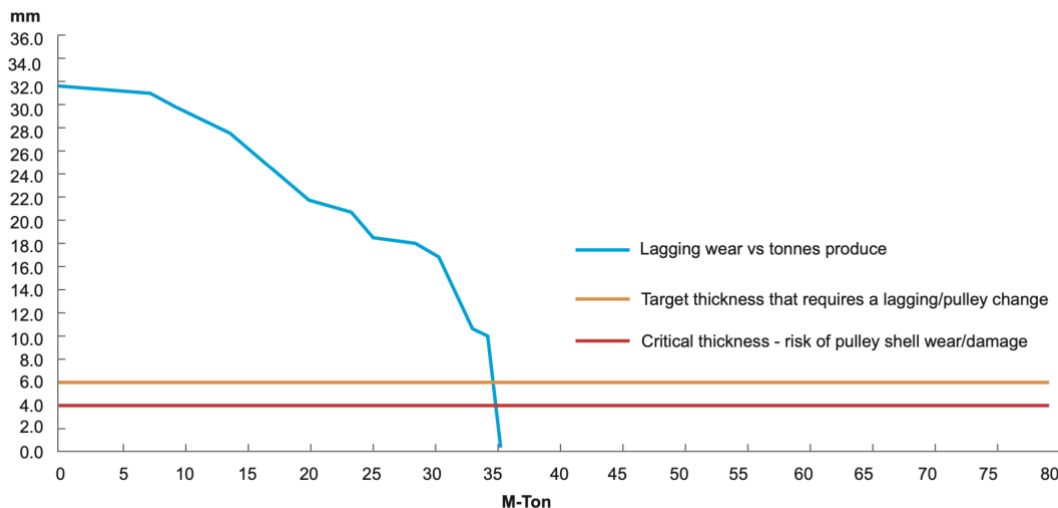
Example of High-Tension bend pulley lagging wear

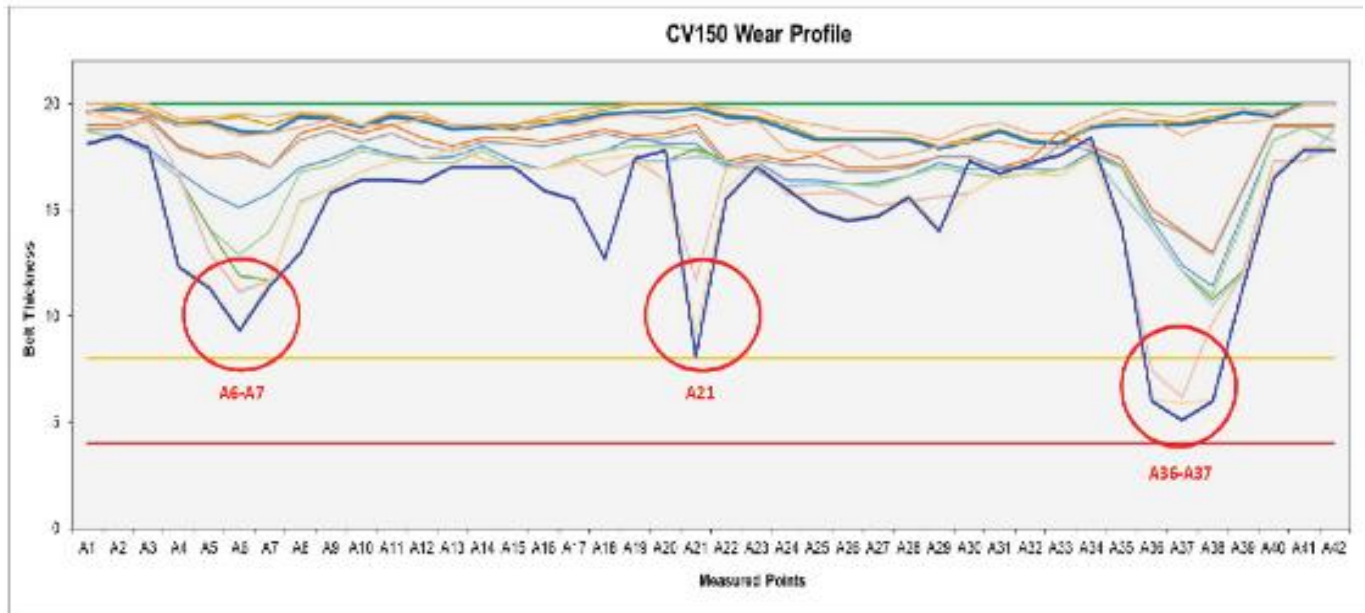
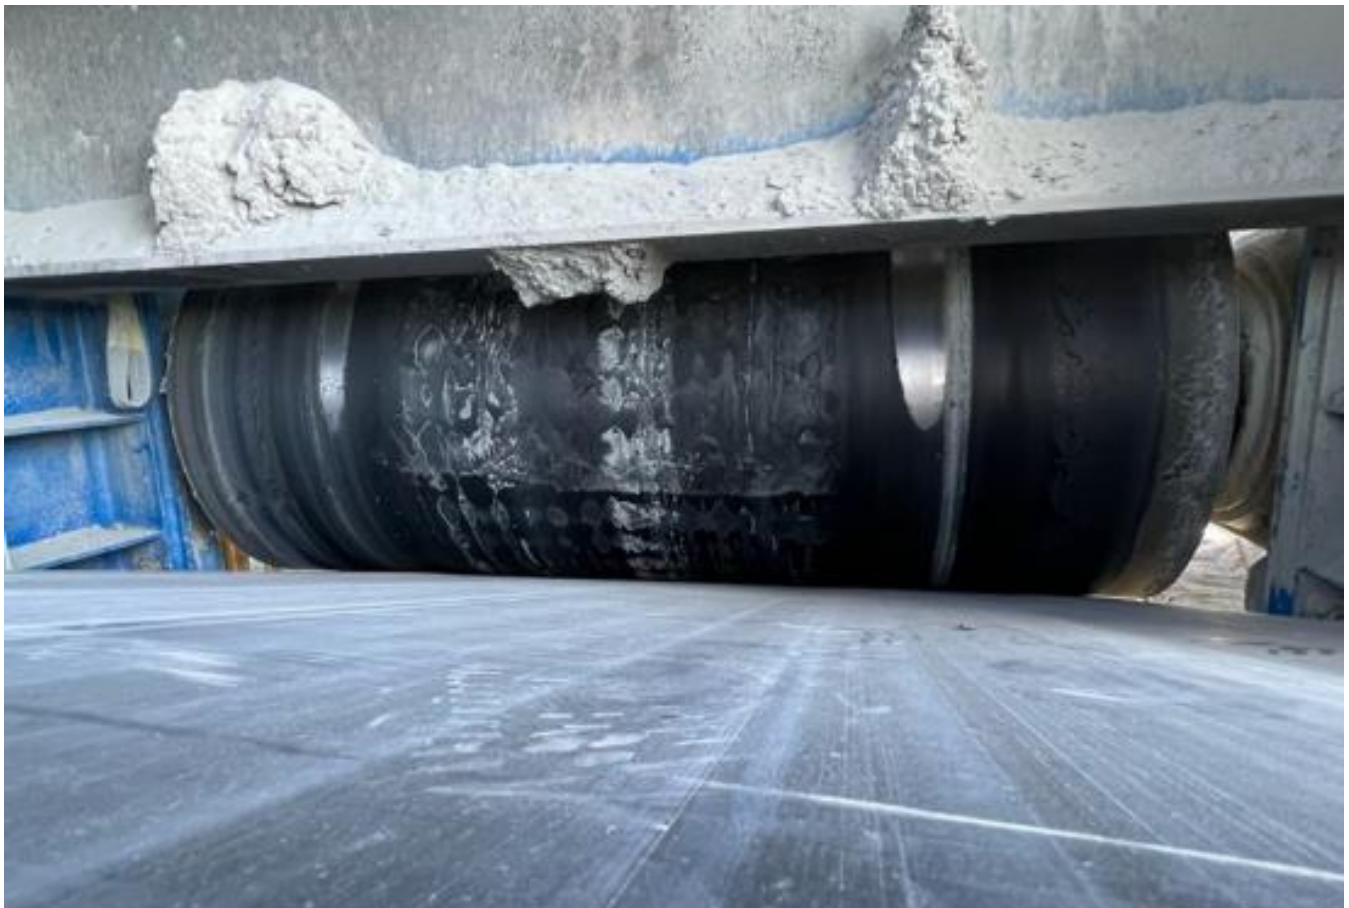
Below, an example of belt top cover wear profile affecting lagging on pulley in contact with this cover.

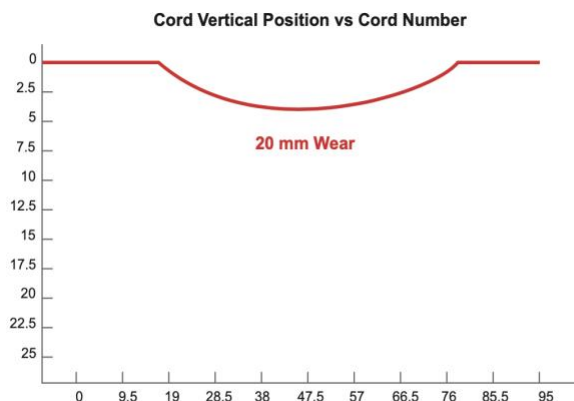
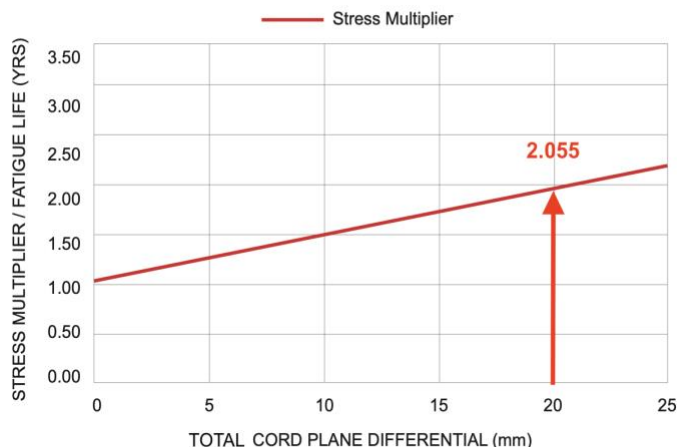
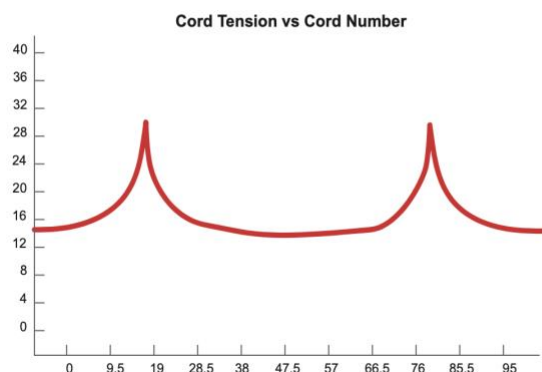
The belt wear acts as a stress multiplier on the cords.

HighestCord = 17
WidthFromEdge = 307.25 mm

$P(0, \text{HighestCord}) \text{ scale}_p = 30.464 \text{ kN}$
 $P(0, 1) \text{ scale}_p = 14.821 \text{ kN}$

$\frac{(P(0, \text{HighestCord}) \text{ scale}_p)}{(P(0, 1) \text{ scale}_p)} = 2.055$

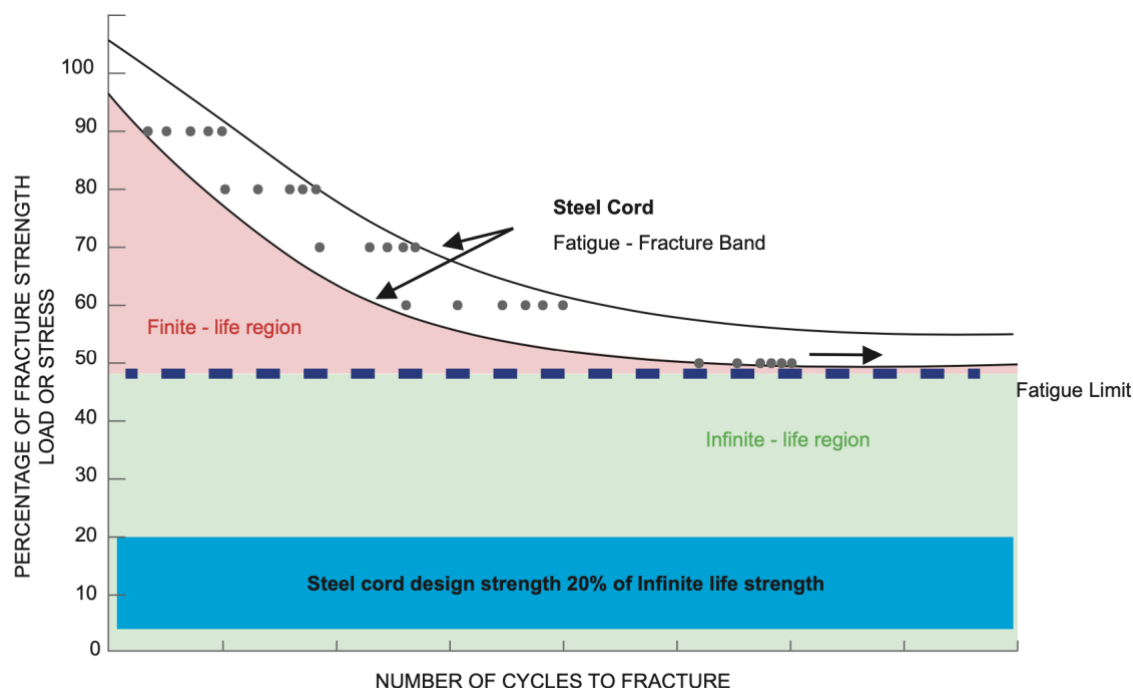
If the belt cord is exposed to stress above the fatigue limit of the splice, premature splice failures occur

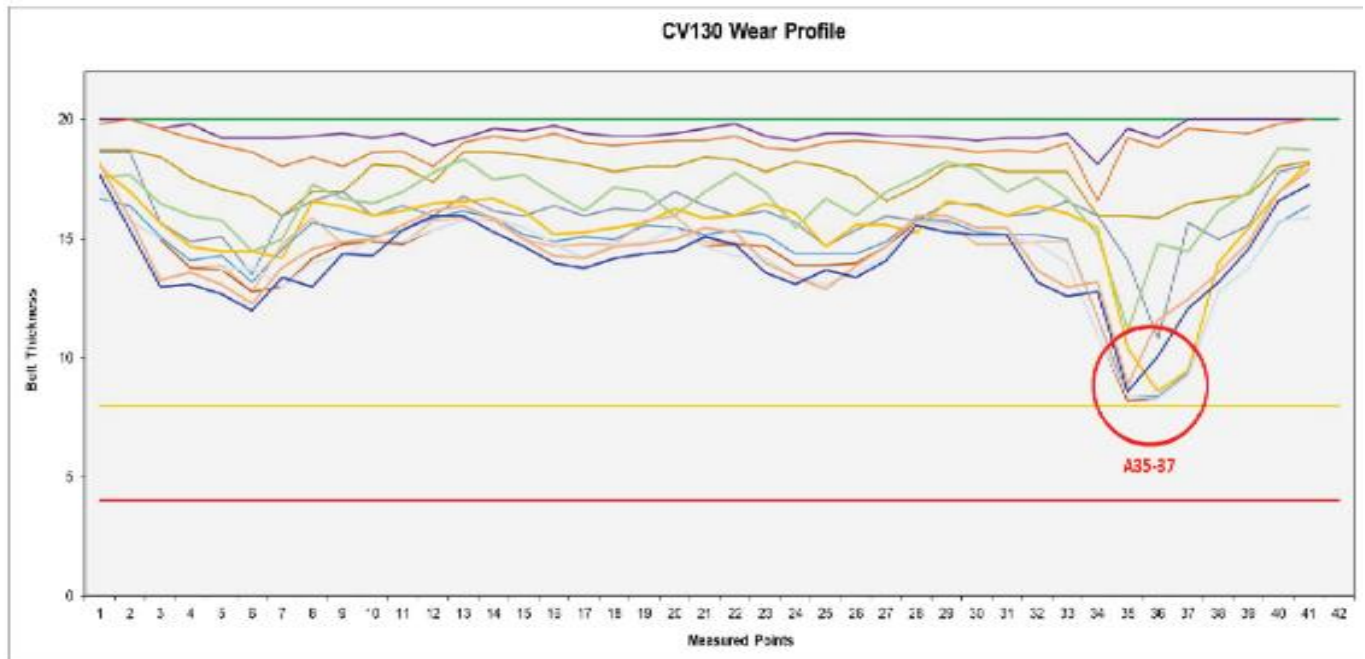
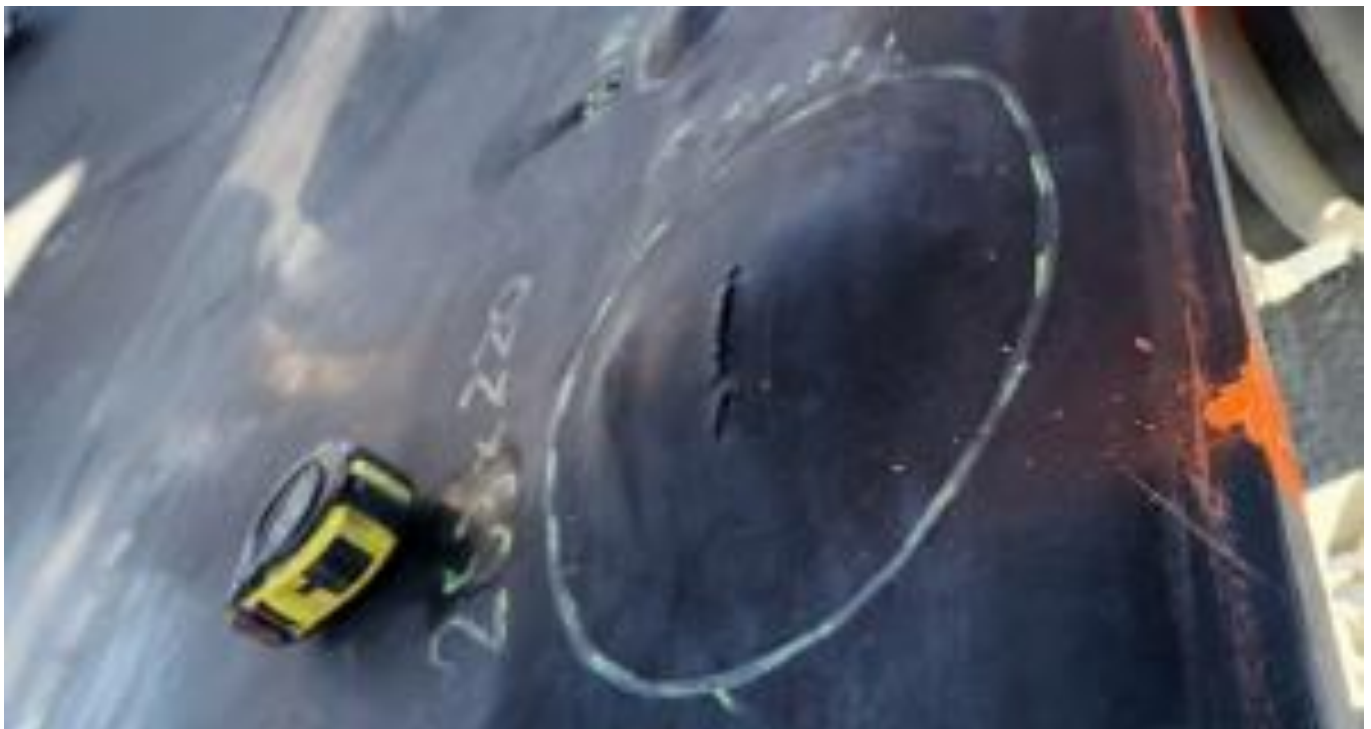
Below an example of belt wear affecting belt cords

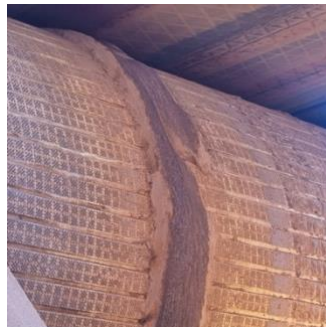
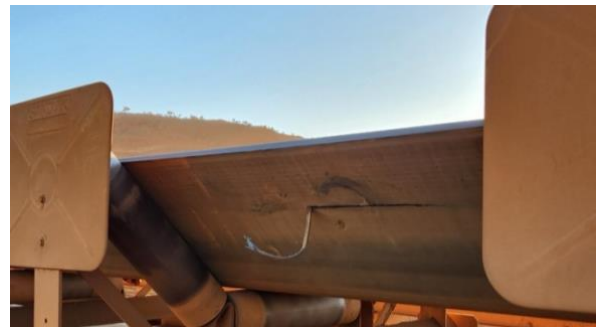
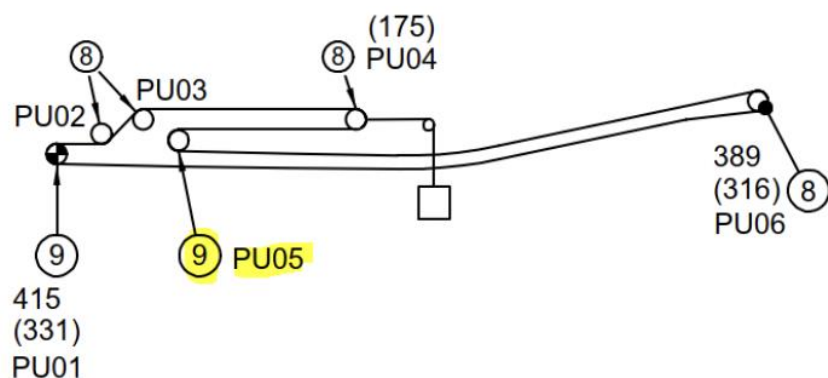
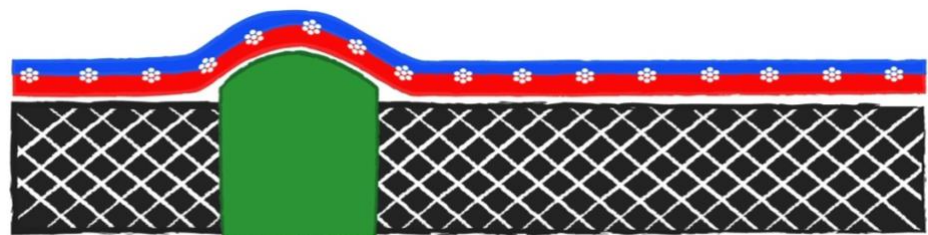
Pulleys in contact with carry side of the belt, and moreover, when they are right after the head pulley, are exposed to carryback material. Material on the carry side that doesn't leave the conveyor, and is not cleaned from the belt, is carried into the belt/lagging interface. When the lagging installed on these pulleys is too stiff, there is a risk of belt damage due to:

- rocks trapped at the interface pushed against the belt pushing cords to the return side.
- material build up due to lack of compression and expansion of the lagging shedding the material with every rotation

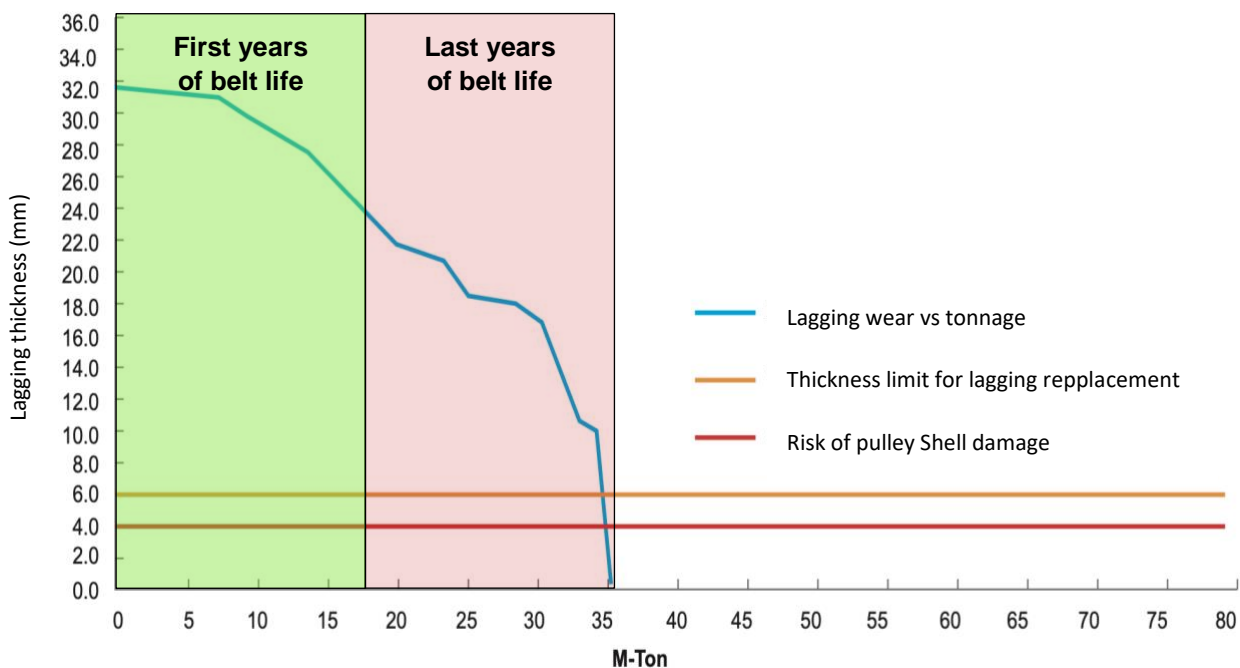
These pulleys have different challenges depending on the stage of the belt life. During the first years of the belt life, the challenges are mainly belting damage due to material carry back. During the last years of the belt life added to the carry back challenge, the belt cover wear introduces a torsion effect on pulley lagging and a stress multiplier on belt cords.

- Aligned belt cords
- Even tension distribution
- Carryback risk damaging belt

- Cords misaligned
- Uneven tensión distribution
- Carryback risk damaging belt
- Torsion effect on lagging
- Overtension on cords/splices due to cords displacement
- Overtension on cords/splices due to carryback

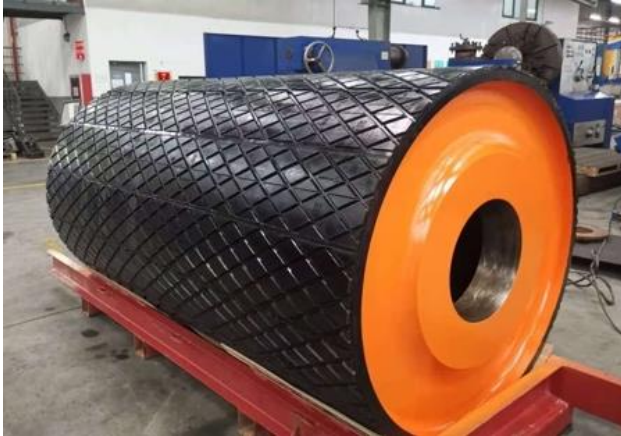
Extreme Abrasion Rubber

- 3 to 5 times more abrasion resistant than belt cover
- Flexible: compression and expansion of lagging in every cycle prevents build up reducing risk of belt damage
- Flexible. Shared load between belt and lagging when material trapped at interface reducing the risk of belt damage

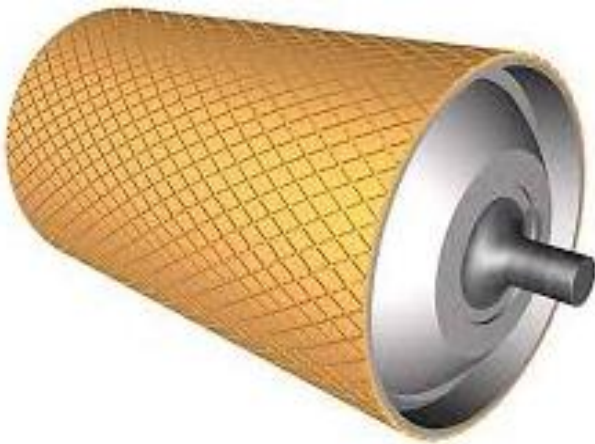
Hot Cast Polyurethane

- 3 to 5 times more abrasion resistant than belt cover
- Non-stick lagging material: prevents build up reducing risk of belt damage
- Stiff. Material trapped pushed against the belt with risk of belt damage.

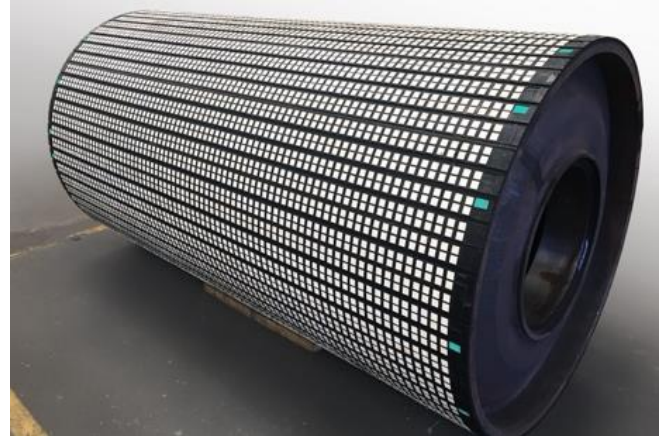
Rubber Backed Ceramic

- 10 times more abrasion resistant than belt cover
- Flexible: compression and expansion of lagging in every cycle prevents build up reducing risk of belt damage
- Flexible. Shared load between belt and lagging when material trapped at interface reducing the risk of belt damage
- Best recommendation

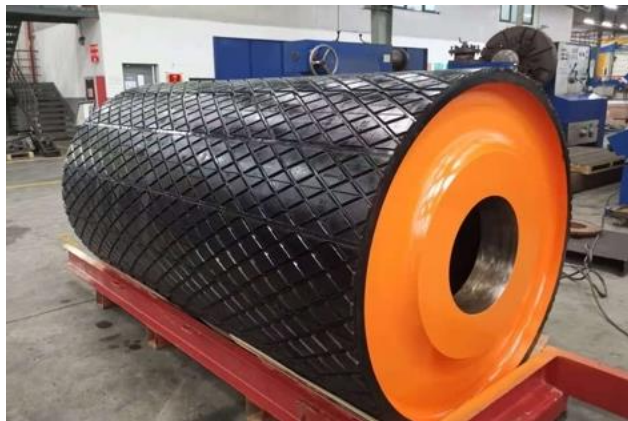
Extreme Abrasion Rubber

Only suitable for applications with tensions <1000N as, on belts with higher tensions, the cord displacement introduces stresses that might fatigue the lagging

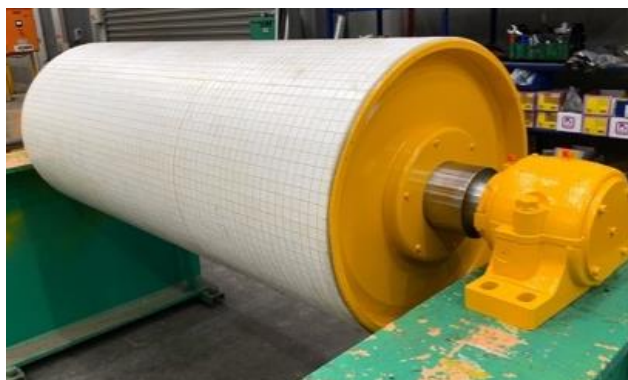
Direct bond smooth ceramic

- 10 times more abrasion resistant than belt cover
- Stiff: no compression and expansion. Risk of material build up that can damage the belt.
- Stiff. Stress from material trapped at interface pushed against the belt. High risk of belt damage is pulley not regularly cleaned.
- Recommended for applications >1500N. Lagging can tolerate the high stresses induced

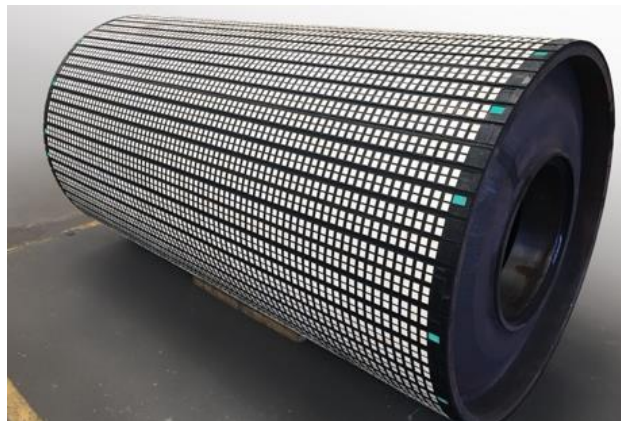
Rubber Backed Ceramic

- 10 times more abrasion resistant than belt cover
- Flexible: compression and expansion of lagging in every cycle prevents build up reducing risk of belt damage
- Flexible. Shared load between belt and lagging when material trapped at interface reducing the risk of belt damage
- Recommended for applications <1500N as, on belts with higher tensions, the cord displacement introduces stresses that might fatigue the lagging
