## CASE STUDY: HOT VULCANISED CERAMIC LAGGING EXTENDS PULLEY LIFE AT AN IRON ORE MINE

**LOCATION:** Western Australia

**APPLIC.:** Material Loading Zone

**SOLUTION:** Hot Vulcanised Ceramic Lagging

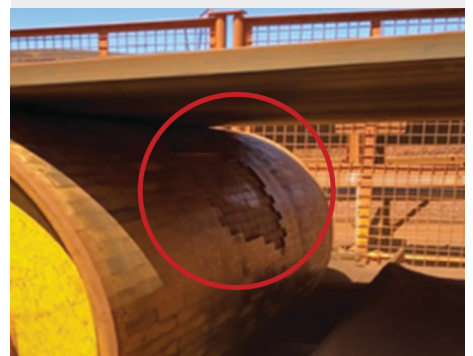
The pulley was experiencing frequent tile debonding in the centre, largely due to its position in a material loading zone with heavy spillage. Spillage material was continuously recirculating between the lagging and the belt, accelerating wear and stressing the system.

As a result, the direct bond lagging lasted only nine months before failure.

*Tile debonding with existing lagging*

One of the primary issues was the sudden stresses created by the movement of the take-up trolley, which introduced extra force onto the pulley and caused over-flexing in the centre.

In addition, the recirculation of spillage material was raising interface temperatures, which gradually weakened the adhesion strength of the direct bond epoxy system. Compounding these challenges was the inherently brittle nature of the direct bond ceramic lagging, which lacked the flexibility to absorb constant flexing and cyclic stresses.

To address these problems, Elastotec and PROK implemented Elastotec Hot Vulcanised Rubber-Backed 80% Ceramic Lagging (15mm thick with smooth tiles). This solution was applied using a hot vulcanisation process at 140°C and 450kPa in an autoclave, creating a permanent chemical bond between the lagging and the pulley shell.
