## CASE STUDY: INCREASED SERVICE LIFE OF PULLEYS WITH ELASTOTEC HVCL

**LOCATION:** Western Australia

**APPLIC.:** Pulley Conveyor

**SOLUTION:** Hot Vulcanised Ceramic Lagging

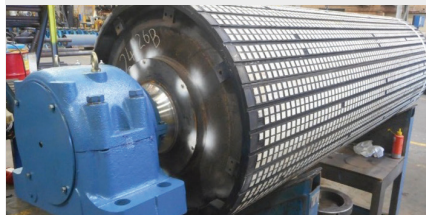
A routine inspection in October 2023 has confirmed the exceptional durability of Elastotec Hot Vulcanised Ceramic Lagging, originally applied in 2014. The lagging remained securely bonded to the pulley shell, with no signs of debonding or separation at the joints, effectively preventing water penetration and preserving the pulley's integrity. Additionally, after nine years in operation, there was no significant tile debonding or noticeable lagging wear. Elastotec' Hot Vulcanised Ceramic Lagging continues to enhance conveyor availability and increase production efficiency. When lagging is engineered for performance, it can outlast the mechanical components of the pulley itself.
