## CASE STUDY: HOW MAGNEFAST SOLVED A TOUGH DROP CHUTE

**LOCATION:** New South Wales

**APPLIC.:** Drop Chute

**SOLUTION:** Magnefast

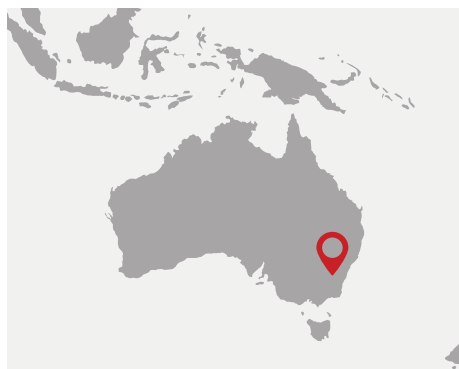
A newly installed SCAT Drop Chute presented several operational challenges:

- Restricted access made maintenance and modification difficult.
- Material build-up and caking altered the flow path, reducing efficiency.
- A hole developed in the BIS400 chute wall due to excessive wear.
- Drilling into BIS400 on site proved difficult and time-consuming.

Additionally, the absence of existing CAD drawings made chute redesign and precise liner fitting more challenging.

In collaboration with our partner Carters Engineering—who handled the design, fabrication, and installation of the SCAT Drop Chute—we implemented Magnefast Ceramic Liners to overcome the limitations of traditional liner systems. This innovative solution delivered a range of benefits that greatly enhanced both operational efficiency and safety.

- **Rapid installation**, which minimized downtime and allowed operations to resume quickly
- **Tool-free application**, eliminating the need for on-site drilling and reducing installation complexity
- **Enhanced safety**, particularly in confined or hard-to-reach areas, thanks to the lightweight and easy-to-handle design

By integrating Magnefast™ system, overall chute performance and wear life were markedly improved. Additionally, the simplified installation and removal process streamlined future maintenance, reducing both time and labour requirements.
