## CASE STUDY: TRANSFORMING CHUTE PERFORMANCE WITH MAGNEFAST

**LOCATION:** New South Wales

**APPLIC.:** Transfer Chute

**SOLUTION:** Magnefast

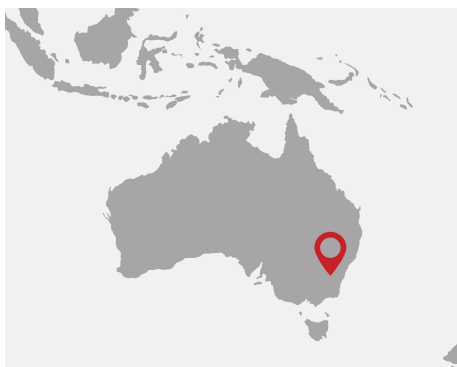
A heavily worn chute at a major processing site was experiencing ongoing liner failure and structural degradation, requiring frequent, labour-intensive shutdowns every four weeks. The goal was clear: extend liner life, reduce maintenance time and safety risks, and improve overall team morale. By implementing a redesign based on advanced scanning, engineering, and fabrication methods, the site is already performing the expected results upon Magnefast installation.

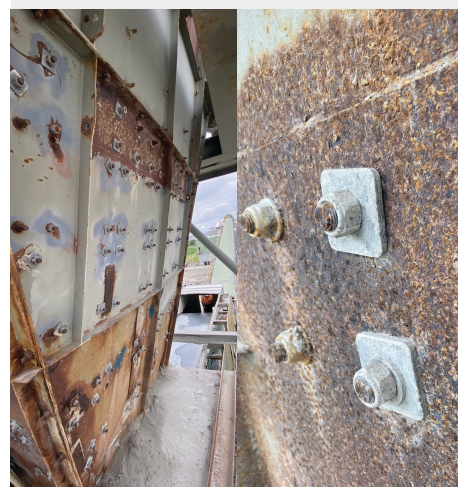
The existing chute was plagued with a range of issues that significantly impacted maintenance efficiency and operational uptime.

- Severely bent and bowed chute walls
- Frequent wear liner failures — changeouts required every 4 weeks
- Multiple holes and temporary patch repairs
- Corroded studs/nuts made liner changes slow and difficult
- External scaffolding was needed, increasing safety risk and time

- Minimum of 3 personnel required for every liner replacement

- Laser Scan** – Captured existing geometry with high accuracy.
- CAD Model Development** – Created a digital twin of the chute to assess deformation and design constraints.
- Redesign to Eliminate Bowing** – Reinforced structural integrity and improved liner fitment.
- Wear Panel Mapping** – Identified high-impact zones to optimise liner layout
- Fabrication** – Custom wear liner panels and chute modifications built to spec
- Installation** – Installed without scaffolding or hot work, using a new fastening system for rapid changeouts

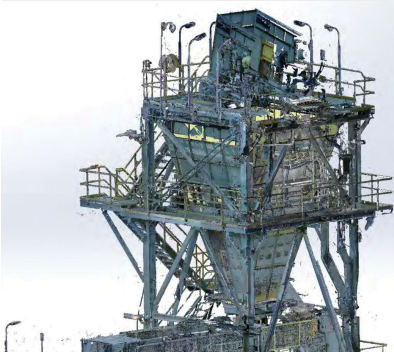
Laser Scan and Chute Image

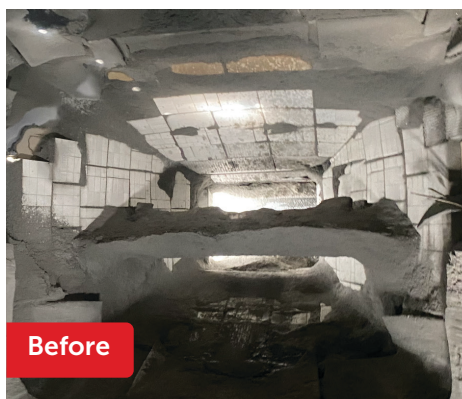
Before

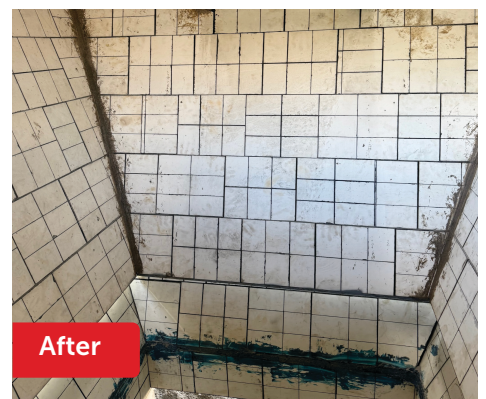
After

The redesigned chute, commissioned and put into service in March 2025, has demonstrated the value of a strategic, engineering-led approach.

By using advanced laser scanning and CAD modelling, we developed an accurate retrofit solution tailored to the site's unique wear patterns and structural challenges. This approach is already showing strong potential to deliver a longer-lasting wear system, along with forecasted savings in time, labour, and safety risks.
