## CASE STUDY: ORE TRANSFER CHUTE IMPROVEMENT AT A POLYMETALLIC MINE

In September 2023, Elastotec trialled its Magnefast Ceramic Wear Panels on a high-impact dual-deck chute handling 25mm lead ore at 110 TPH. The panels replaced white iron liners that lasted just 7–8 weeks and required 36+ hours of labour per changeout. Over 6 months and 517,000+ tonnes, Magnefast aimed to do better – with less downtime, longer wear life, and zero scaffolding.

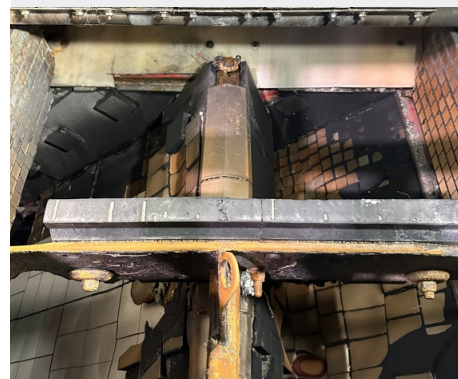
Liner replacements previously required three 12-hour day shifts, with scaffolding setup taking up to 2 hours. Over a 6-month period, the system handled approximately 517,440 tonnes of ore. Inspection showed the lower-floor white iron liners had worn completely

through, exposing the rubber backing and even the chute substrate.

Below photo shows the lower floor white iron worn through into the rubber lining and into the chute substrate.

In September 2023, the site trialled Elastotec's Magnefast Ceramic Wear Panels on a dual-deck transfer chute, replacing the existing studded white iron liners on the top floor and side wall.

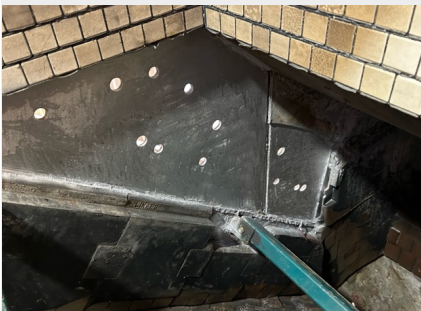
Side wall preparation

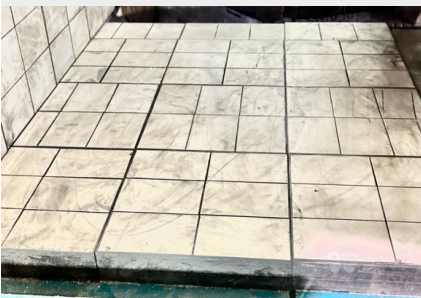
Install 2023

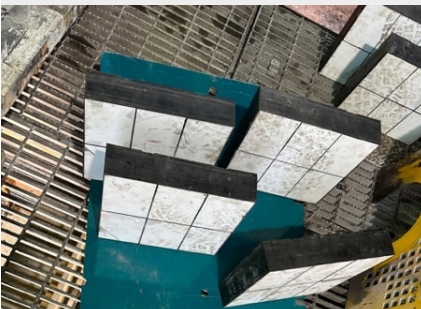
Top floor install
