## CASE STUDY: MAGNEFAST TRAIN LOAD OUT DEFLECTOR RELINE

**LOCATION:** Marulen, NSW

**APPLIC.:** Deflector Reline

**SOLUTION:** Magnefast Wear Panels

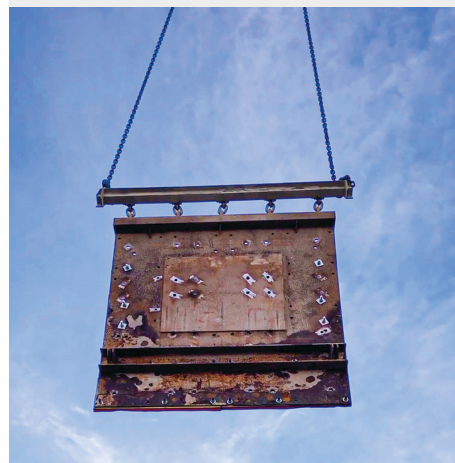
A major quarry in Western Australia faced ongoing issues with its train load out deflector system, including frequent wear panel replacements, extended downtime during relining and a high reliance on crane hire during maintenance. The existing rubber wear panels had a limited-service life of just 10 months, leading to recurring disruptions and increased operational costs, with more than 12 hours of work required for installation and/or repair.

Additionally, the use of direct bond adhesives and ceramic

resins was time-consuming and labour-heavy, leading to safety risks during maintenance.

To address the client's challenges, the Elastotec's engineers focused on optimising the installation and wear management process using Magnefast technology.

The first step involved cleaning and preparing the existing backing plate to ensure a strong and reliable foundation for the new installation. With Magnefast's streamlined system, the deflector was efficiently relined and replaced with wear panels specifically engineered for enhanced durability. This approach minimised downtime and eliminated the need for complex, time-consuming installation methods, ultimately eliminating reliance on crane hire and improving overall maintenance efficiency.
