## **CASE STUDY: 80% REDUCTION IN SHUTDOWN TIME AND 500% INCREASE IN WEAR LINER LIFE, WITH MAGNEFAST**

**LOCATION:** Port Hedland, WA

**APPLIC.:** Transfer Chutes

**SOLUTION:** Magnefast

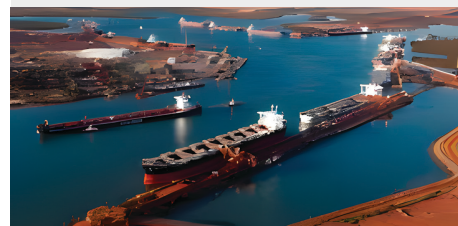
One of the key challenges faced by the operations team was the frequent need for maintenance shutdowns due to the short service life (just 10 months) of the studded steel wear liners previously in use.

The initial target was to substantially reduce the time required for a wear liner change and at the same time increase the wear liner service life from 10 months with the existing Bisalloy wear liners.

Implementation of the Magnefast Ceramic Wear Panels began in October 2019 with a trial installation at Port Hedland, on one of their transfer chutes.

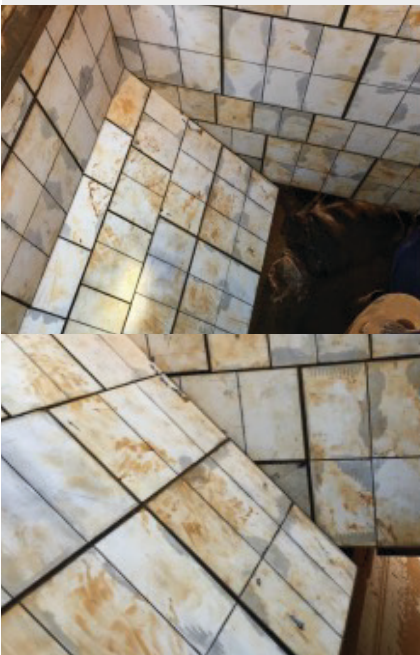
Magnefast Ceramic Install 2020

Following the success of the trial, a full chute that had previously been lined with studded steel liners was converted to Magnefast ceramic liners in December 2020. The panels were individually numbered and supplied as a complete, ready-to-install kit, which streamlined the installation process and enhanced efficiency and accuracy during scheduled shutdowns.
