## CONSEQUENCES OF CATASTROPHIC FAILURE WITH COLD BONDED LAGGING FOR NEW MINING PROJECTS

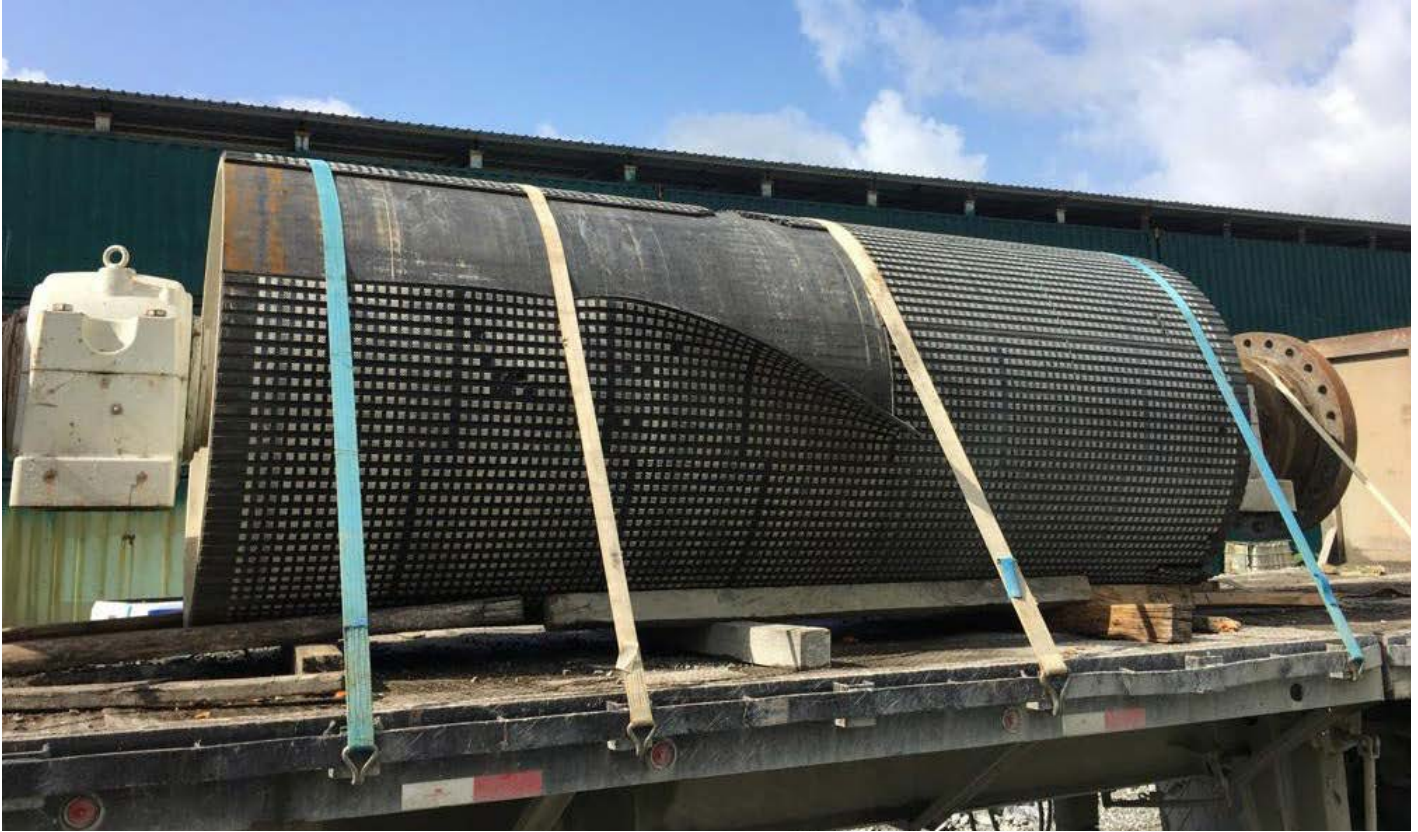
The photo above is one of four new pulleys supplied earlier this year to a new mine site undergoing commissioning and commencement of production – this was the first pulley placed into service.

**Catastrophic lagging failure due to debonding occurred within two weeks of installation and operation of the pulley, resulting in a shutdown of production, and necessitated a replacement of the pulley. Within only two weeks of service, this ceramic lagging was already experiencing loss of the ceramic tiles.**

The second pulley put into service as a replacement also suffered the same catastrophic lagging debonding, and resulted in a second plant shutdown. At this point, the conveyor component manufacturer PROK was contacted by the customer to evaluate and provide a solution to the failure. The pulleys in question were cold bond lagged and provided by another well-known pulley manufacturer.

PROK engaged partner supplier Elastotec to work on a solution. Our recommendation was for both new and refurbished pulleys to be applied with hot vulcanised lagging. The reason for this is that the 100% rubber tear bond achieved with a hot vulcanised lagging application, eliminates any chance of lagging failure due to debonding. In this instance, due to time pressure to restart the plant, and the lead time required to ship the pulleys for hot vulcanising, this was not an option, and the Elastotec cold bonded lagging and adhesive system was chosen.

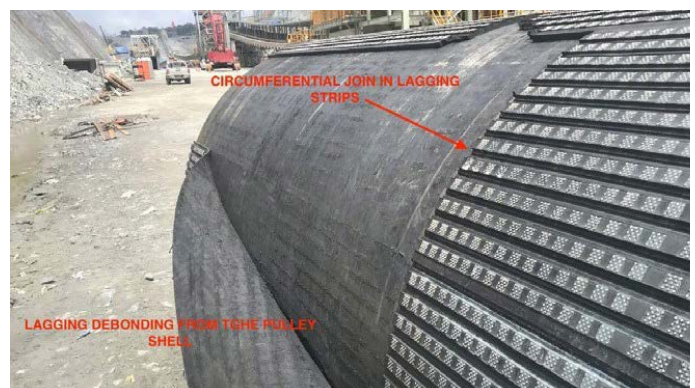
In addition to the catastrophic debonding and the tile loss after only two weeks service, a fundamental flaw in application technique was observed in a circumferential join in the lagging (see photo below).

These pulleys have a 3600 mm face width and the original applicators have chosen to cut and join shorter strips to cover the 3600 mm pulley. This places a weak point midway across the pulley and greatly increases the risk of a lagging failure. Strippulley lagging must always be applied as strips that cover the full pulley face width in a single piece.

Elastotec supported PROK to urgently manufacture the 3800 mm long ceramic lagging strips for the four pulleys and had this shipped, with the Elastotec cold bonding system, by airfreight to the mine site. An Elastotec applications engineer was sent to the site to assist with training, and supervision of the lagging application – duplicate adhesion tests were carried out on each pulley lagged, and the results were above the Elastotec requirement of a minimum of 12N/mm. The pulleys are back online and are operating satisfactorily.

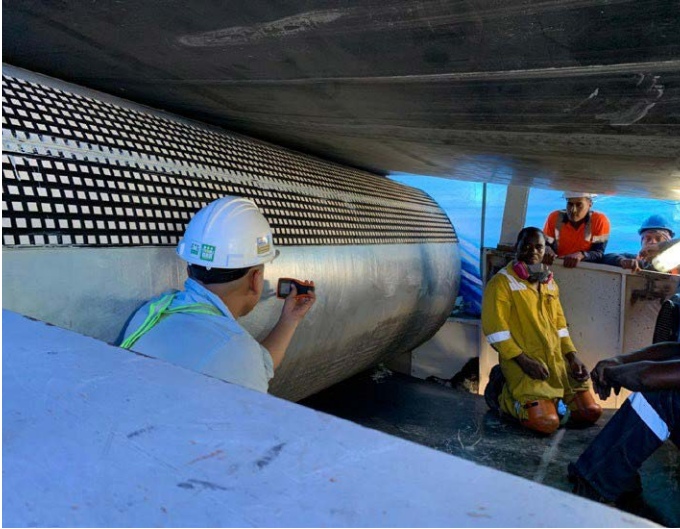
Elastotec ceramic lagging being applied on conveyor with Elastotec supervision and training
