# PT Kembla Coal Terminal Case Study

In early 2012 Port Kembla Coal Terminal (PKCT) identified a need to refurbish the drive pulleys on their two Stacker Reclaimer units. Included in this refurbishment was replacement of the lagging.

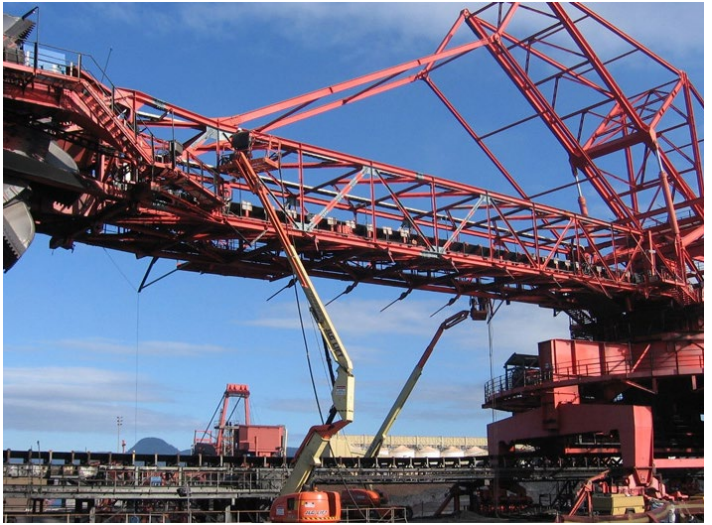
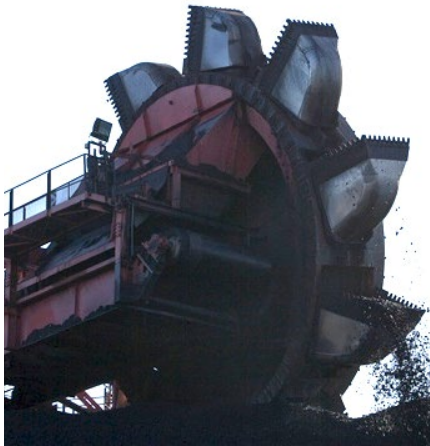
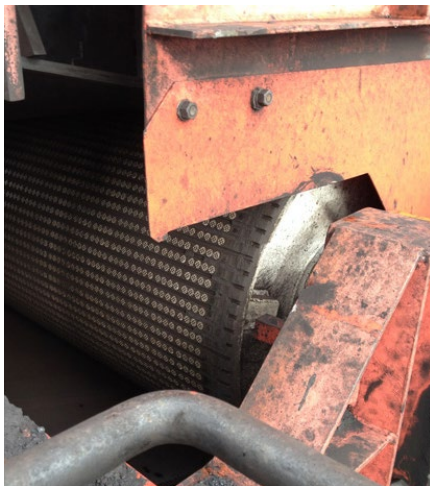
PKCT made the decision to proceed with the application of the Elastotec Hot Vulcanised Ceramic lagging to the first pulley for the No.2 Stacker Reclaimer in 4th quarter 2012. This was completed with a 3 week turnaround. The second drive pulley for the No. 1 Stacker Reclaimer was lagged during the 1st Quarter of 2013. For both drive pulleys the 20 mm HV Ceramic was selected.

Both Stacker Reclaimer drive pulleys are now back in service and Elastotec the manufacturer of the Hot Vulcanised Ceramic lagging expects a long service life for the Ceramic lagging as the chance of the more common ceramic lagging failure modes ( tile pull out , and lagging debonding from the pulley shell) have been eliminated. Additionally the chance of excessive belt wear due to slippage has been greatly reduced.
