## CASE STUDY: MAGNEFAST TRAIN LOAD OUT DEFLECTOR RELINE

**LOCATION:** Marulan, NSW

**APPLIC.:** Deflector Reline

**SOLUTION:** Magnefast Wear Panels

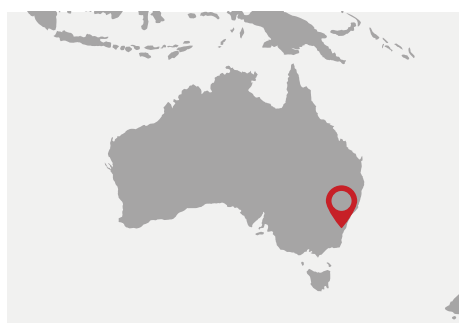
A major quarry in New South Wales sought to improve the efficiency and durability of its train load out deflector system. The key objectives were to reduce change-out and relining time, minimise reliance on crane hire, and extend the service life of existing rubber wear panels - which were currently lasting only 10 months.

To address the client's challenges, the Elastotec's engineers focused on optimising the installation and wear management process using Magnefast technology.

The first step involved cleaning and preparing the existing backing plate to ensure a strong and reliable foundation for the new installation. With Magnefast's streamlined system, the deflector was efficiently relined and replaced with wear panels specifically engineered for enhanced durability. This approach minimised downtime and eliminated the need for complex, time-consuming installation methods, ultimately eliminating reliance on crane hire and improving overall maintenance efficiency.

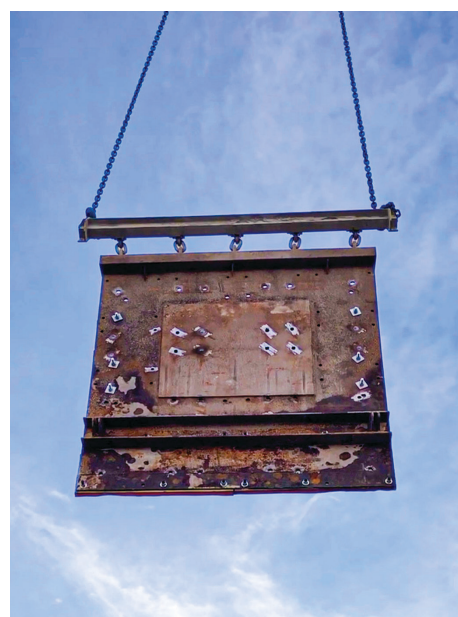
A major quarry in New South Wales faced ongoing issues with its train load out deflector system, including frequent wear panel replacements, extended downtime during relining and a high reliance on crane hire during maintenance. The existing rubber wear panels had a limited-service life of just 10 months, leading to recurring disruptions and increased operational costs, with more than 12 hours of work required for installation and/or repair.

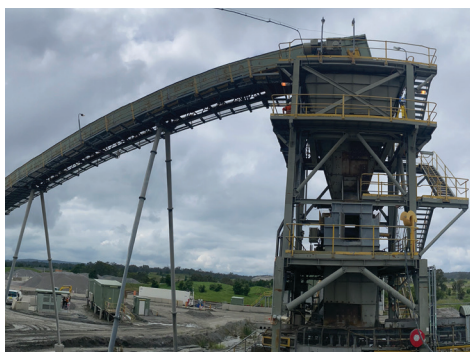
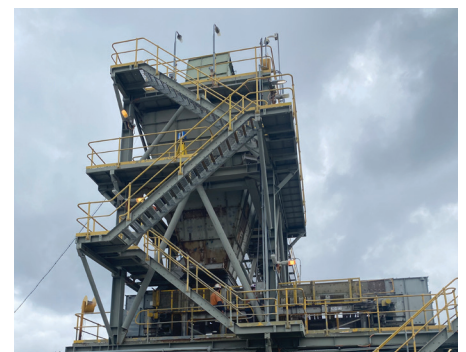
After three months in operation, the deflector system remained in excellent condition, showing no significant signs of wear. At the six-month inspection, wear was measured at just 5mm significantly outperforming the previous rubber lining. Continued monitoring over time confirmed consistent, predictable wear, with the Magnefast™ liners achieving up to 60-months of service life (photos on next page).

During a planned shut a work platform was set up between the head pulley and the swing wall and the panel rotation and/or swapping was typically completed in less than 30 minutes.

Through strategic panel rotation and repositioning, the full wear profile of each liner was utilised, allowing high-wear zones to be managed without premature replacement. This approach not only enabled the 60-month achieved service life, but also delivered a more sustainable, long-term solution for the train load-out deflector system.

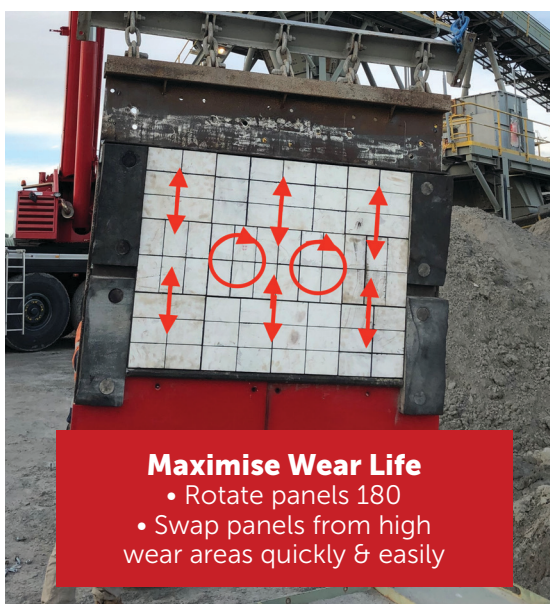
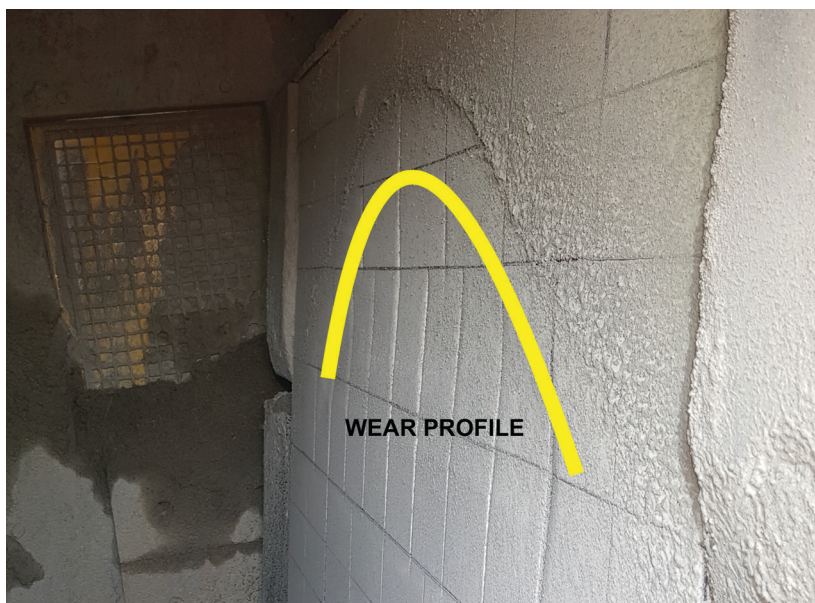
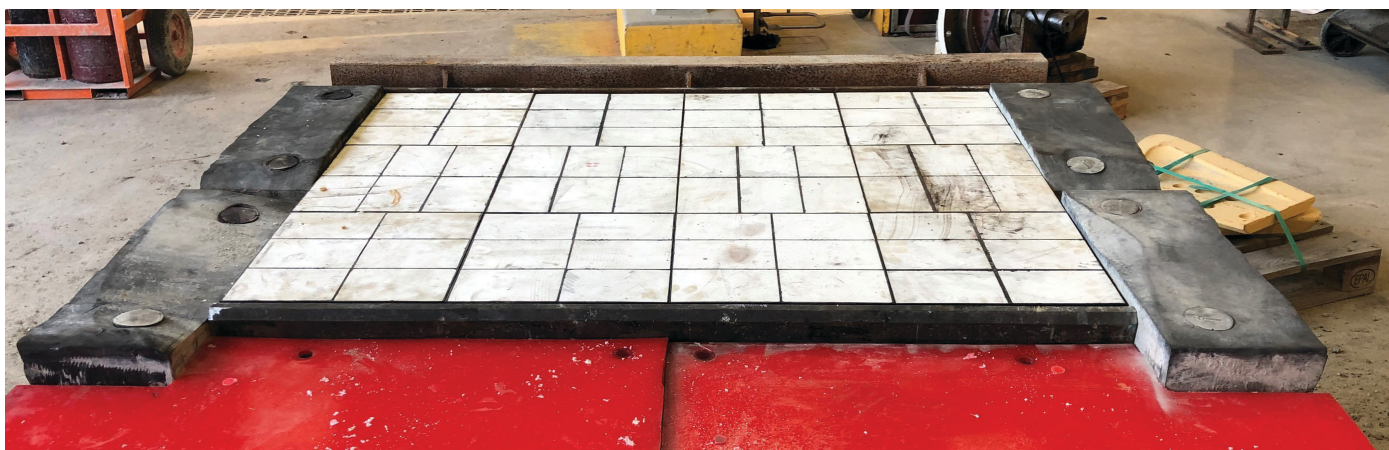
Deflector applications are subject to highly localised wear due to directional material flow and impact angles. Magnefast™ wear liners provide a significant advantage in these environments by enabling targeted wear management without full liner replacement.

For this site the Magnefast™ panel rotation/swapping was typically less than 30 minutes. This flexibility allows operators to fully utilise the entire wear profile of each panel, rather than prematurely replacing liners due to localised damage.

- Rotate panels to bring unworn sections into high-wear zones
- Swap panels between high- and low-wear areas to balance overall liner consumption
- Extend service life without crane hire or complex relining procedures
