## CASE STUDY: MAGNEFAST™ CERAMIC LINERS ENABLE RAPID SHUTDOWN INSTALLATION AT 24/7 GOLD LEACH PLANT

**LOCATION:** Near Townsville  
**YEAR:** 2025  
**APPLIC.:** Gold Mineral Process Leach Hoppers  
**SOLUTION:** Magnefast™ Ceramic Liners

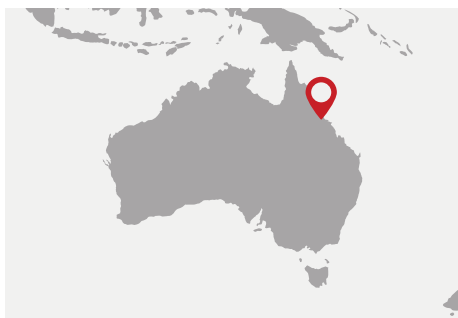
A gold leach wet process plant operating continuously 24 hours a day, 7 days a week had not experienced a full shutdown since commissioning more than three years ago. The plant's leach hoppers were exposed to aggressive wear conditions, requiring a lining solution that could be installed within a tightly constrained shutdown window while delivering improved service life and long-term reliability. With the first planned shutdown approaching, Elastotec was engaged to provide a solution that balanced installation speed, wear resistance, and operational confidence.

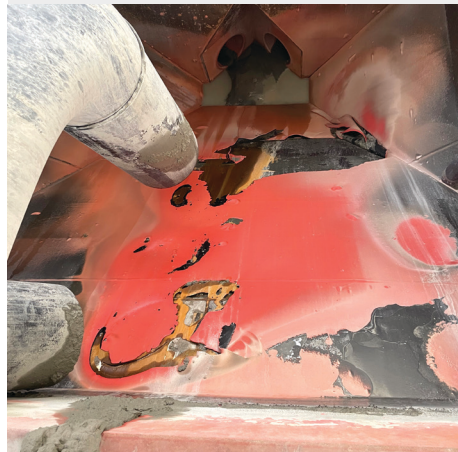
The leach hoppers had previously been protected with cold-bonded rubber lining, which had failed on multiple occasions under sustained wet process conditions. Progressive wear resulted in breakthroughs to the hopper steel skin, creating an ongoing maintenance risk.

To maintain continuous production, site personnel were forced to carry out temporary welded steel patch repairs while the plant remained operational.

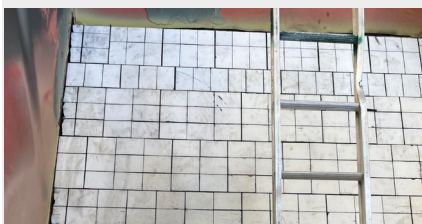
The damaged hopper wall was re-skin with 8 mm thick steel to provide a clean flat surface for the Magnefast™ ceramic liners.

Bitrac identified the opportunity to resolve the re-lining challenge within a four-day shutdown using Magnefast™ ceramic liners and managed the full project scope, including steel re-skin repairs, primer coating, and Magnefast™ panel installation.
