## CASE STUDY:

# UNLOCK HIGHER PRODUCTION WITH MAGNEFAST™ – REVOLUTIONARY TECHNOLOGY THAT REDUCES REGULAR FIXED PLANT SHUTDOWNS FOR WEAR

**APPLIC.:** Screen Underpan Chutes

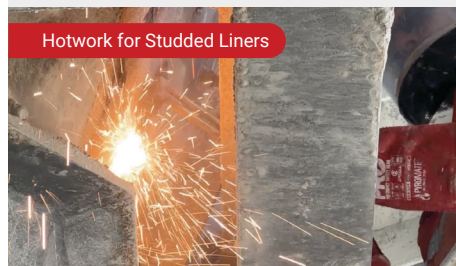
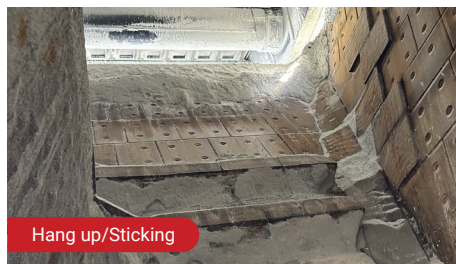
- Frequent material hang-up and build-up, requiring regular washdowns
- Short liner service life (~13 weeks) leading to high replacement frequency
- Restricted shutdown windows (48 hours) limiting maintenance scope
- Labour-intensive liner replacement, involving gas axe cutting of corroded studs and manual punching and removal
- Dependence on scaffolding and hot work, increasing safety risks and complexity

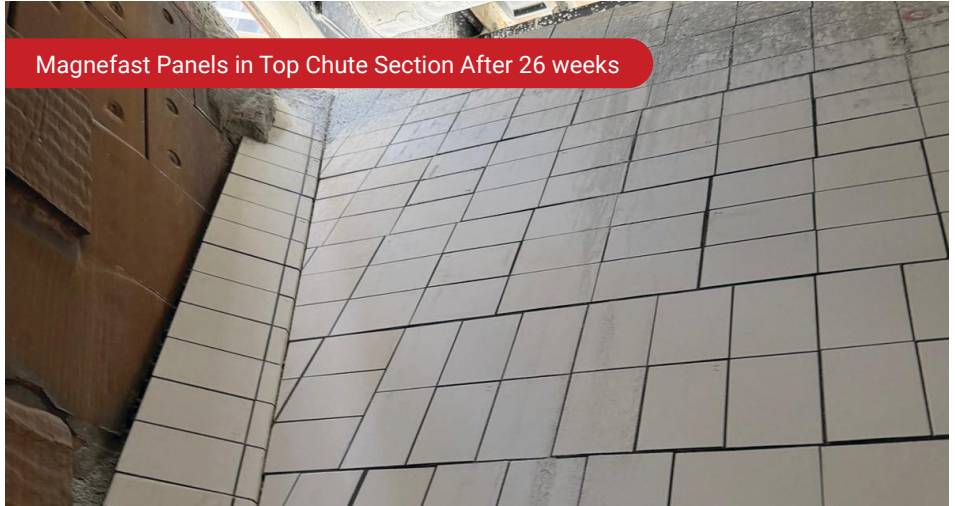
Inspections also showed original mould markings still visible on many ceramic panels, highlighting the durability of the liner system under demanding operating conditions.

Magnefast Panels in Top Chute Section After 26 weeks

The implementation delivered a major improvement in chute performance, maintenance efficiency and operational reliability. Following the installation of the Magnefast™ ceramic liner system, liner service life increased from approximately 13 weeks to >104 weeks based on measured wear rates, an improvement of more than 8x over the previous NiHard liner system.

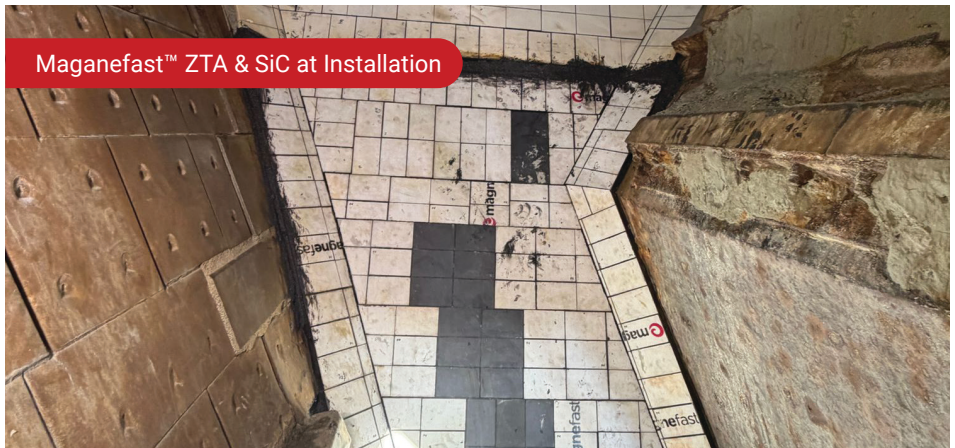
Magnefast™ ZTA & SiC at Installation

Following the success of the initial trial, the site expanded the application into the high-wear lower chute section using a combination of ZTA and Silicon Carbide (SiC) Magnefast™ liners to further optimise wear life and material flow performance.

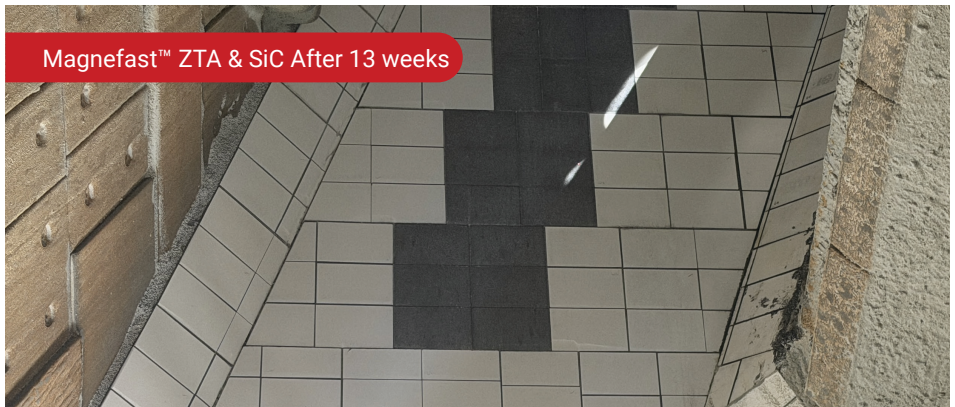
Magnefast™ ZTA & SiC After 13 weeks
