## CASE STUDY:

# IRON ORE EXPORT PORT USES NEXT-GEN MAGNEFAST™ TECHNOLOGY TO ELIMINATE 14-WEEK WEAR LINER REPLACEMENT

**LOCATION:** Western Australia  
**YEAR:** 2026  
**APPLIC.:** Lower Transfer Chute  
**SOLUTION:** Magnefast™ Ceramic Liners

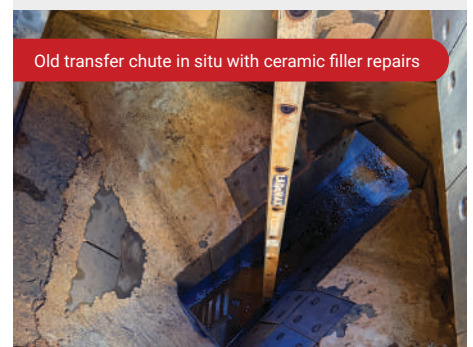
This chute was originally lined with studded Ni-Hard steel liners. With shutdowns scheduled every 14 weeks and limited to just five days, there was rarely enough time to complete comprehensive repairs across all transfer chutes.

Instead, the maintenance team relied on repeated patch repairs using Epoxy Ceramic Filler. While quick to apply, these fixes were temporary and required rework at every shutdown consuming valuable labour, time and maintenance resources.

Old transfer chute in situ with ceramic filler repairs

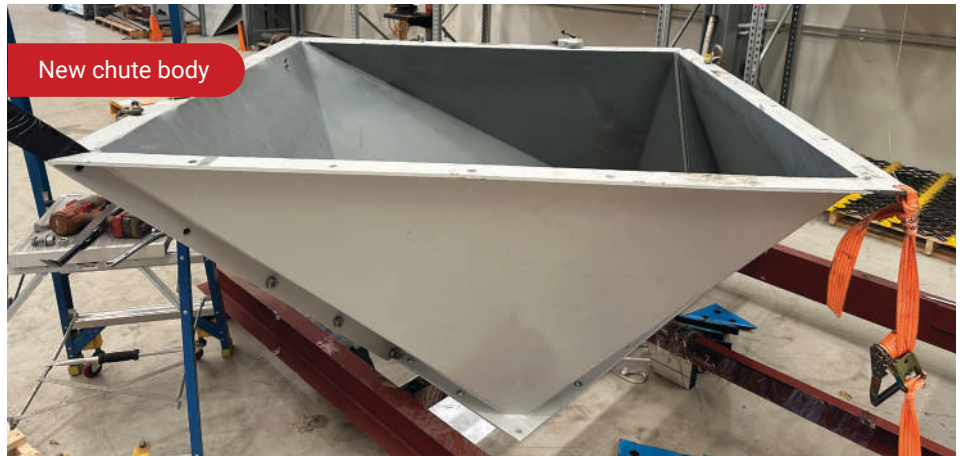
New chute body

1. Manufacture a new mild steel chute body and skirt assembly to replace the heavily worn existing 30 year old components. Remove existing chute body and replace with new chute body and skirt.
2. Optimise the selection of Wear Liner Material. In this case 95% Aluminium Oxide ceramic was chosen to replace the existing NiHard wear liners. Expected increase in service life was > 500%.
3. Magnefast™ 95% aluminium oxide wear liners were installed to reduce labour and time required for wear liner replacements. An added benefit was the ability to quickly and easily rotate wear liners to move worn areas out of the high product flow and/or swap with adjacent unworn liner.

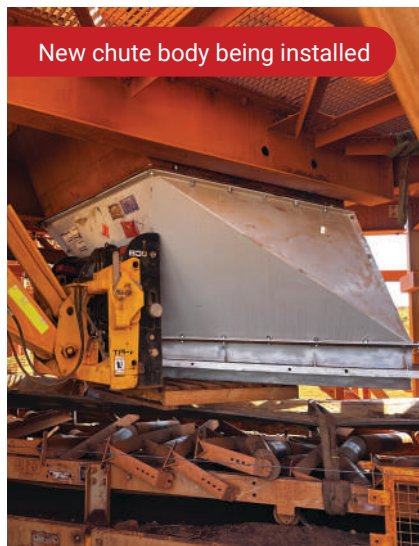
New chute body being installed

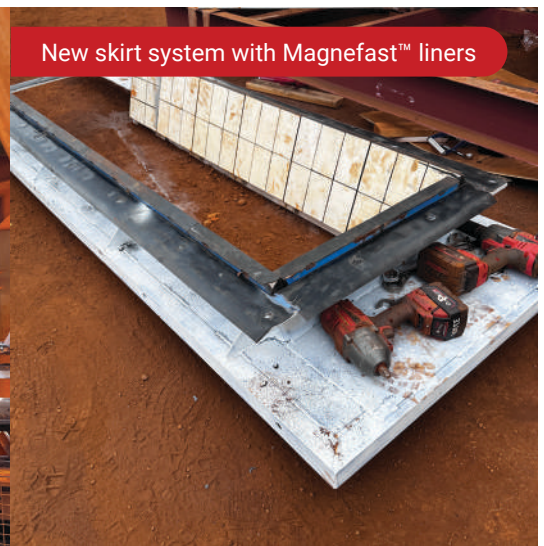
New skirt system with Magnefast™ liners

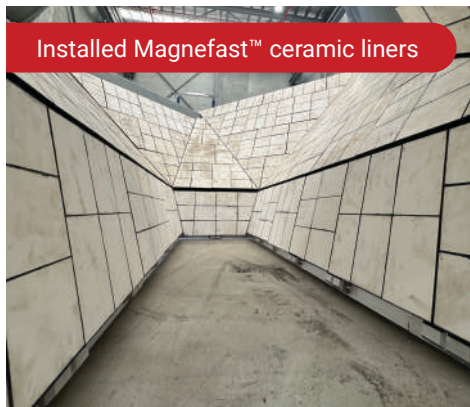
Installed Magnefast™ ceramic liners

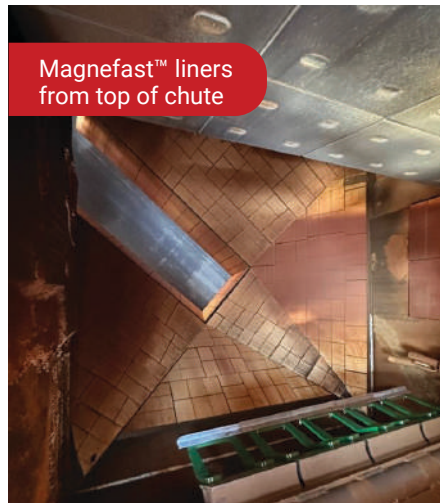
Magnefast™ liners from top of chute
