# EXTENDED SERVICE LIFE FOR MAJOR FIXED PLANT IN DIFFICULT LOCATION AND COMPLEX SHAPE: FORTESCUE IRON BRIDGE AIR CLASSIFIER

**LOCATION:** Western Australia  
**YEAR:** 2026  
**APPLIC.:** Air Classifier System  
**SOLUTION:** Magnefast™ Ceramic Liners  
**MATERIAL:** Magnetite Ore

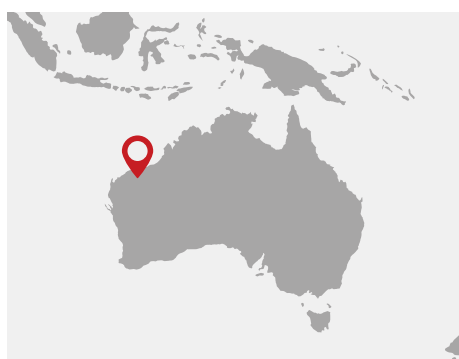
FMG's Iron Bridge magnetite operation required a wear lining solution for its air classifier system, where high-velocity air carrying abrasive iron ore fines created severe wear conditions. The complex internal geometry of the steel ductwork, combined with strict weight limitations and the risk of shell erosion caused by gaps between conventional liners, made reliable wear protection particularly challenging. The objective was to implement a lightweight, high-performance lining system that would extend service life, protect the ductwork and reduce long-term maintenance requirements.

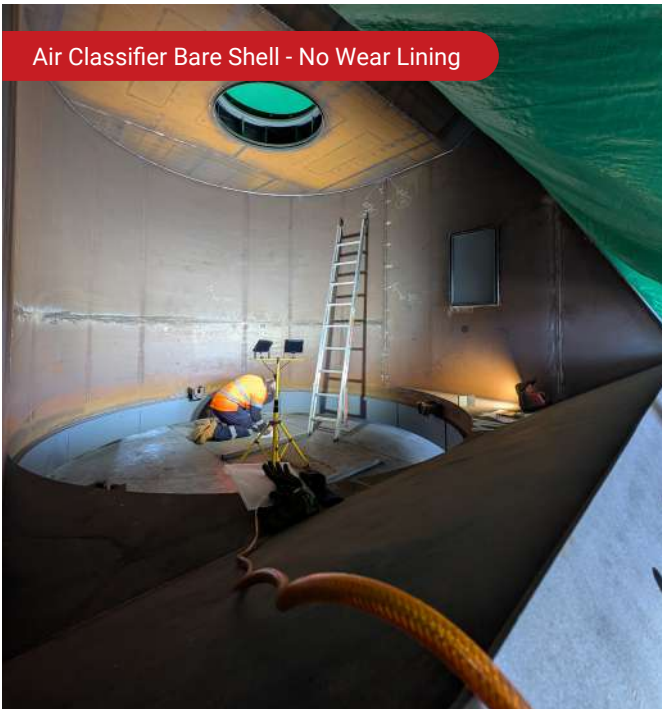
Air Classifier Bare Shell - No Wear Lining

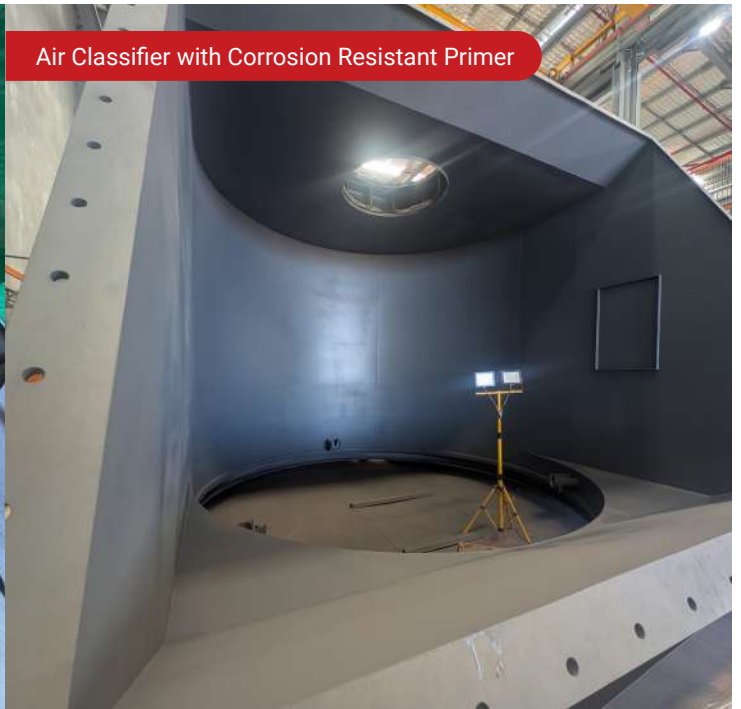
Air Classifier with Corrosion Resistant Primer

Using a detailed 3D model of the air classifier, a complete wear panel layout and individual panel drawings were developed to ensure precise fitment. The internal surfaces were then shot blasted, prepared, and coated with a corrosion-resistant primer before the Magnefast™ ceramic liners were installed across all internal wear surfaces.

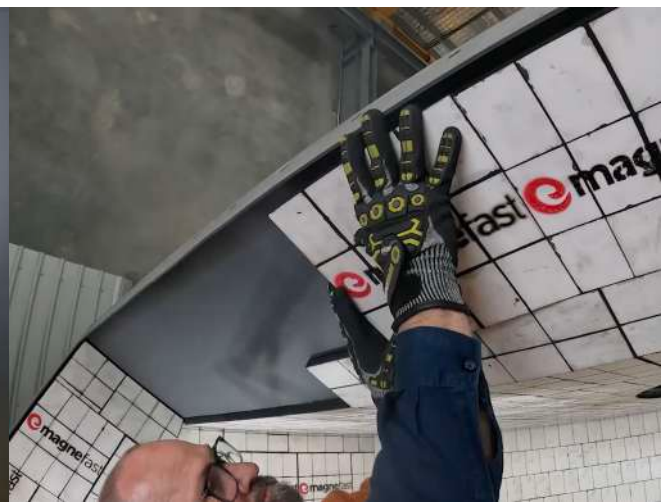
Magnefast™ Installation

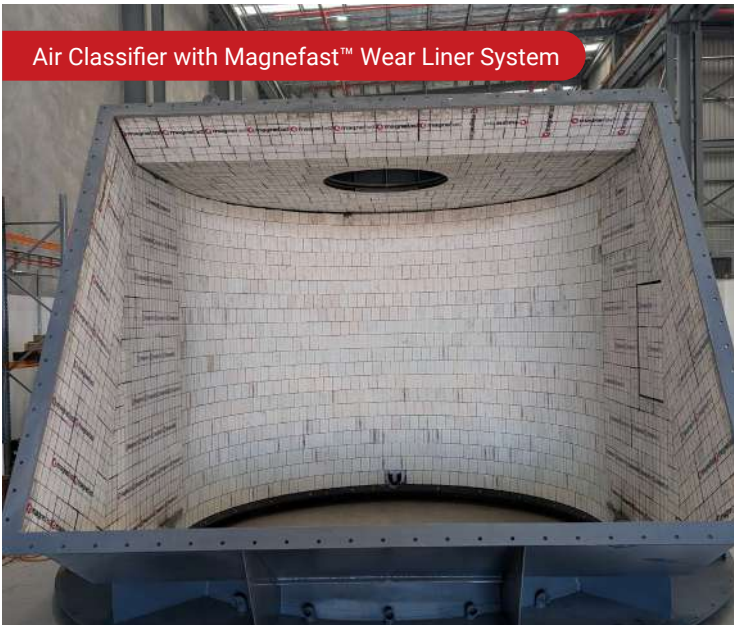
Air Classifier with Magnefast™ Wear Liner System

The fully lined air classifier was delivered back to site and commissioned in January 2026, ready for operational service.

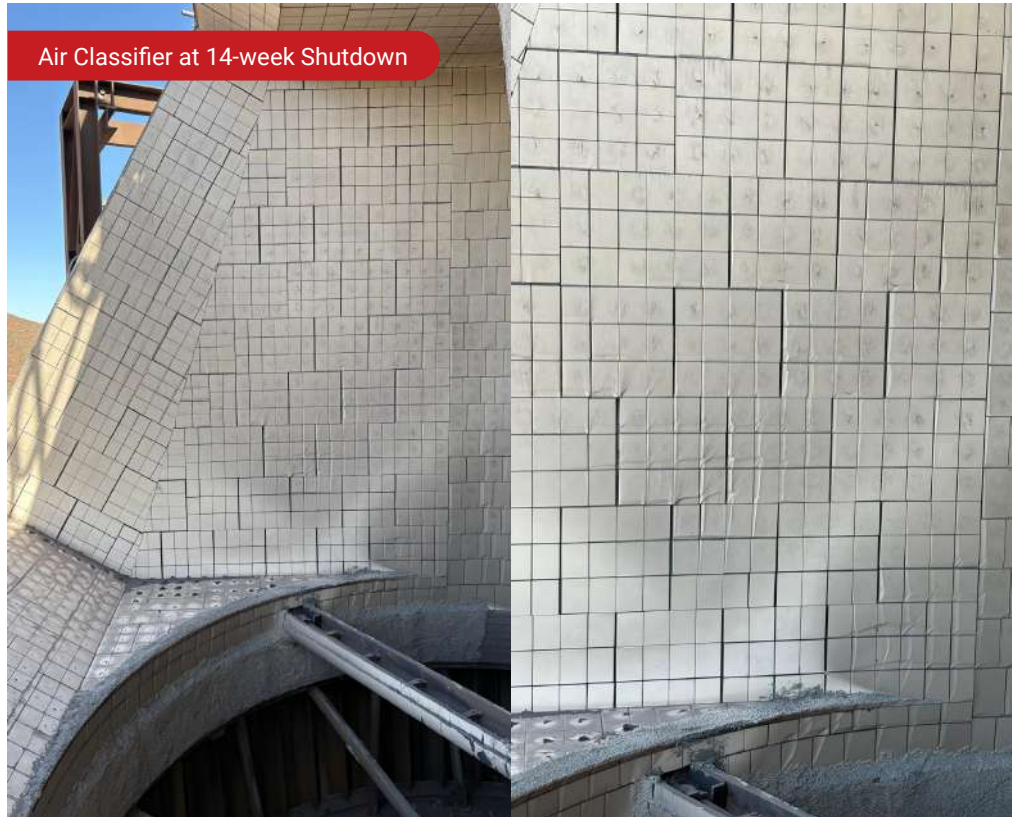
Air Classifier at 14-week Shutdown

The first inspection, conducted during the 14-week planned shutdown, confirmed the Magnefast™ Wear System was performing as intended under demanding operating conditions.

All ceramic liners remained securely in position, confirming no interaction with Magnetite dust during operation and were found to be in excellent condition, with only minor, localised wear observed on the leading edges of a small number of liners. The highest recorded wear was approximately 5mm, while the majority of the liners showed little to no measurable wear.

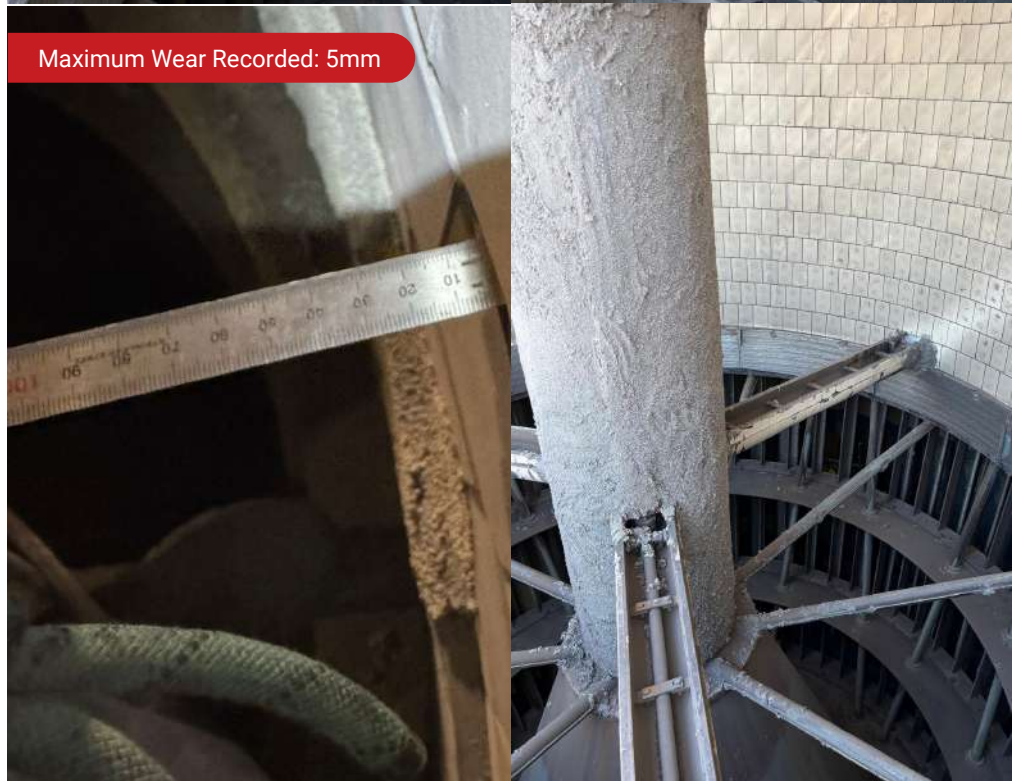
Maximum Wear Recorded: 5mm

Based on the inspection findings, the site estimates the lining system will continue operating for at least four additional 14-week shutdown cycles before liner replacement is required. Extending the original wear life from X weeks (With concrete) to 70 weeks.

Furthermore, because wear is concentrated on one side of the liners, individual panels can be simply rotated in the highest wear areas to maximise service life and further extend maintenance intervals. This modular approach provides greater flexibility, reduces replacement costs and minimises future shutdown requirements.
