## CASE STUDY:

# OPEX BUDGET UNLOCKS IMMEDIATE LONGTERM PRODUCTIVITY GAINS: HOW ONE HIGH-VOLUME LITHIUM MINE INCREASED UNDERPAN WEAR LIFE BY 8X - ON MULTIPLE CHUTES, ONE SHUTDOWN AT A TIME.

**APPLIC.:** Screen Underpan

**SOLUTION:** Magnefast™  
Ceramic Liners

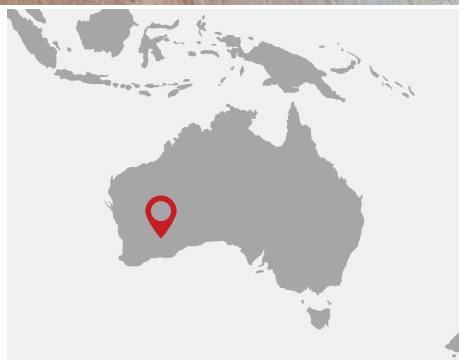
The site's four screen underpans had been lined with traditional studded Ni-Hard liners since the plant was commissioned. Processing highly abrasive and corrosive lithium ore fines created several ongoing maintenance challenges, including:

Material hang-up and build-up, particularly in wet conditions, requiring frequent washdowns to prevent blockages.
-

High wear rates requiring liner replacement every 14-week shutdown.

First, the existing studded Ni-Hard liners were removed and replaced with new 8mm mild steel skins to provide the clean, flat surface required for Magnefast™ installation. To maximise wear performance, the liner design was tailored to each wear zone:

**Upper Section:** Installed with Magnefast™ 95% Aluminium Oxide ( $\text{Al}_2\text{O}_3$ ) ceramic liners for areas experiencing lower wear.

**Lower Section:** Installed with a combination of ZTA (Zirconia Toughened Alumina)

**Silicon Carbide (SiC) ceramic liners** to withstand the highest wear and flow concentrations. Silicon Carbide was also introduced as a trial material to evaluate its potential for even longer service life.

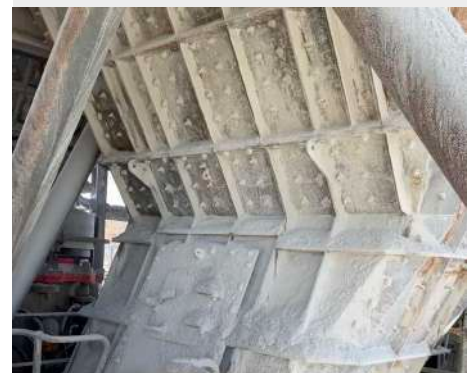
Labour-intensive changeouts involving scaffolding, gas axe cutting, and removal of corroded studs.
-

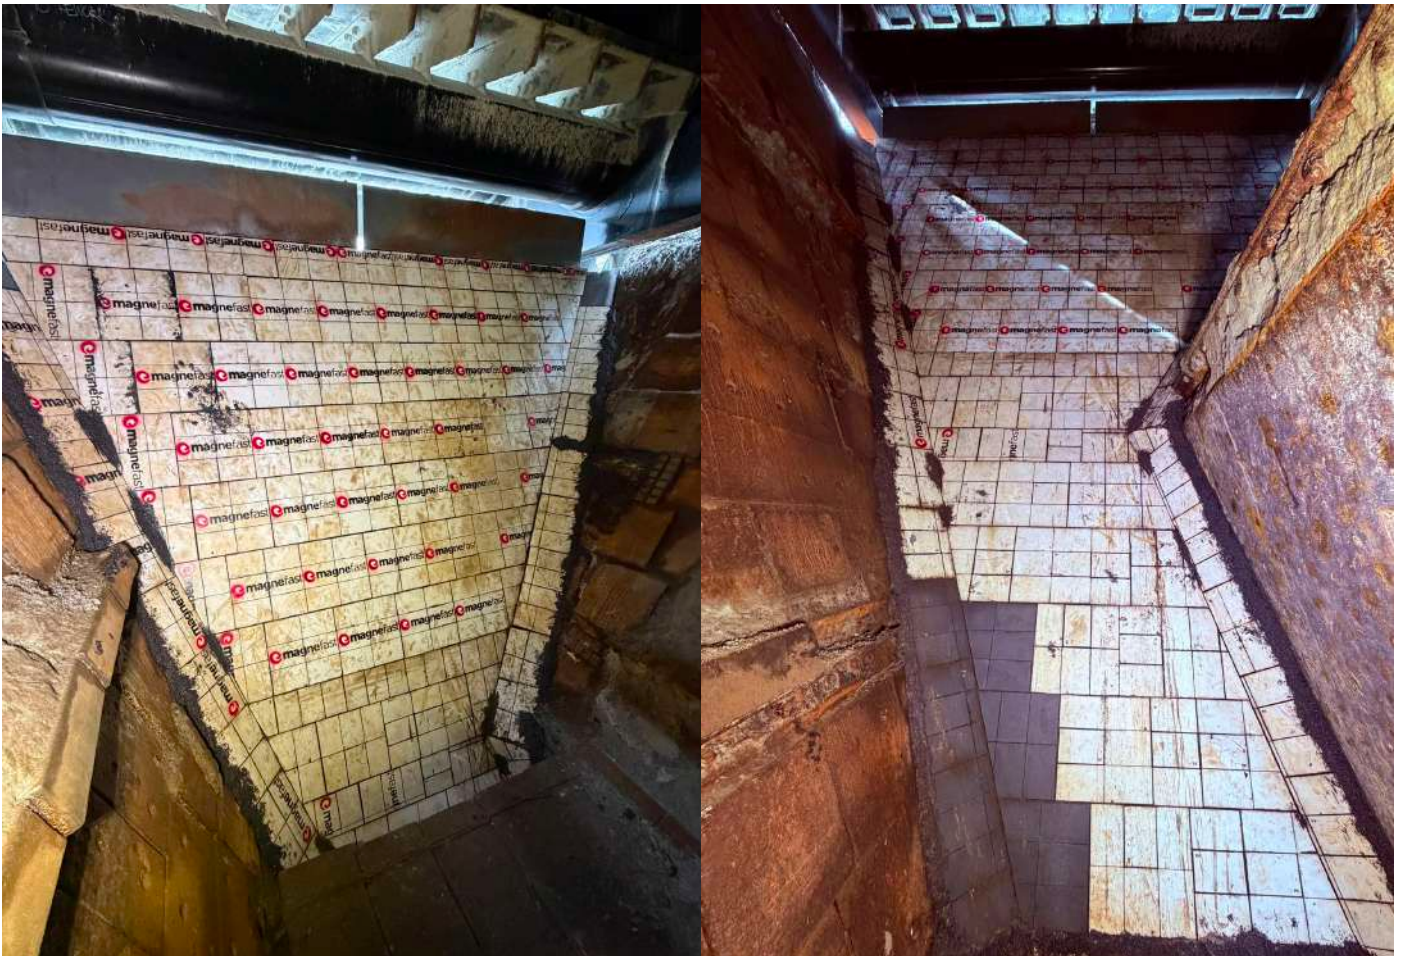
Unlike conventional studded liners, the Magnefast™ system allows adjacent panels to be installed without gaps, helping prevent material ingress, steel erosion, corrosion and the solving a key issue on site.

This installation took place in June 2026 with the first planned 14 week shut due first half of October 2026.
